FILE: ENG.KGEO03138-01

March 21, 2019

Geotechnical Assessment for Proposed Development at Lake Okanagan Resort

2751 Westside Road, Kelowna, BC - Revision 2

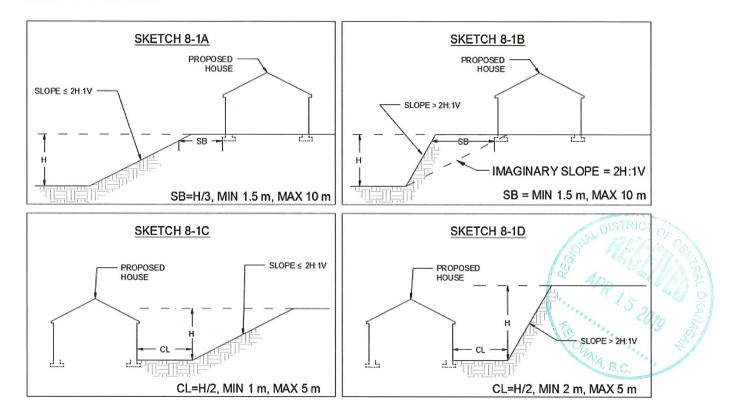
Sketch 7-1: Illustration Showing Set-Back and Clearance Distance for Soil Slopes

- Where a soil slope below a property is equal to or shallower than 2H:1V, the set-back distance between the outer edge of the foundation and the soil slope should be at least the height of the slope divided by 3 (see Sketch 8-1A) but no less than 1.5 m with no need to be greater than 10 m.

- Where a soil slope below a property is steeper than 2H:1V, the set-back should be such that an imaginary line between the outer edge of the foundation and the toe of the slope has an angle of 2H:1V or less (see Sketch 8-1B). In addition, the set-back distance between the outer edge of the foundation and the soil slope should be no less than 1.5 m horizontally from the face of the slope with no need to be greater than 10 m.

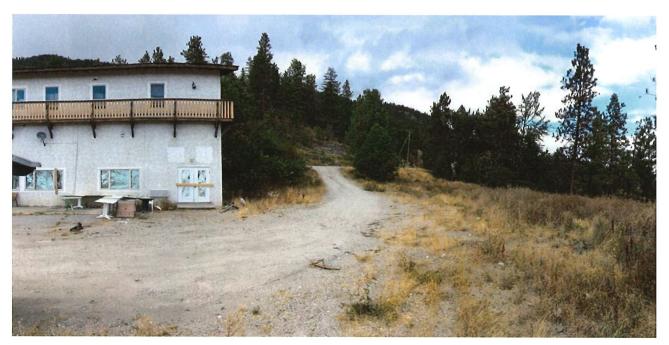
Photo 1: Looking northeast across the area of uncontrolled fill with the decommissioned building shown at the left. (Date of Photo – September 19, 2017).

It is recommended that the uncontrolled fill located east of the decommissioned building be excavated and removed from site. If necessary, the area should be backfilled with structural fill as detailed in Section 7.4.

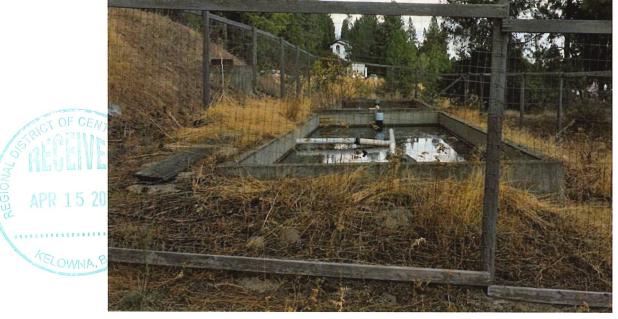
Photo 2: Looking north across the existing sand filters. (Date of Photo – September 19, 2017).

The information gap created by restrictions on the extent of the testpit investigation due to the presence of operational sanitary water sand filters and leaching fields creates a geotechnical risk for development in this area. It is recommended that further investigation occurs once utilities are decommissioned. Alternatively, geotechnical design could be completed for the area during construction. However, design during construction will carry significantly more uncertainty and risk both in terms of potential impact to foundation cost and construction timeline.

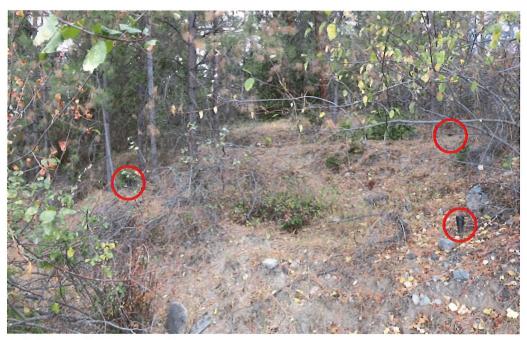
Photo 3: Looking west and uphill from near the bottom of part of the leaching field. Dug terraces are visible along with black PVC pipe (circled in red). (Date of Photo – September 19, 2017).

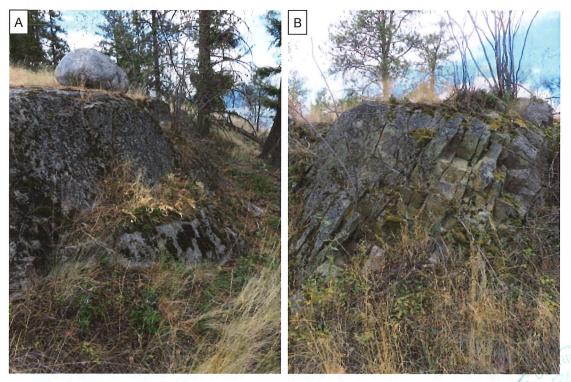
Photo 4: Bedrock outcrop A) looking northwest from the southern area of the site next to the edge of uncontrolled fill. B) Looking west and uphill from near the southern extent of bedrock outcrop close to lake level. (Date of Photos – September 19, 2017).

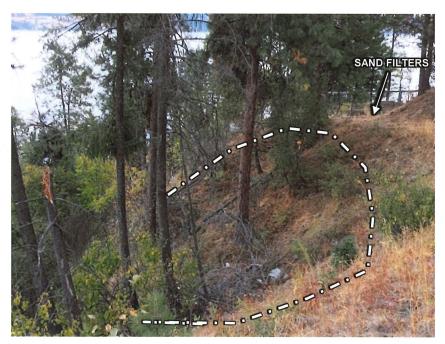
This landslide is located in the northwest corner of the property above the steep side gully separating the site from the main Lake Okanagan Resort. The area did not appear to be active at the time of investigation. However, historic movement is evidenced by a small concave depression in the slope with a potential backscarp that is approximately 10 m in width. Characteristic bending in the trunks of some of the trees in the area of the suspected instability was also observed. It is possible that this instability has occurred in overbank fill materials placed when sand filters for sanitary water disposal were constructed. In addition, the location of slip 1 is relatively close (~ 12 m) to the sand

Photo 5: Looking east from Westside Road at landslide 1 area. The concave area where historical movement may have occurred is indicated. (Date of Photo – September 19, 2017).

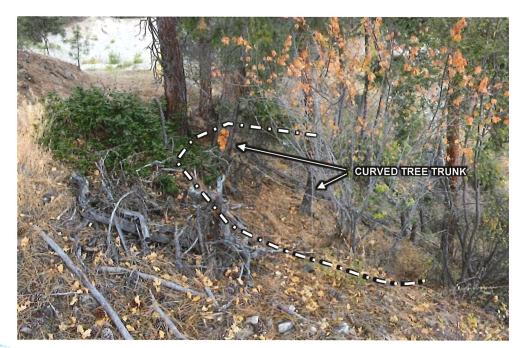
Photo 6: Looking west toward landslide 1 area. The concave area where historical movement may have occurred is indicated along with curved tree trunks that often indicate slope movement. (Date of Photo – September 19, 2017).

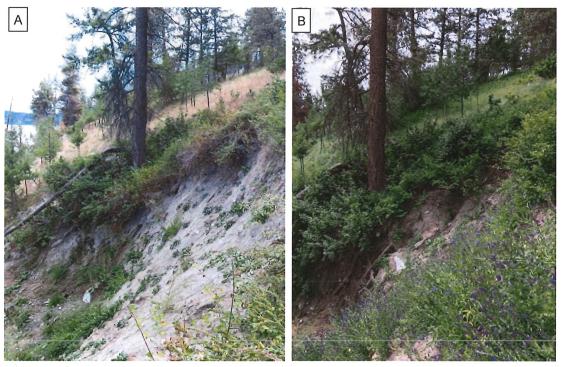
This landslide is located in the northeast corner of the property and is an active landslide that currently extends from lake level back to the track leading up from the sanitary water treatment plant (see Figure 1). The landslide is located directly below the location where it is suspected that the forcemain from the sanitary water treatment plant turns approximately 90 degrees to the west and heads straight uphill to the sand filters. Water has been observed seeping from the bottom of the main backscarp every time the site has been visited.

The landslide is not visible in 2016 aerial imagery on the RDCO website but is visible on Google Earth imagery dated August 4, 2017. At the time of initial inspection in September 2017, the landslide area was relatively free of vegetation when compared with vegetation present during testpitting in June 2018. Some additional failure has occurred since our September 2017 inspection.

The information presented above suggests that the main body of the landslide failed in 2017, likely in the spring or early summer during the unusually high lake levels experienced that year. It is our assessment that high lake levels likely caused shoreline erosion that removed toe support for the slope. In addition, groundwater seepage will have significantly reduced the shear strength of the soil. It is our assessment that removal of toe support coupled with loss of strength due to groundwater seepage were the two key contributing factors resulting in the main failure of the slope in 2017.

It is likely that groundwater seepage observed at the backscarp is directly related to the sanitary water seeping through the sand filters and leaching field. Much of the infiltrating sanitary water is likely channeled to the landslide 2 area by both the bedrock surface and a direct flow path along the forcemain trench. At least some of the groundwater flowing along and through the forcemain trench likely exits the trench at the 90 degree turn where the forcemain turns to the treatment plant as this corresponds with the apex point of the landslide.

Photo 7: Looking south along the main backscarp of landslide 2. A) September 19, 2017. B) June 29, 2018.

Currently the active landslide area of landslide 2 is not directly impacting proposed chalets locations. Preliminary slope stability analysis suggests that if infiltration of sanitary water is stopped and groundwater level is lowered, slopes at the site may be battered back and considered stable. However, more detailed slope stability analysis is needed to further evaluate the landslide and undertake mitigation measures to stabilise it.

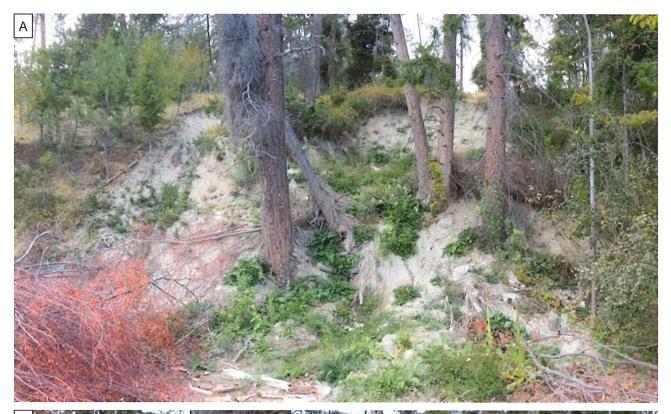
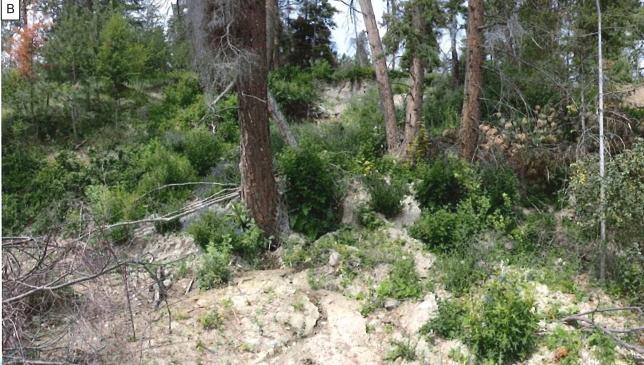
Photo 8: Looking west from lake level uphill to the area of landslide 2. A) September 19, 2017. B) June 29, 2018.
