MEMORANDUM

To: Dan Plamondon, Director Planning Services, RDCO

From: Don Dobson and Michelle Cook

Subject: Shorts Creek Risk Assessment

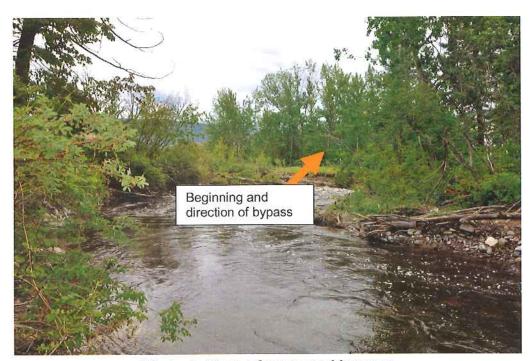
Photo 1: Start of proposed bypass

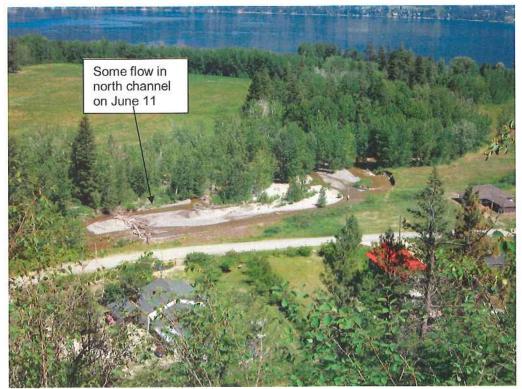
Photo 2: June 11, high water has moved creek flow into the North Channel

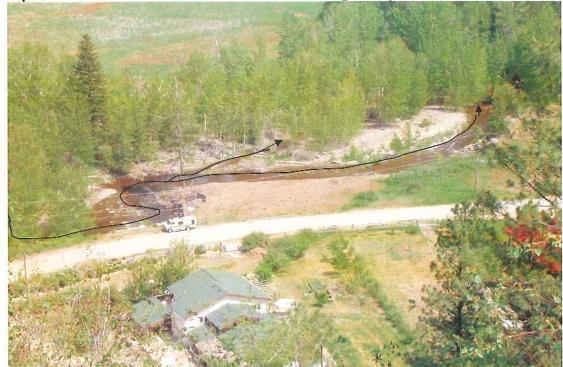
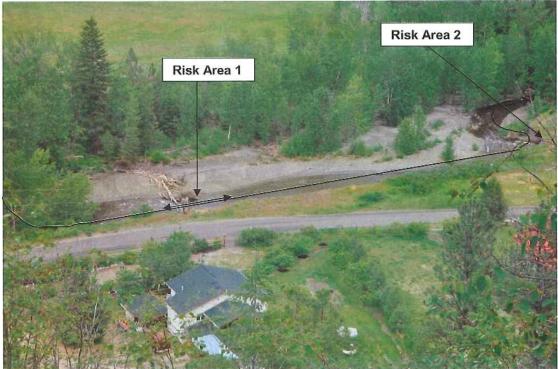
Photos taken in 2009 and 2012 have been compared to show the channel movement over the three-year period. Comparison 1 identifies the two most significant areas of risk. The photos show the erosion of the 'hook,' and the loss of land between the channel and the road. The channel is now running parallel to the road in this section and the fine sediment composition of the bank means that the road will likely be threatened with the next major flood or rain event.

In the 2009 Dobson report it was noted that "the channel has formed a very well defined 'hook' on the right bank upstream of Lot 88 that creates a further threat to Lot 88 when the flow erodes the bank at this location." During the April 25/26, 2012 flood event this indeed did occur and the hook was completely washed away (refer to Comparison 2). The loss of the 'hook' resulted in a change in flow pattern with the flow now tight against the south bank as can be seen in Comparison 1, 2 and 3.

Comparison 1: Shorts Creek 'hook' erosion along Fintry Delta Road south bank

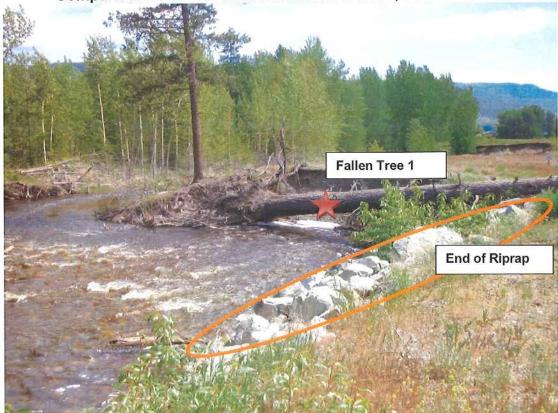
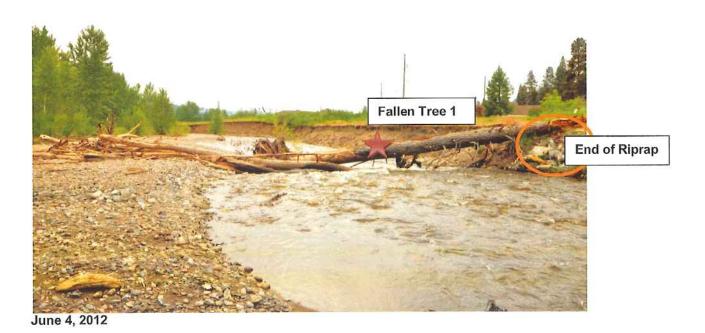
Comparison 2: Shorts Creek total loss of hook, tree and land mass.

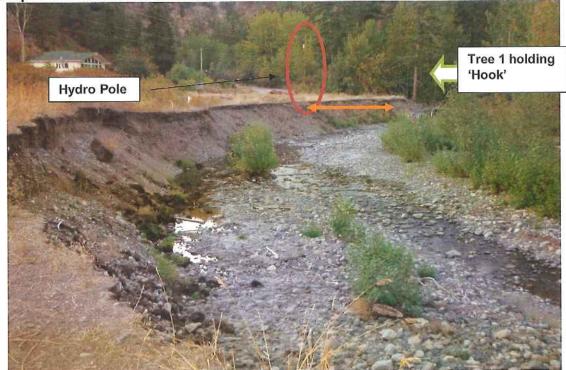
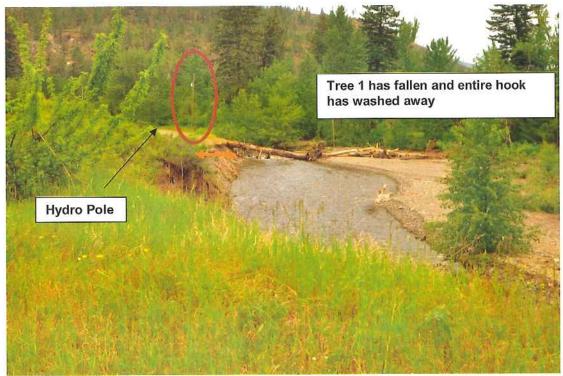
The first risk area is to the Fintry Delta Road. Between 1997 and 2008 The Ministry of Transportation and Infrastructure maintenance contractor installed riprap along the south bank of the creek along the Fintry Delta Road right of way, upstream of the hook to protect road at this location. If this riprap had not been in place the creek would have undermined the road. Comparison 2 shows the end of the current riprap, located just under the fallen tree. When the fallen pine tree in Comparison 2 that has it top resting on the south bank collapses into the channel, it will divert the flow into the south bank downstream of the riprap and threaten the Fintry Delta Road. This is the most significant risk to public infrastructure. Comparison 3 shows Shorts Creek bank erosion movement towards the Fintry Delta Road looking west.

Comparison 3: Shorts Creek bank erosion movement towards the Fintry Delta Road

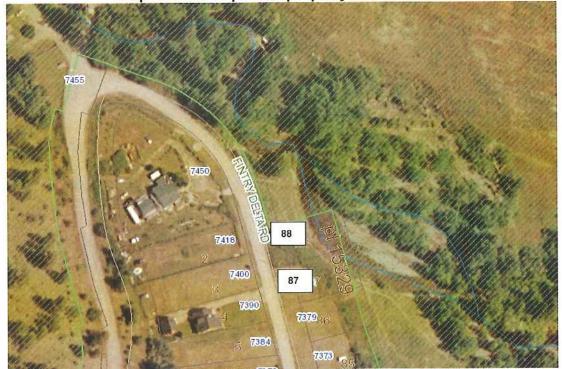
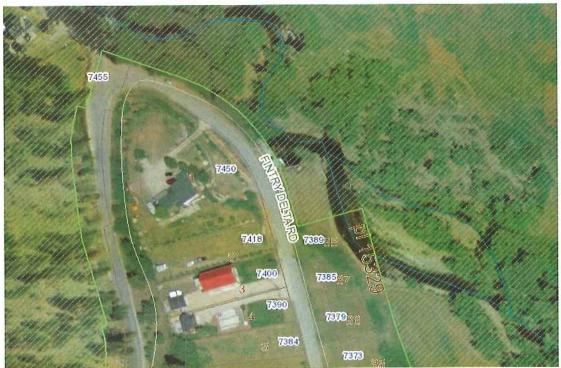
Comparison 4 shows the RDCO GIS photography dated the spring of 2005, and again the spring of 2009. Between 2005 and 2009 a significant amount of private land was lost from both Lot 88 and 87 as the channel continued to migrate to the south. During the 2012 field assessment the depth of Lot 88 on the north property line is now 10.6 m. (The original property line length was 120 feet or 30.6 m.) It is understood that it is no longer possible to build on Lots 88 and 87 due to the loss of land and the ongoing flood risk. The erosion has now progressed into Lot 86. There is a residence under construction on Lot 85. In 2009 the south side of the creek was approximately 23 m

Comparison 4: Regional District of Central Okanagan Geographic Information System

Map erosion of private property Lot 88 and 87.

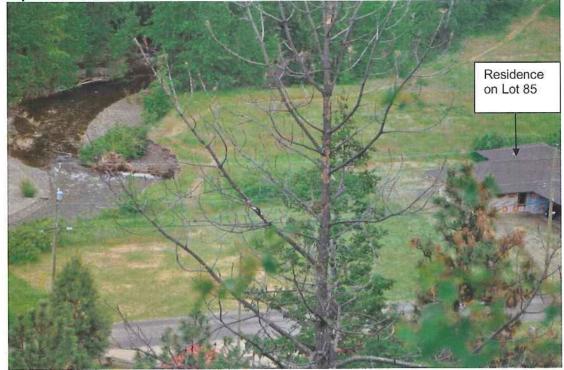
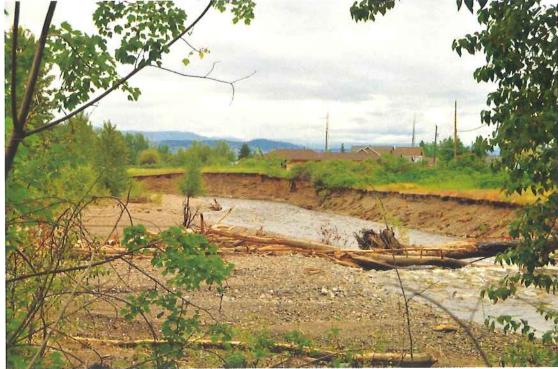
north of the northeast corner of Lot 85. The bank erosion in 2012 has moved the bank within approximately 16 m of the northeast corner of that lot (refer to Comparison 5).

Comparison 5: Distance between Lot 85 residence and the Shorts Creek channel

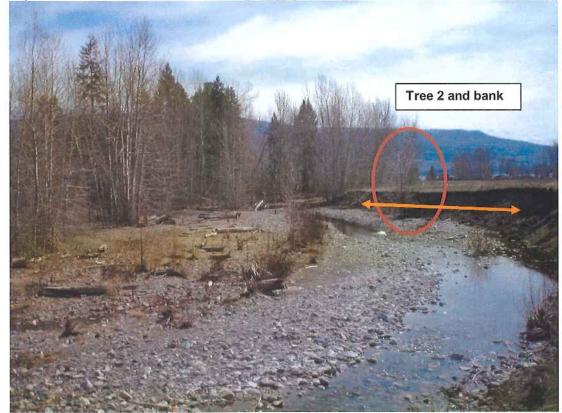
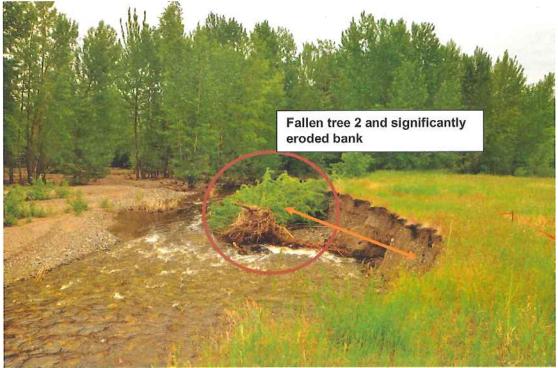
Comparison 6 shows the downstream and Comparison 7 the upstream view of the second risk area. The location of the cottonwood (Tree 2) on the bank in the 2009 photo (refer to Comparison 6) that is now lying in the creek in the 2012 photo illustrates the extent of erosion during the 2012 high flow event. In Comparison 7 it can be noted that the channel is no longer flowing on the north side of Tree 3. Aggradation of the channel since 2009 has shifted the flow to the south.

Comparison 6: Shorts Creek erosion downstream of 'hook' loss and private property

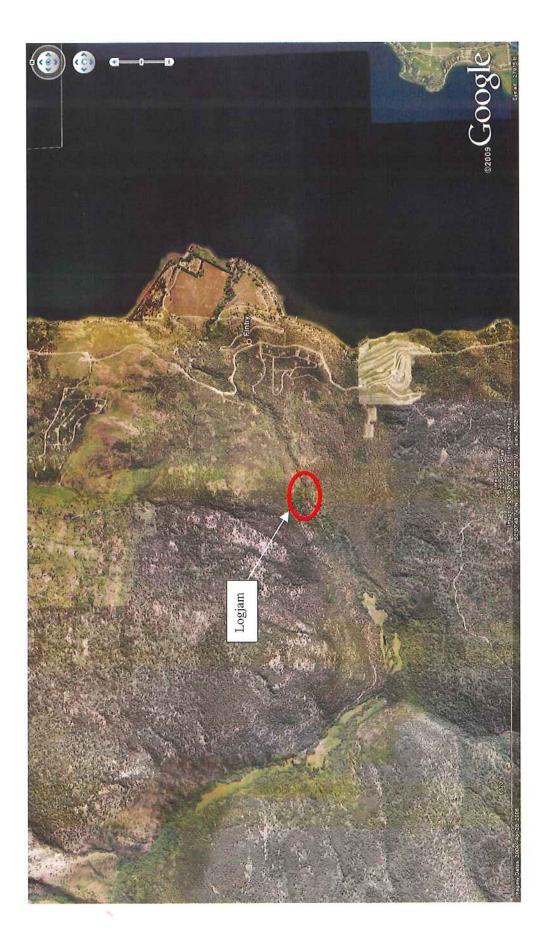
The Shorts Creek channel was reviewed from the headwaters to the fan as part of another project undertaken by Dobson Engineering in 2008. A major logjam was identified in the main channel approximately 1.5 km upstream from the Westside Road crossing (Figure 7). This logjam had a large accumulation of gravel upstream of the jam (Photo 4) and appeared to have interrupted the natural bedload transport downstream. Although the date of the logjam is not known, it is likely that additional logs were added to the jam during the 1997 high flows that was the last major flood event in the system. The jam was in tact in 2009 and continues to trap bedload causing a major disruption to the stability of the stream downstream.

Figure 7. Location of logjam on Shorts Creek upstream of Westside Road

The logism upstream of the Westside road should be breached to restore the natural bed load transport. If this was done the stream power would gradually return to a natural level and the down cutting downstream of the canyon would eventually cease and the original channel geometry restored bed load from upstream moved downstream.

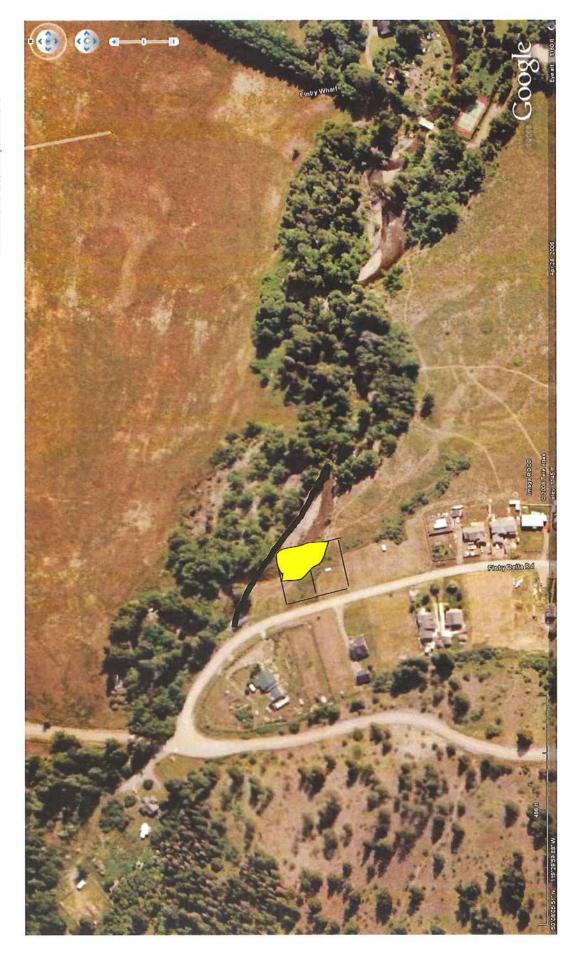
Figure 8. Approximate location of reconstructed and armoured bank alignment and reconstruction of Lots 88 and 87.

The solution to this problem is beyond the capability of the owners of these lots. As a minimum action needs to be taken immediately to restore the flow downstream of the new bridge back into the original channel near the north bank. This will require approximately 150 m of armour starting approximately 80 m downstream of the new bridge on the right bank and extending downstream past the private lots. This armoured restored bank line would maintain the flow in it original channel and provide an overall channel width of at least 40 m that would be similar to the channel widths upstream of the bridge and downstream (Figure 8).
