Project: 20021

June 26, 2020

**Re: Mission Creek Greenway Cedars Bridge – 2020 Flood Damages**

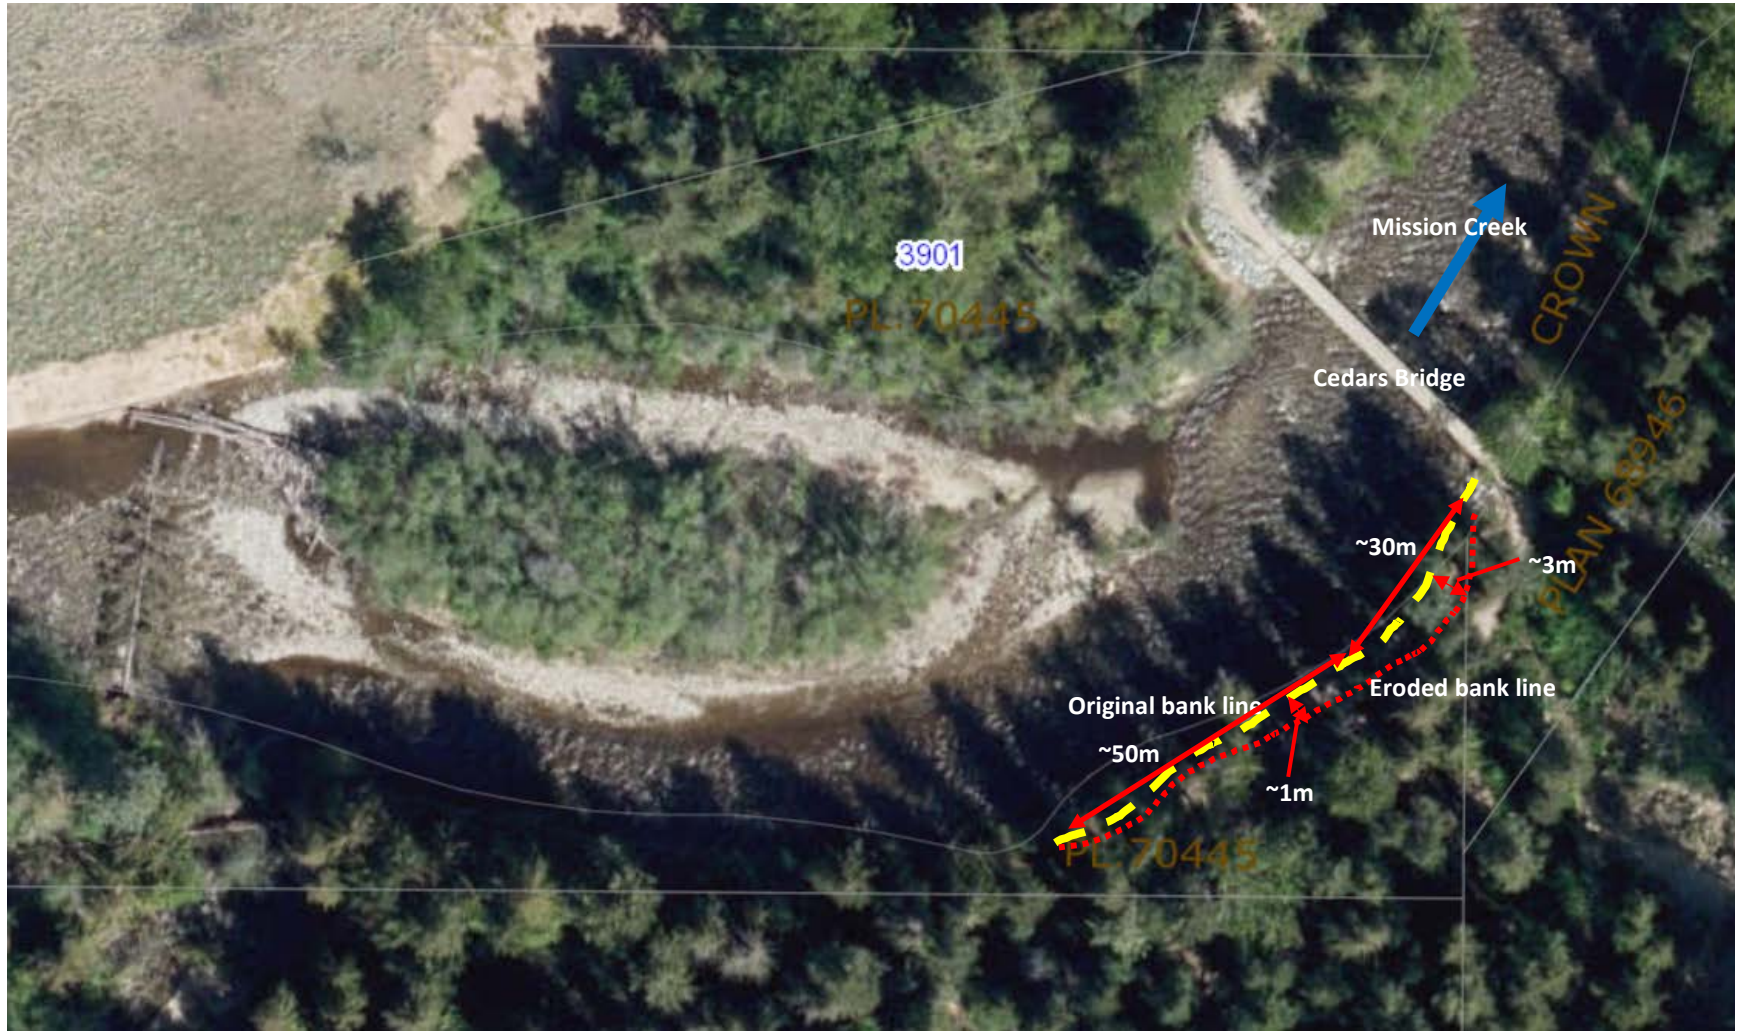
The bridge is situated in a moderate bend in the creek channel (Figure 2). The erosion has occurred on the outside of the bend. The right bank shows recent abrasion starting ~90m upstream of the bridge with obvious bank erosion at ~80m upstream with the bank eroded back ~1m on average over the first 50m and increasing to ~3m back over the last 30m (Photos 3&4). Currently the erosion stops ~3m upstream of the riprap protecting the right bank bridge abutment (Photo 5).

Figure 2 – Mission Creek at Cedars Creek Bridge 2020 erosion

The preferred restoration plan is to restore the pre-flood bank alignment over the ~30m section immediately upstream of the bridge and armour the restored bank with riprap. The riprap should extend upstream for an additional 50m to protect the section of bank that was also eroded this spring to ensure that the section of most susceptible natural bank line is protected for further erosion. The Greenway walking trail is located on the floodplain along this section and is vulnerable if there was future erosion.

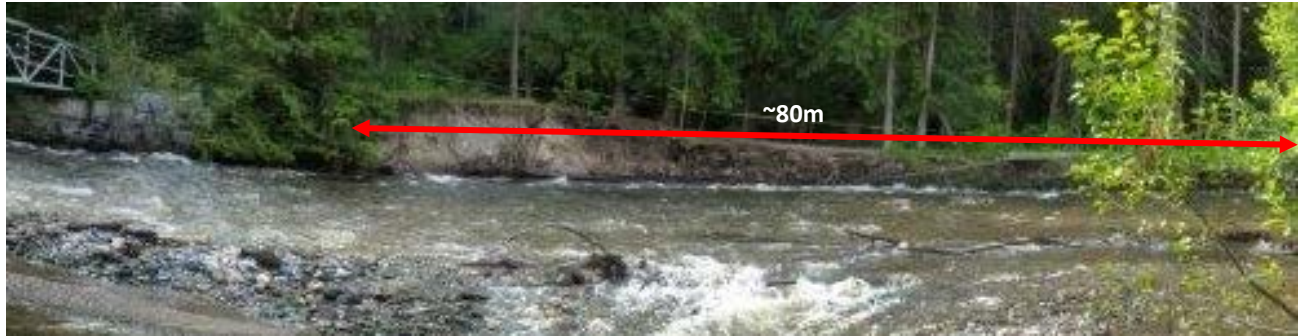
The Cedars Creek bridge is part of the Mission Creek Greenway Regional Park (Phase 2) and is located approximately 1.2km upstream of the East Kelowna Road Bridge (Figure 1). During the 2020 spring freshet in Mission Creek, likely during the peak flows on May 31-June 1 of ~107cms, the right bank upstream of the bridge was eroded over ~80m extending downstream to the bridge abutment (Photos 1&2).

**Photo 1 – Extent of 2020 erosion on right bank at Cedars Bridge**

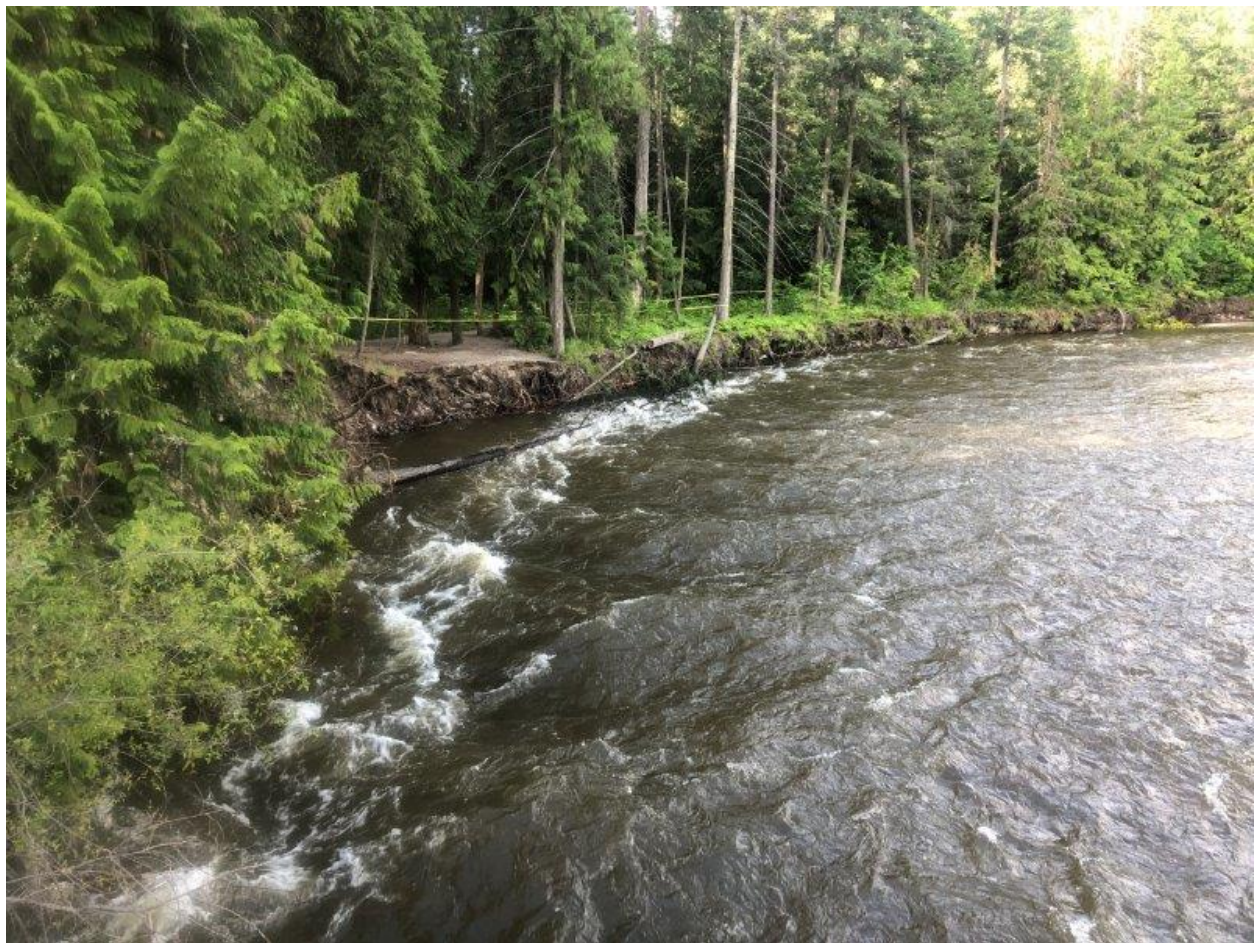
**Photo 2 – View looking upstream from bridge at right abutment**

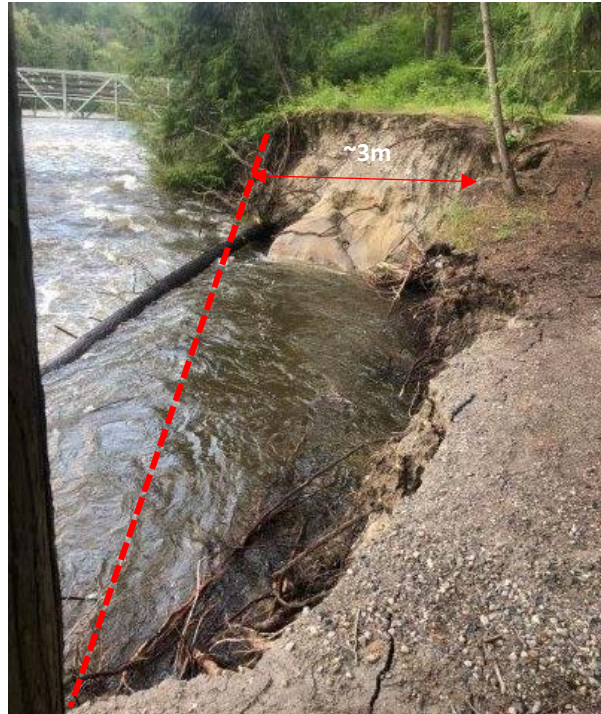
The recent erosion has put the Cedars Bridge at risk. The downstream end of the eroding bank has eroded the bank back by ~3m with the end of the erosion within 3m of the armour at the right bank abutment. Unless the bank is restored and armoured the erosion will continue during future high flows and there is a high risk that the erosion will extend behind the existing riprap compromising the bridge abutment.

Photo 3 – Section of eroded bank near abutment showing 3m loss of back

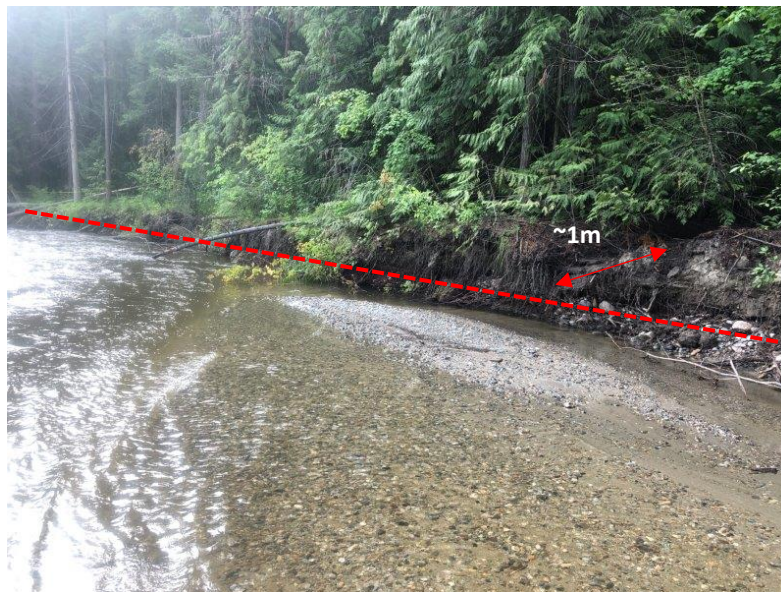
Photo 4 – Section of bank eroded back ~1m

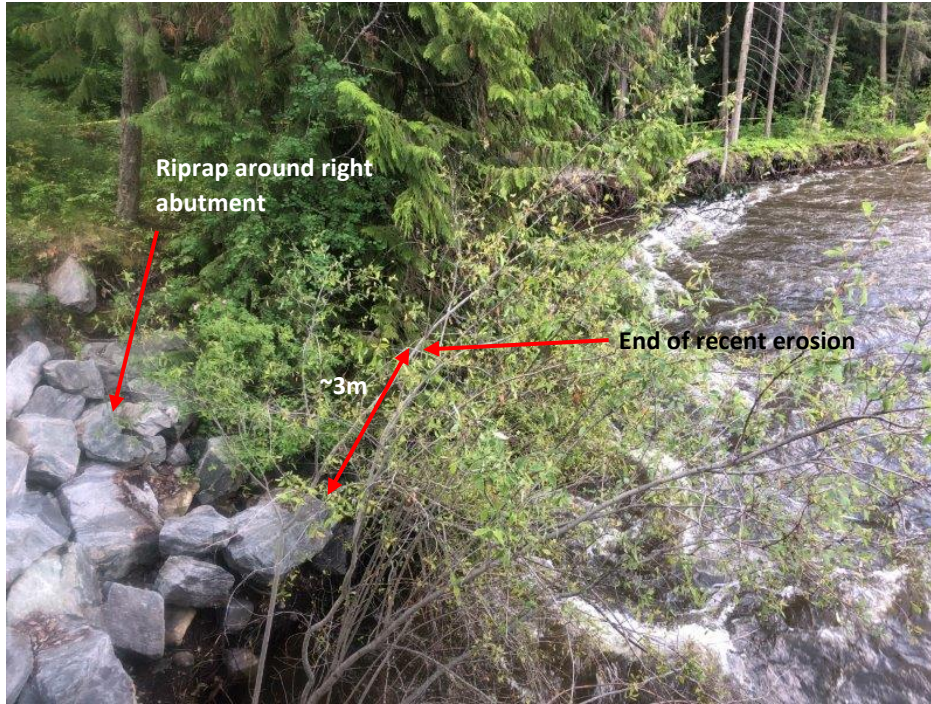
Photo 5 – Erosion ends ~3m upstream from riprap at right abutment

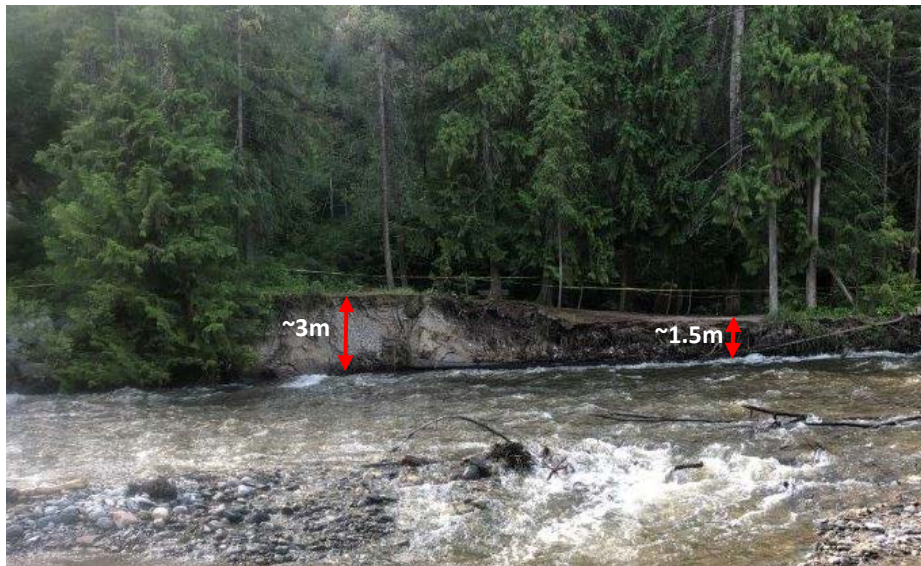
Bank heights range from ~1.5m over the upstream 50m and ~3m over the downstream 30m (Photo 6). Bank materials are primarily unconsolidated fluvial sands and gravels. The bank erosion also caused mature Ponderosa pines along the stream bank to fall into the stream.

Photo 6 – Eroded bank heights from June 26<sup>th</sup> water level
