CLARKE GEOSCIENCE LTD.

POST-WILDFIRE ENVIRONMENTAL AND HAZARDOUS CONDITIONS ASSESSMENT OF THE NORTH WESTSIDE ROAD AREA

Dated: February 1, 2022
Presented To: Regional District of Central Okanagan
Attention: Brittany Nichols, Environmental Planner
CGL Project # 21-0115 EOC #A21-674

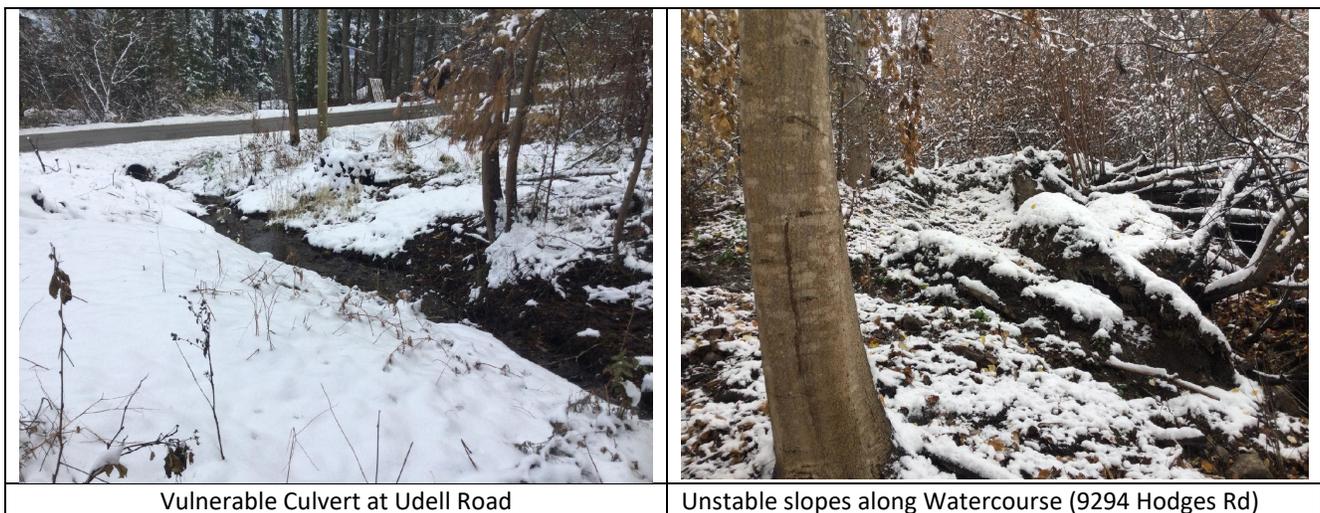
Figure 4-1: Vulnerable Culvert and Unstable Slopes in the Killiney Beach area

Because of the moderate to high hazard level associated with post-wildfire hydrologic effects and the close proximity to the water course (high spatial likelihood of impact), the risk is determined to be high to very high. The downstream property at 9294 Hodges Road has an elevated hazard (i.e., high) and risk (i.e., very high) because of observed soil slumping and instability along the stream channel (see Figure 4.1, photos). For these identified properties, increased peak flow runoff from the slopes above may result in a hazardous condition with the potential to cause damages to property and/or infrastructure.

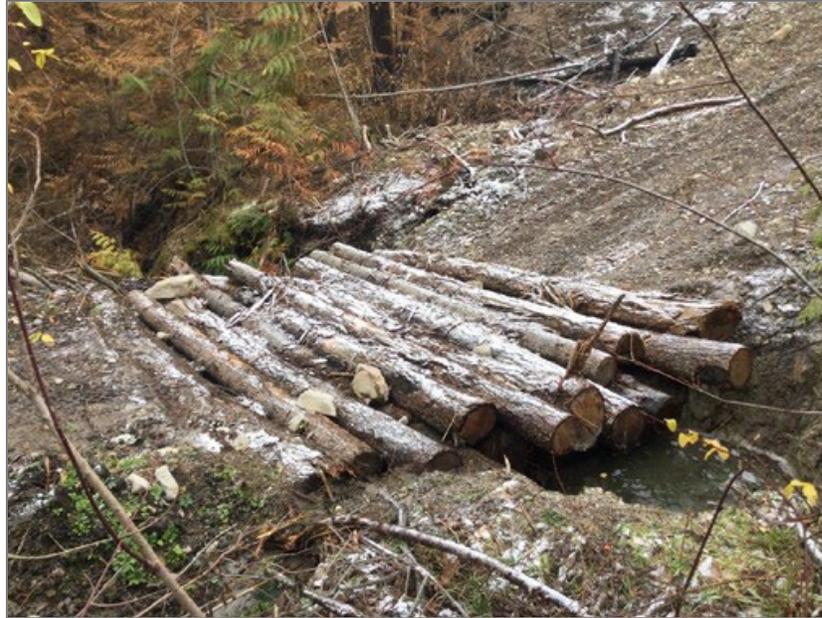
Figure 4-2: Woody Debris within Channel at Fireguard Crossing on Norris Creek

1. A fireguard crossing on Norris Creek, located south of the Killiney Beach area and accessed off the end of Winchester Road. Logs placed in the channel to facilitate fire suppression efforts through the area constitute a hydrologic hazard that may potentially impact properties downslope (see Figure 4.2, photo). The site conditions were communicated to staff at the Ministry of Forests, Lands and Natural Resource Operations and Rural Development (Shuswap Okanagan Forest District office) for rehabilitation. It is recommended that the logs within the channel be removed and the fill material along the banks be pulled back to a stable angle.

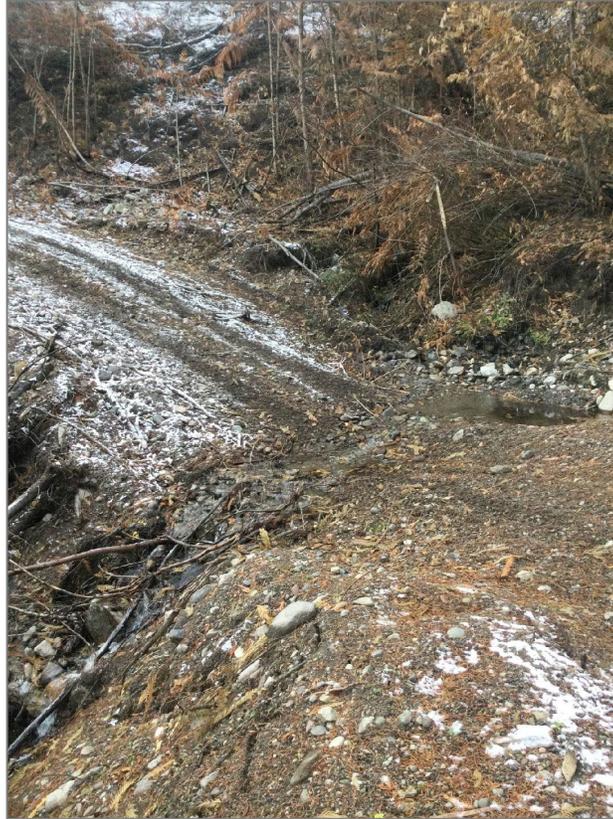
Figure 4-3: Unstable Fills at Trail Crossing on Norris Creek

2. A trail crossing on Norris Creek, just upstream of the fire guard crossing described above (see Figure 4.3, photo). Instability along the channel and trail fill slopes likely pre-date the wildfire, but now present a risk to downslope properties if the channel experiences increased runoff. The trail crossing location appears to be associated with a domestic water intake site (RDCO) that is no longer in use. Conditions at this site were communicated to RDCO staff.

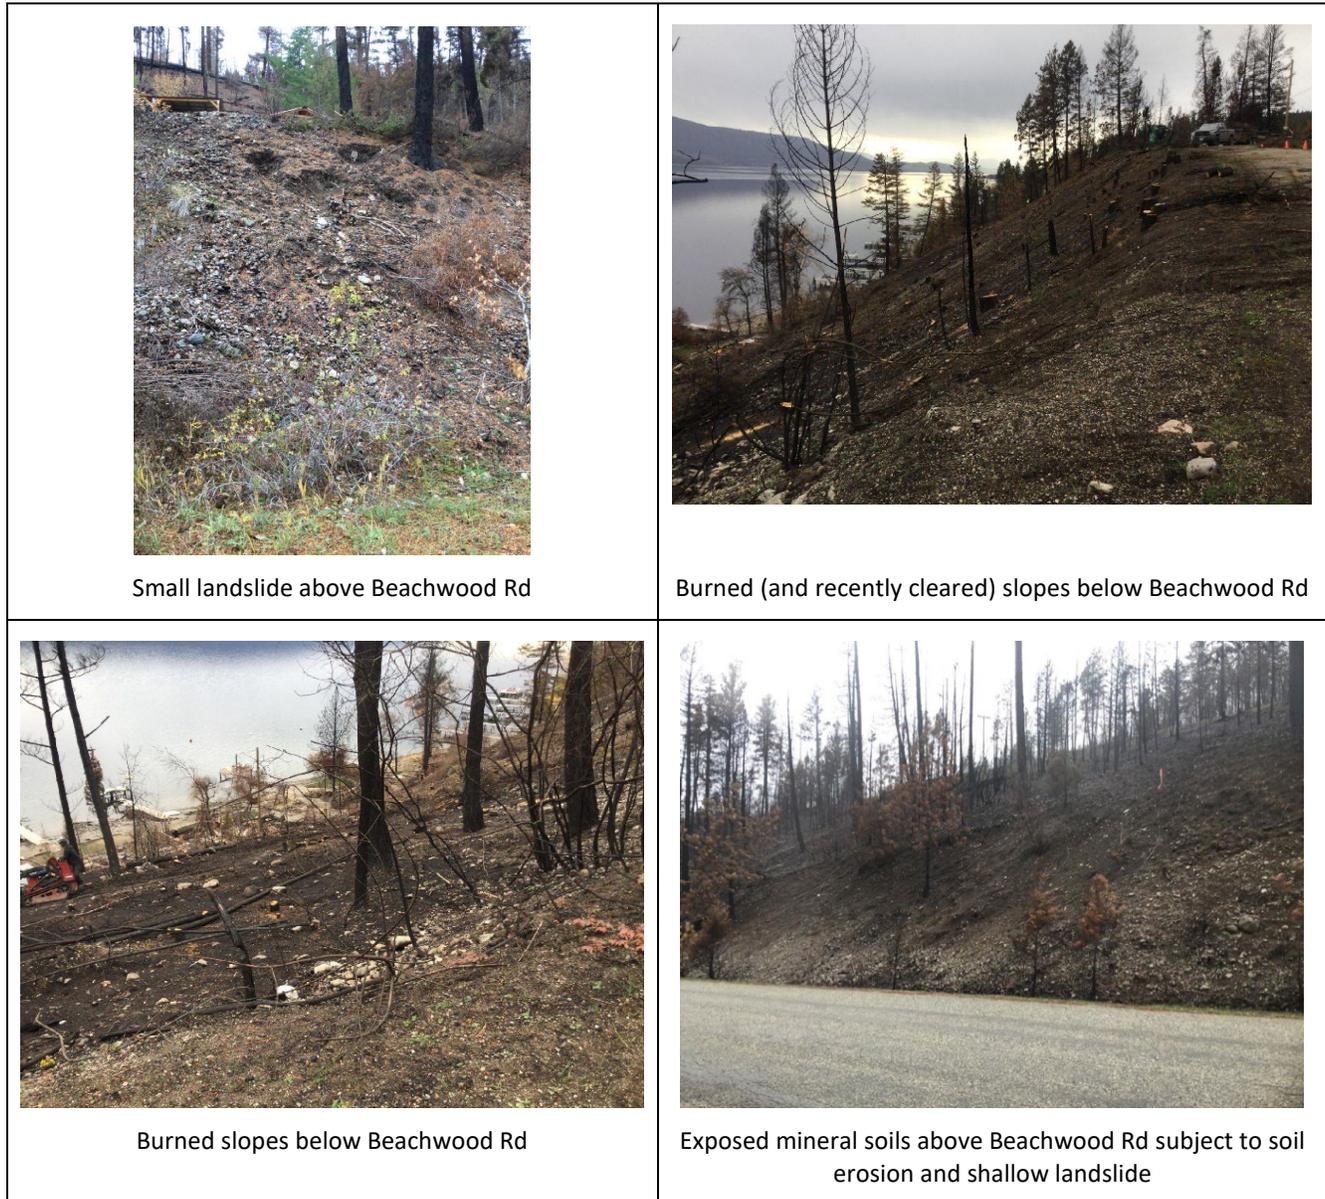
Figure 4-4: Photos of Severe Burn along Beachwood Rd (Estamont Area)

Severely burned steep slopes above and below Beachwood Road appeared to have observed soil slumping, small scale instability, and had exposed mineral soils considered to have a high potential for soil erosion (see Figure 4.4, photos). There is a high likelihood that sediment would reach Beachwood Road, the downslope properties, and Okanagan Lake. At the time of the assessment, a privately retained landscape contractor was clearing burned trees from the slopes along three properties and was intending to plant and seed the area. Further recommendations for the area are provided in Section 6 of this report.

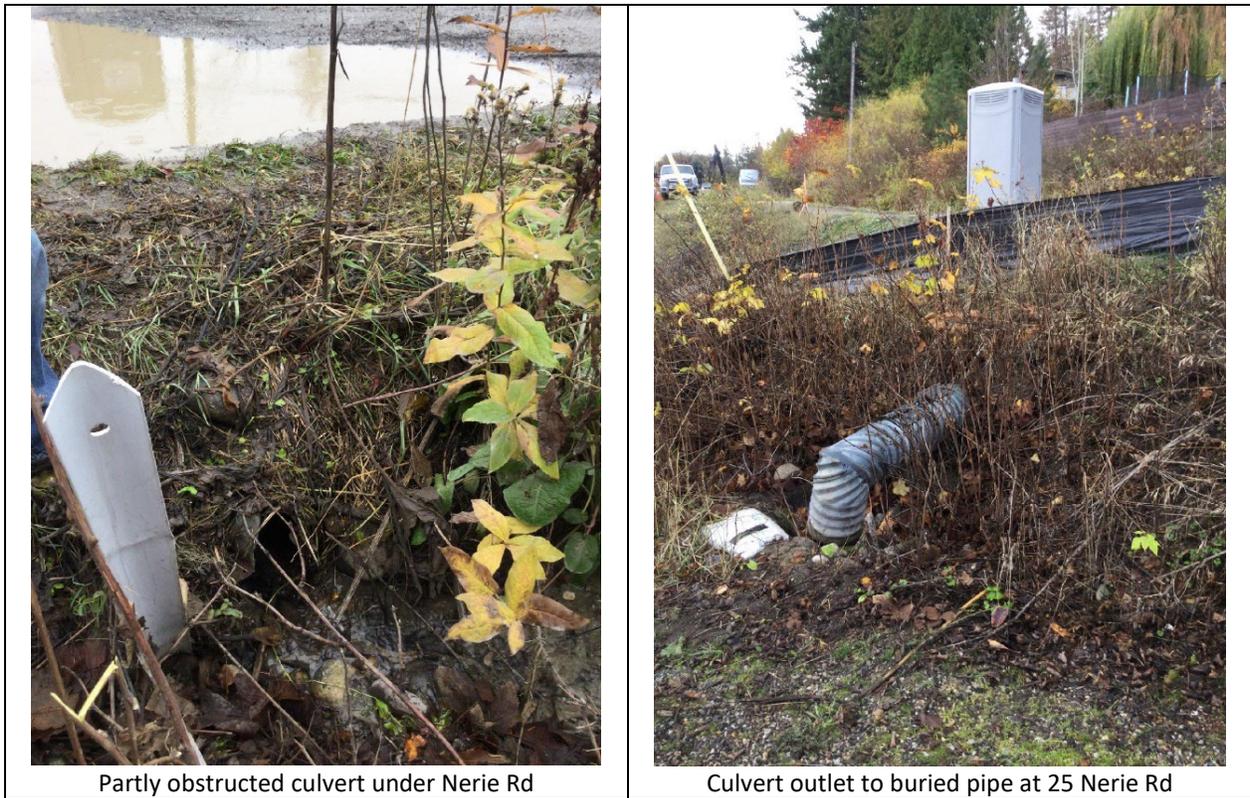
Figure 4-5: Potentially Vulnerable Culverts along Buchanan Spring along Nerie Rd (Estamont Area)

Two of the twenty-one assessed properties in the Nerie Road area have a high-risk level associated with groundwater seepage and the potential for geotechnical instability. A small watercourse identified as Buchanan Spring emerges from a zone of groundwater emergence above 104 Elliott Road, then flows through a culvert under Nerie Road (see Figure 4.5, photos). Runoff is conveyed by pipe through downslope properties before emerging within and between 23 Nerie Road and 25 Nerie Road. It is unclear whether culverts and pipes in the area can accommodate increases in groundwater discharge. Soil and groundwater effects in the general area may result in a hazardous condition with the potential to cause damages to property and/or infrastructure.

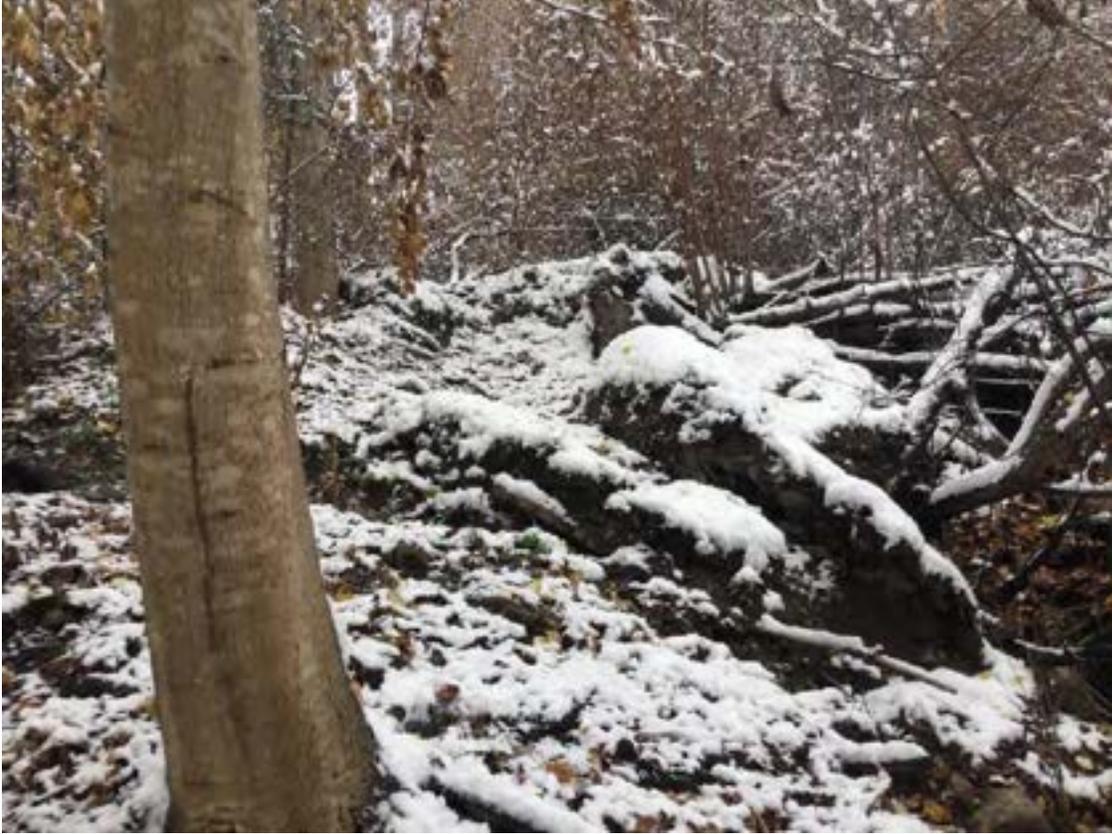
Photo 3: Unstable slopes observed along watercourse within 9294 Hodges Rd.

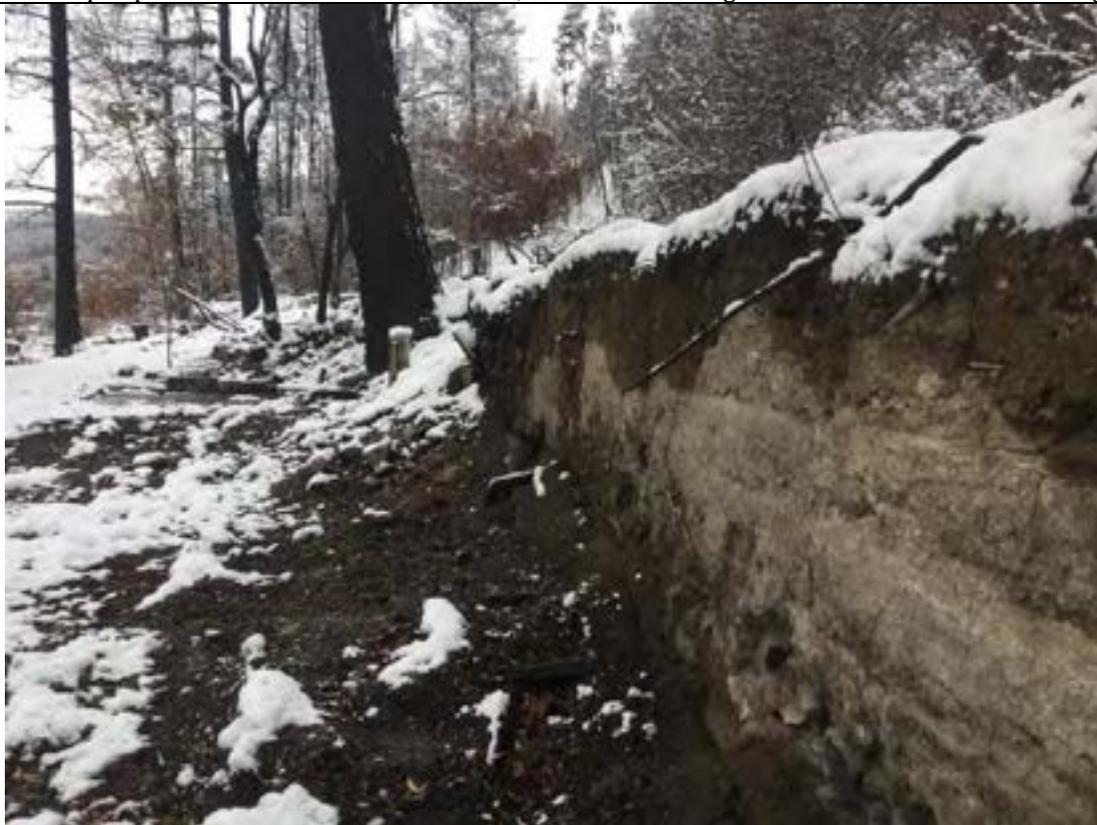
Photo 2: Close up view of burned wood retaining wall at 55 Killarney Pl.

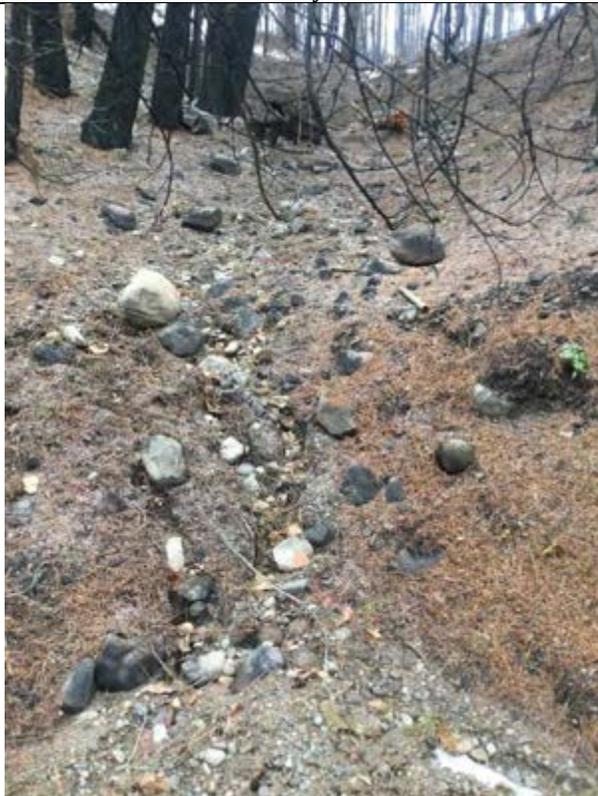
Photo 4: Small gully located on 81 Killarney Pl, with evidence of sediment transport through burned area

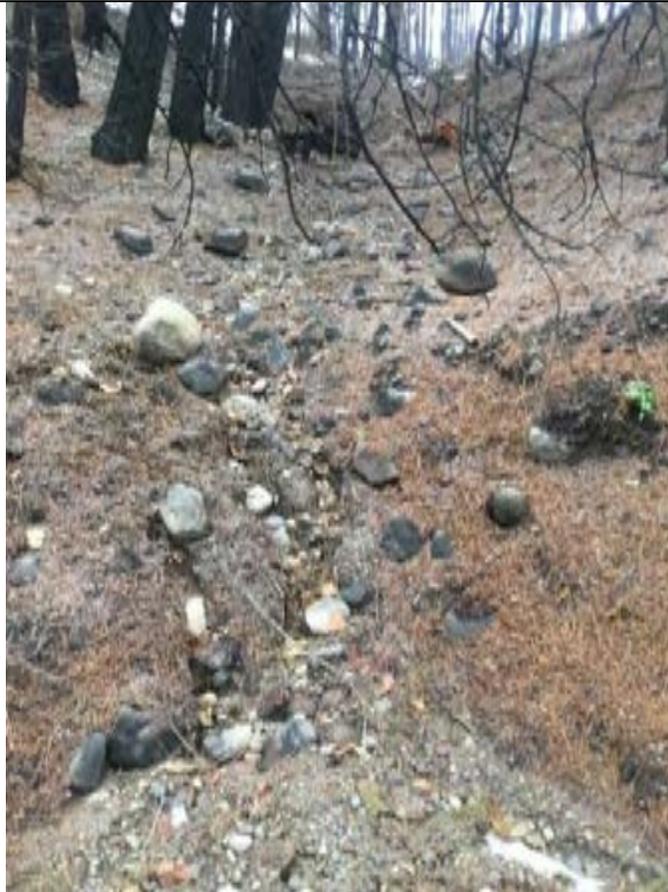
Photo 3: View of small gully situated along property line (from 81 Killarney Pl.) showing recent sediment transport through burned area

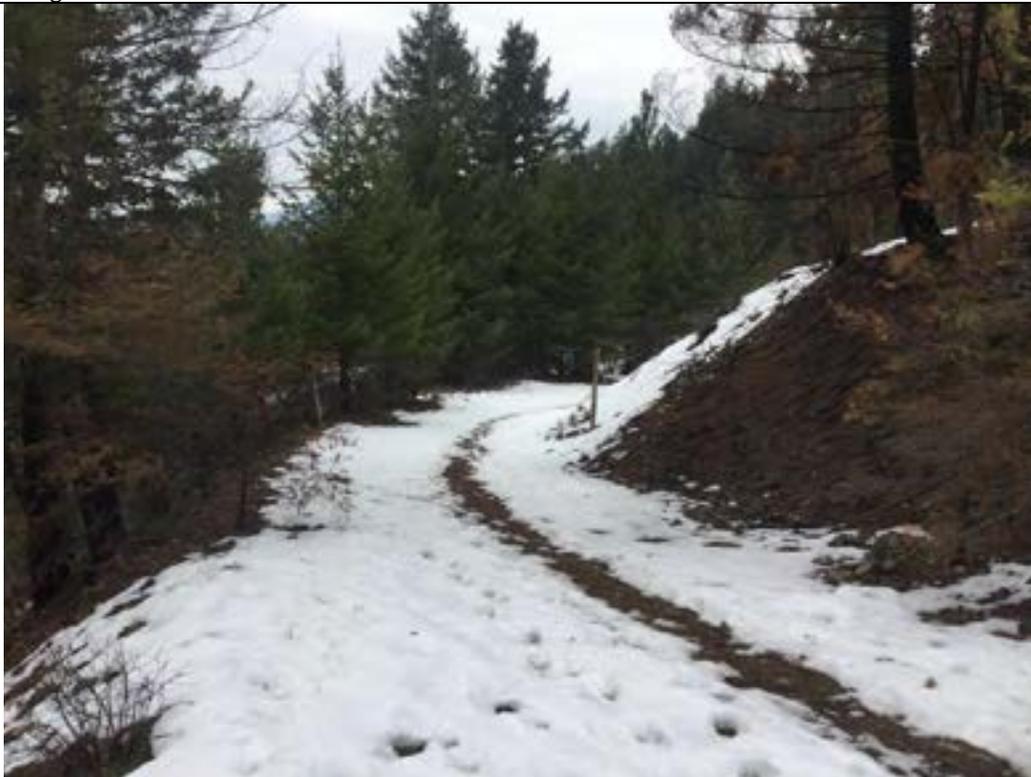
Photo 4: Unpaved access trail switchbacks off end of Killarney Pl. Minor raveling cutslopes and minor erosion along trail surface.

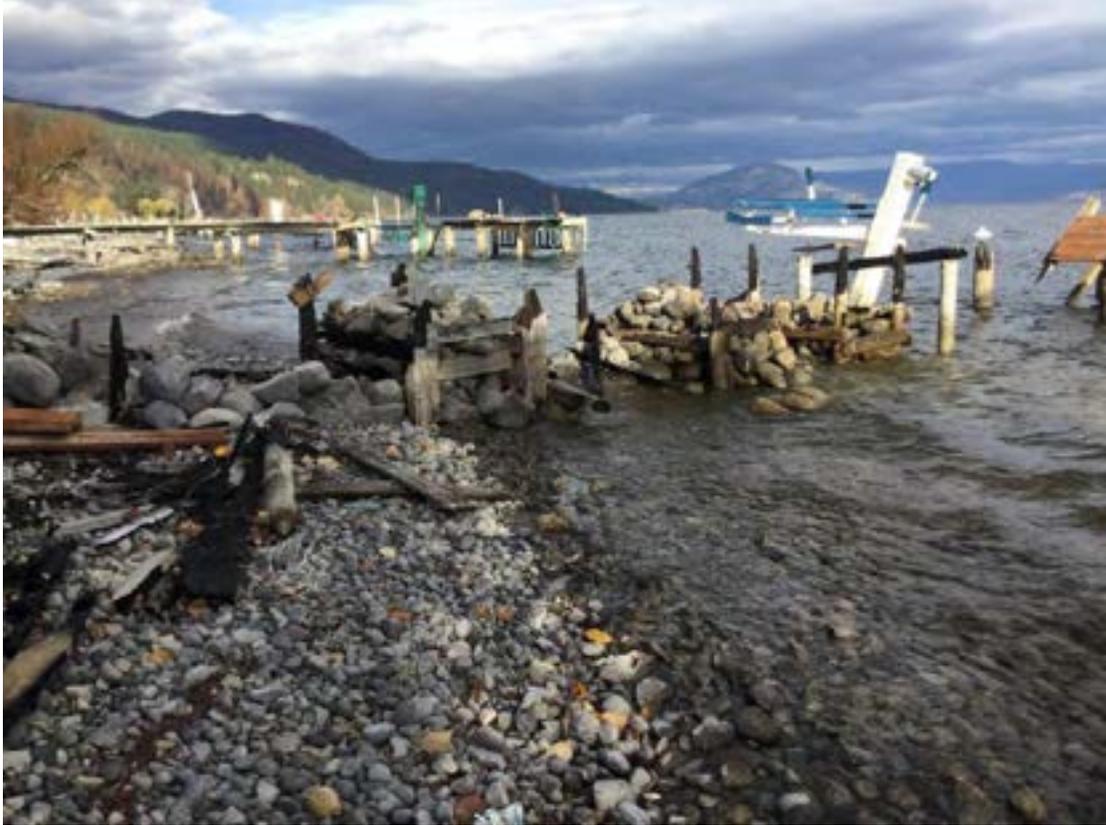
Photo 3: View of damaged dock with rock filled piling at 2 Nerie Rd.

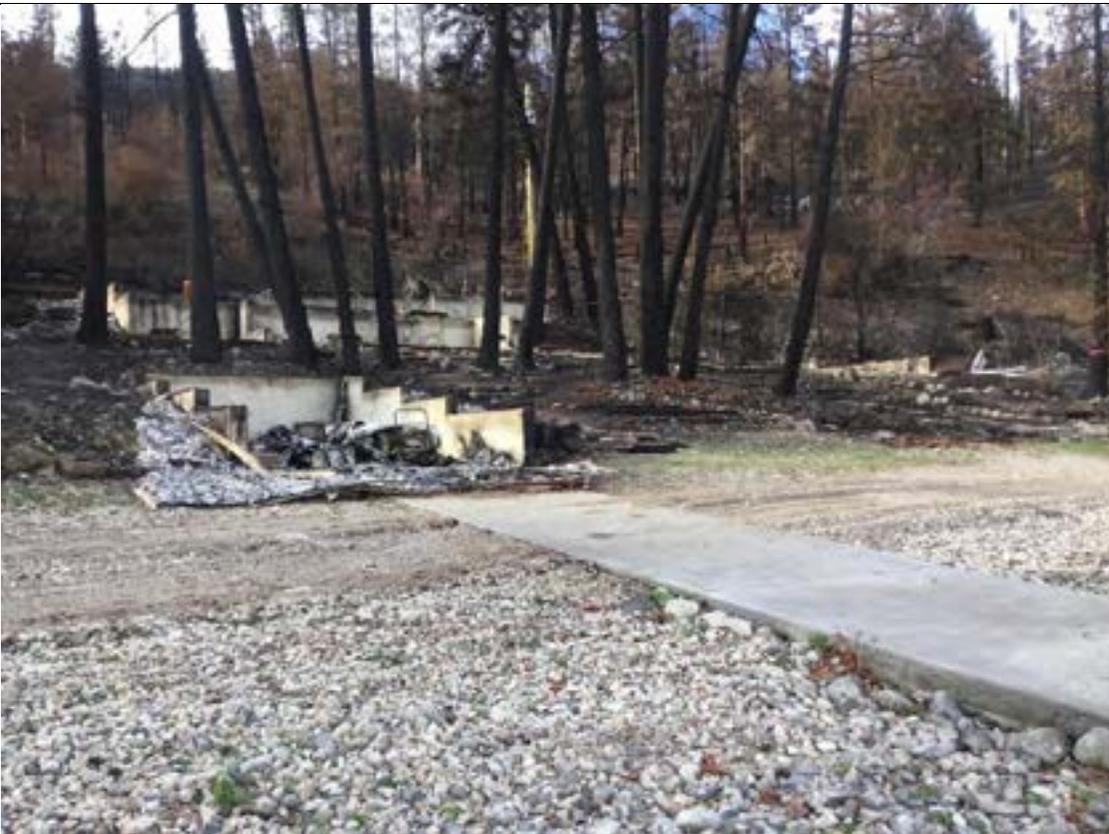
Photo 2: View from foreshore area at 11 Nerie Rd. with concrete boat ramp and burned boat house

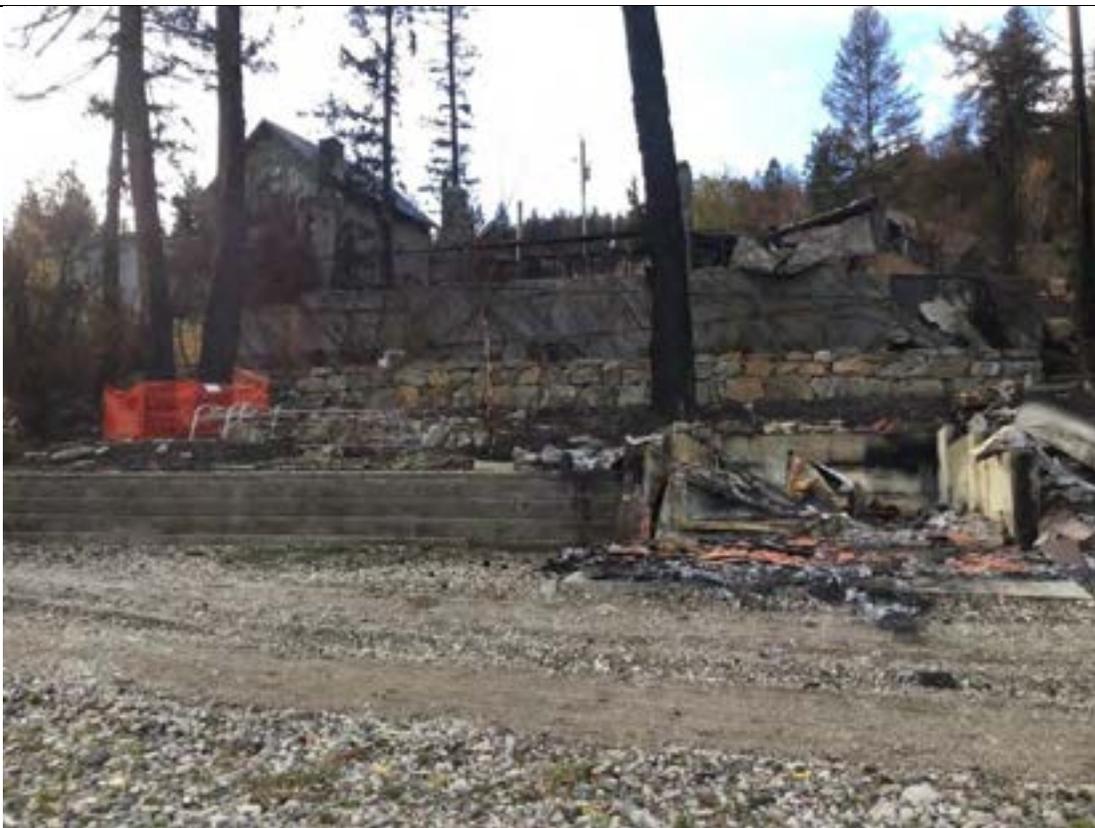
Photo 2: View from foreshore area at 13 Nerie Rd. with retaining wall and burned boat house

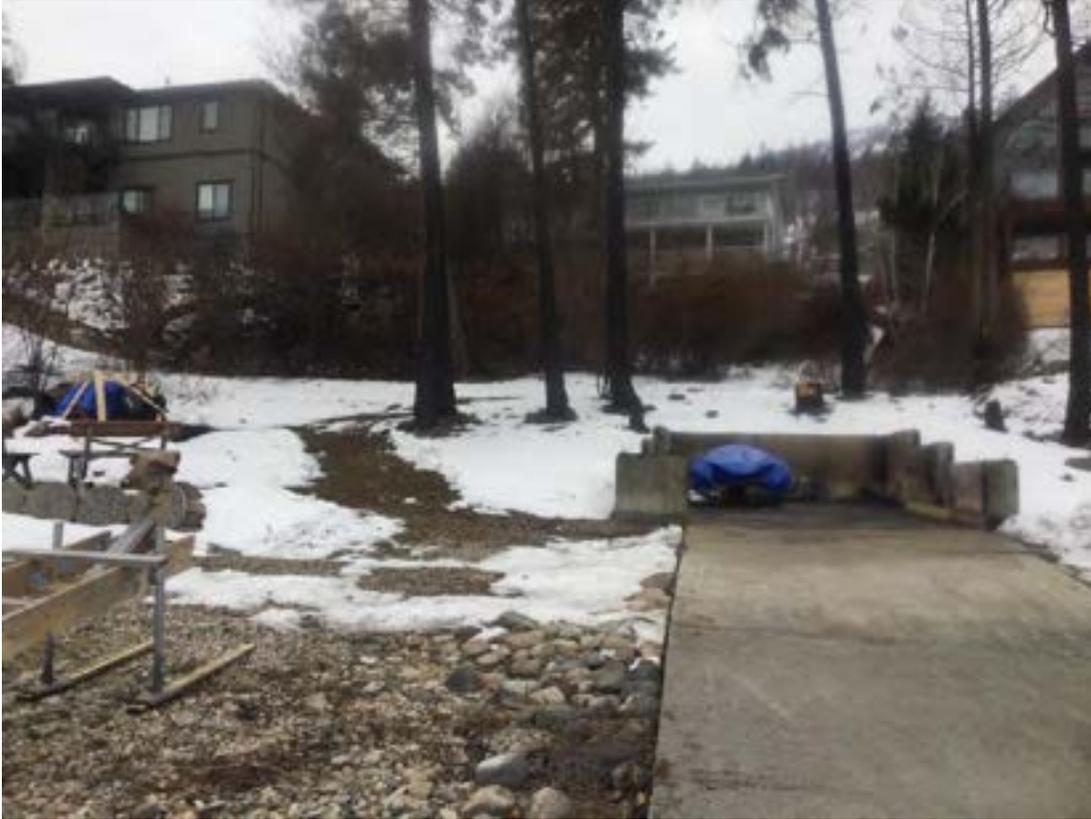
Photo 1: View upslope from foreshore area at 19 Nerie Rd. Note concrete boat ramp and burned boat house.

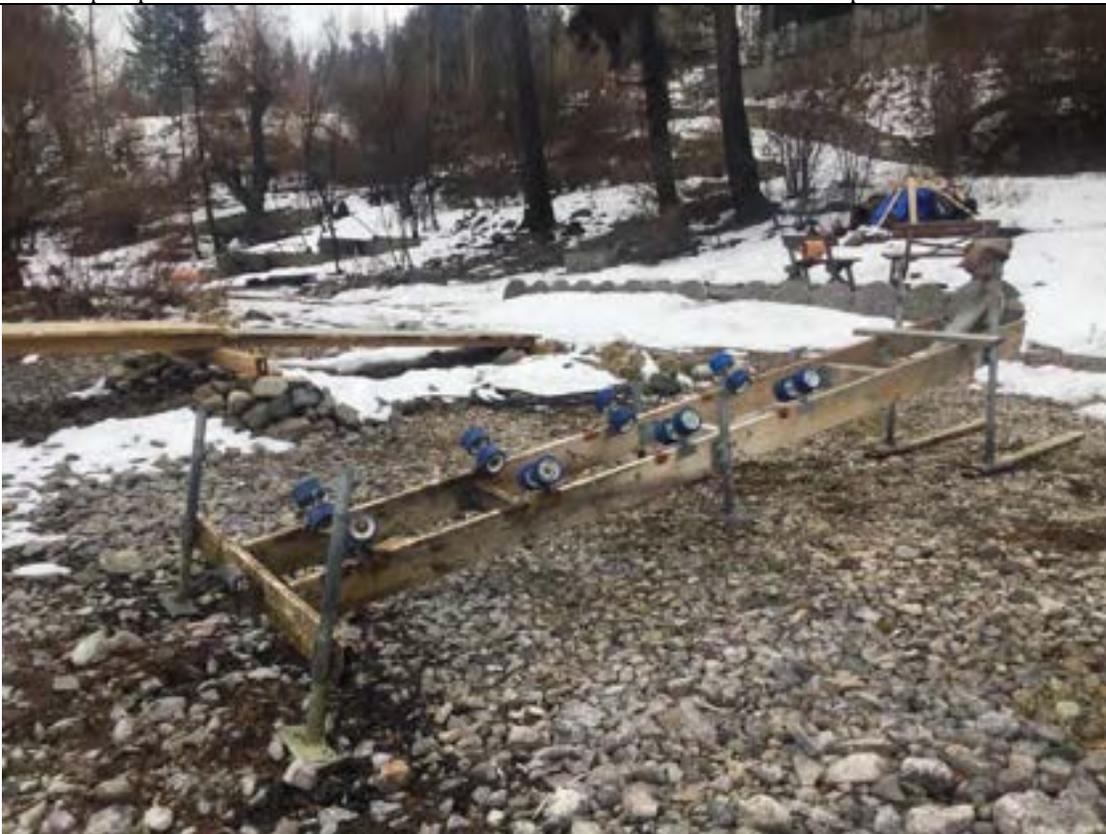
Photo 2: View of foreshore area at 19 Nerie Rd. End of dock is repaired.

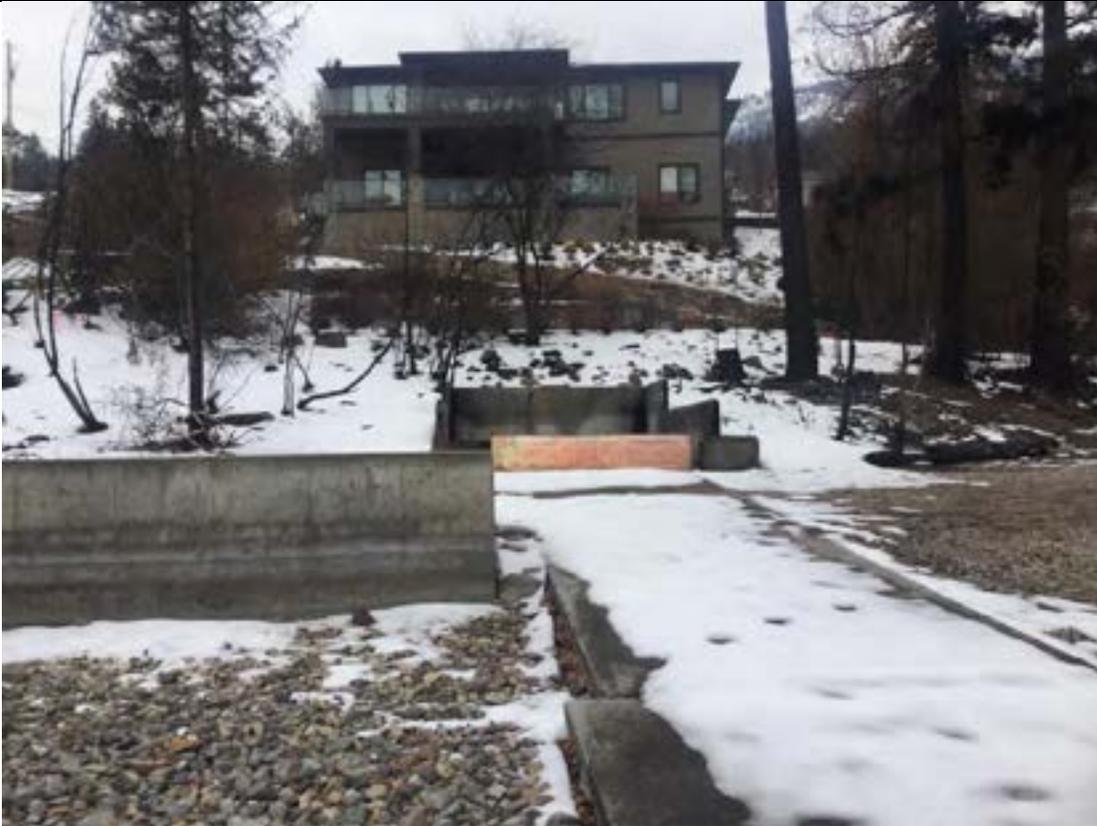
Photo 1: View upslope from foreshore area at 21 Nerie Rd. Note concrete retaining wall, boat ramp and burned boat house.

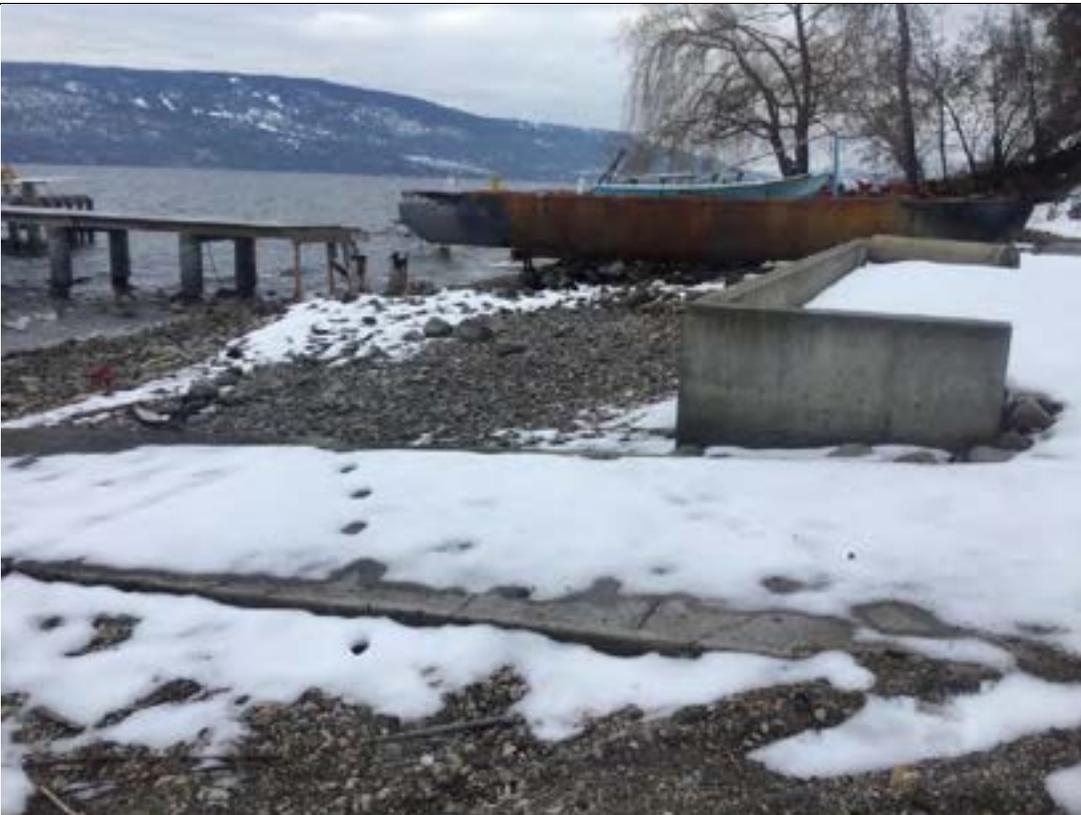
Photo 2: View of foreshore area at 21 Nerie Rd. Note retaining wall and damaged end of shared dock.

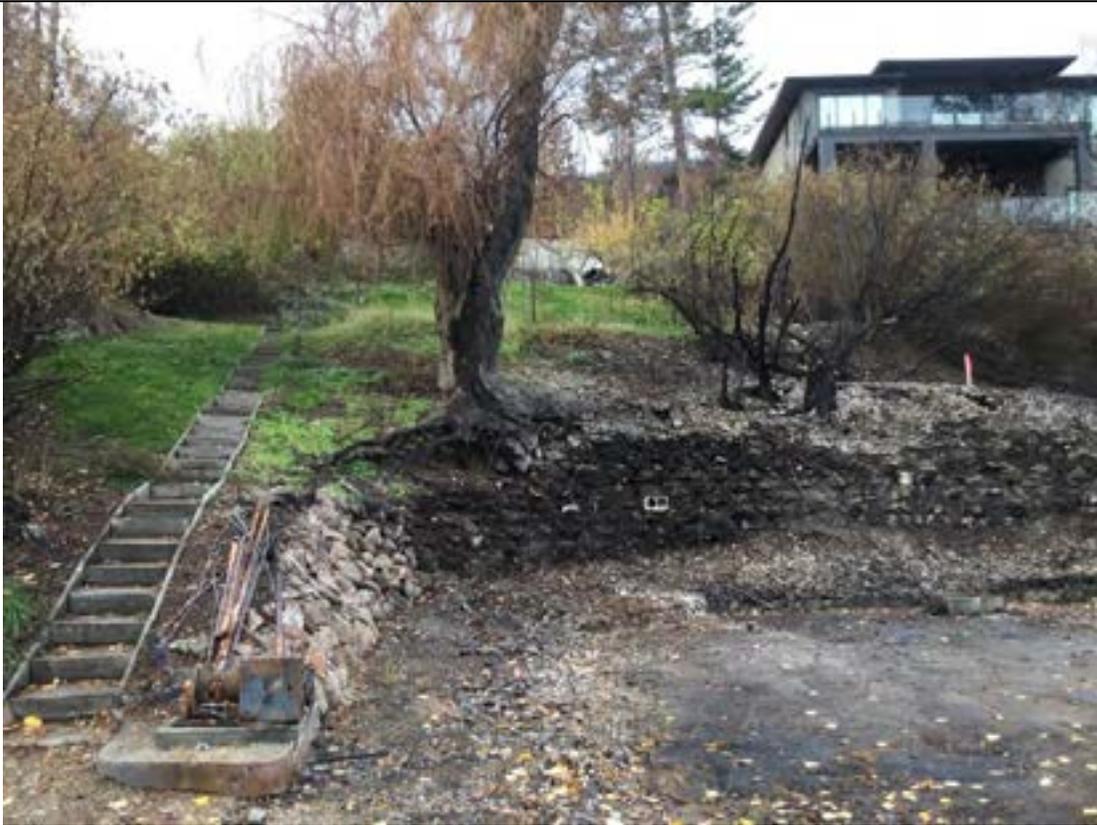
Photo 3: View of slope above foreshore area with burned garage and burned tire retaining wall
