POST-WILDFIRE NATURAL HAZARD RISK ASSESSMENT (WHITE ROCK LAKE WILDFIRE)

Presentation to the RDCO Board
of Directors: February 10, 2022

By Jennifer Clarke, P. Geo.
jen@clarkegeoscience.com

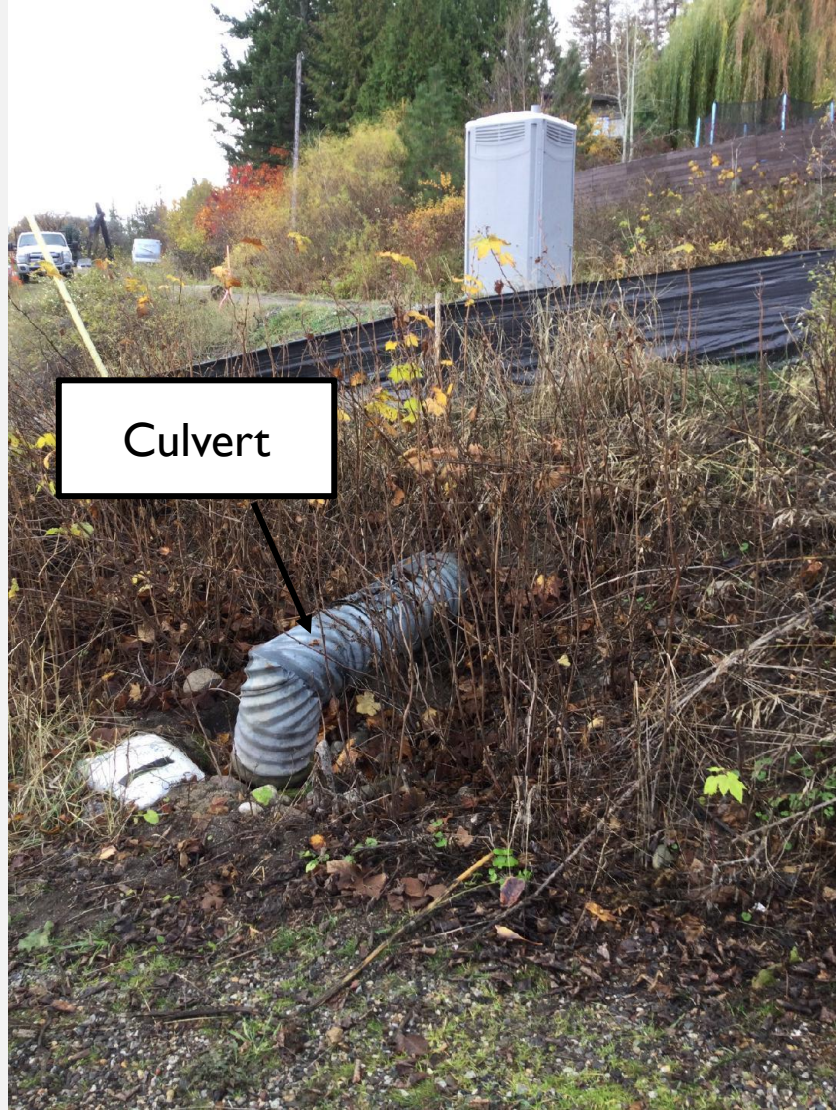
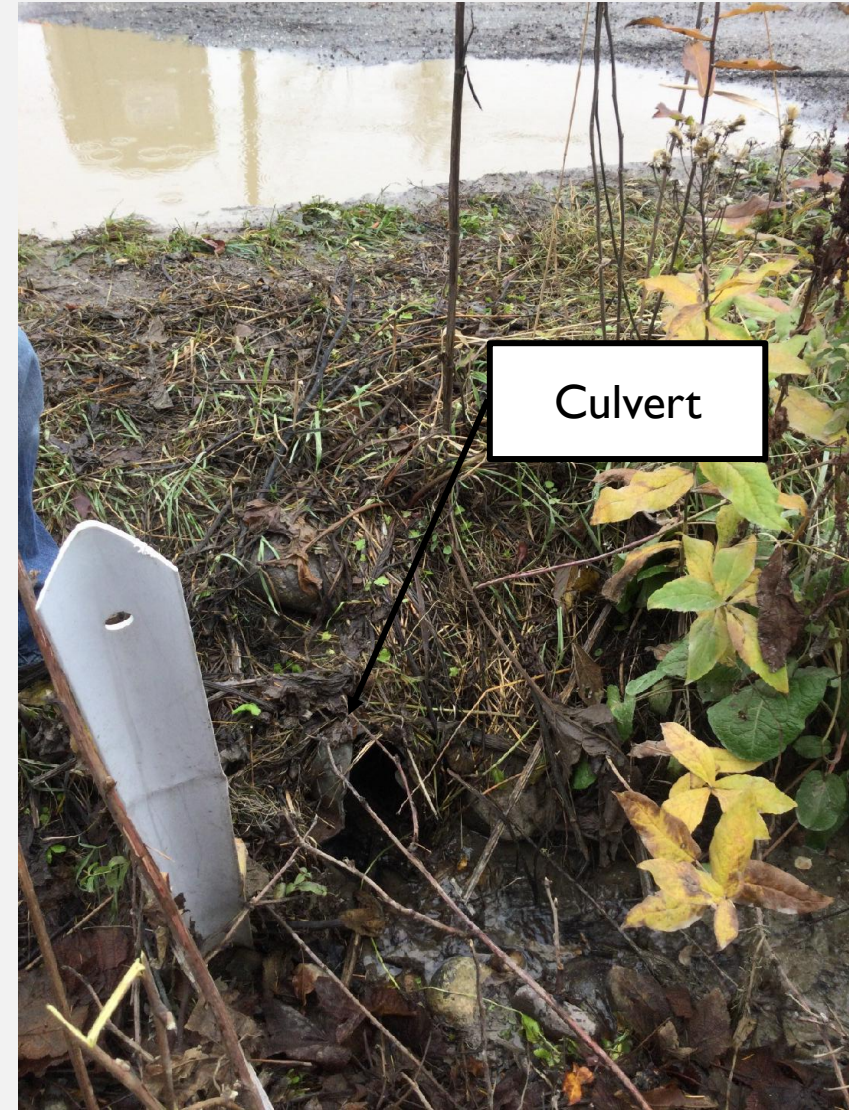
Hazards associated with flooding due to increased peak flows on small streams flowing through the area

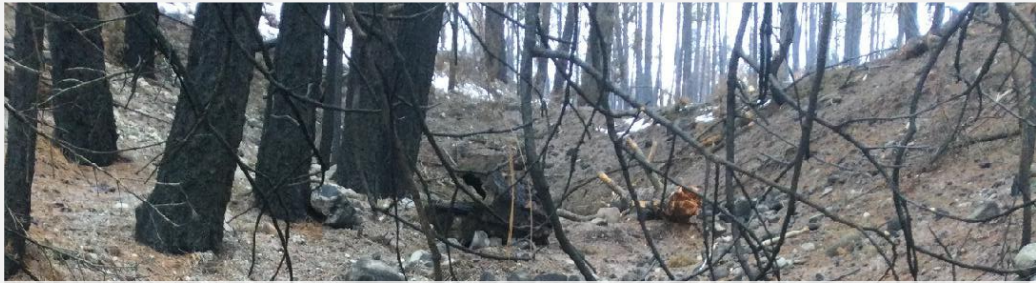
Hazards associated with flooding due to increased groundwater flows on springs in the area

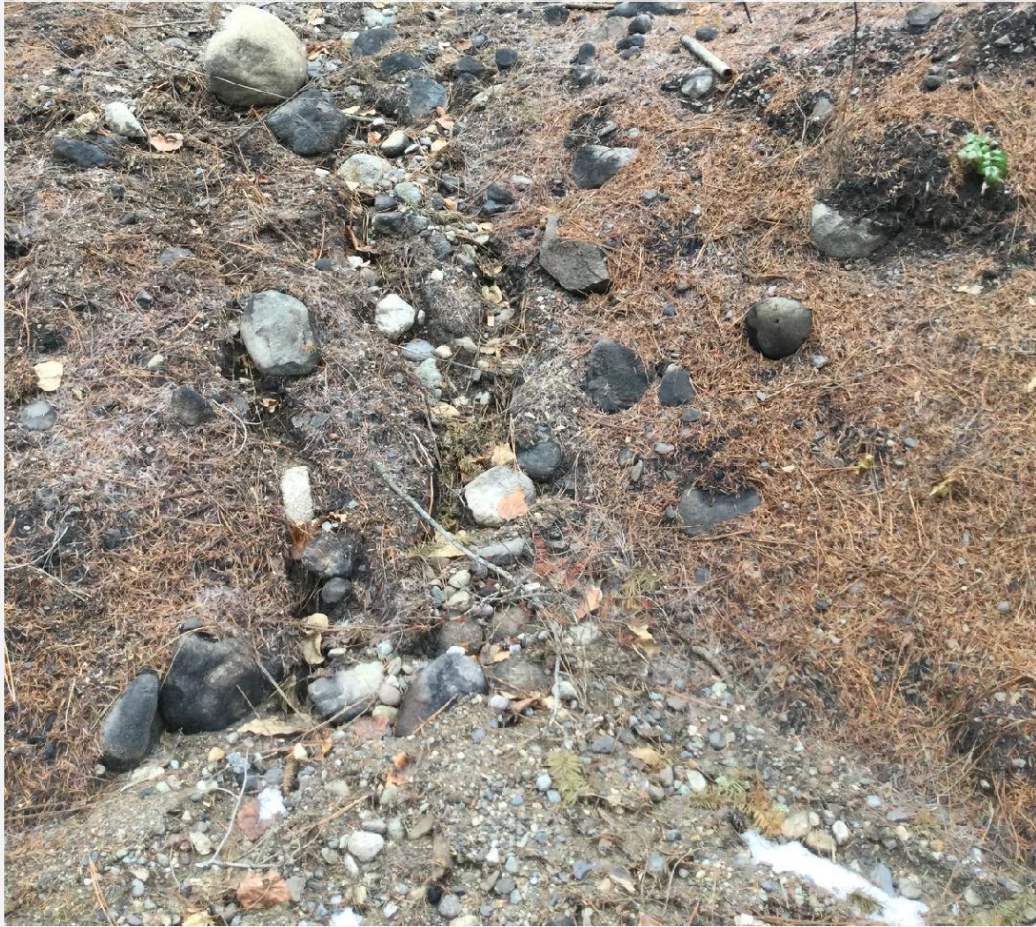
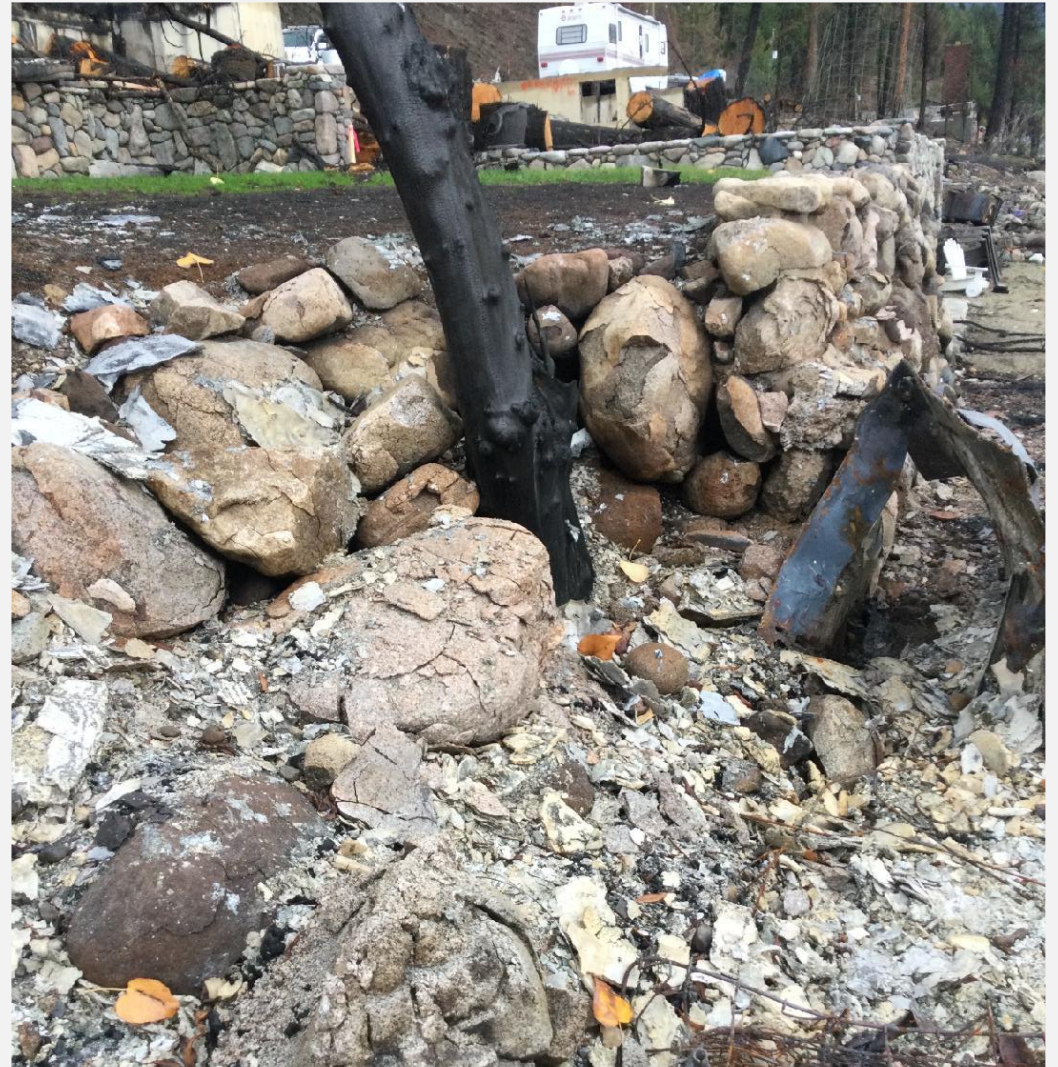
Increased runoff leads to erosion and instability

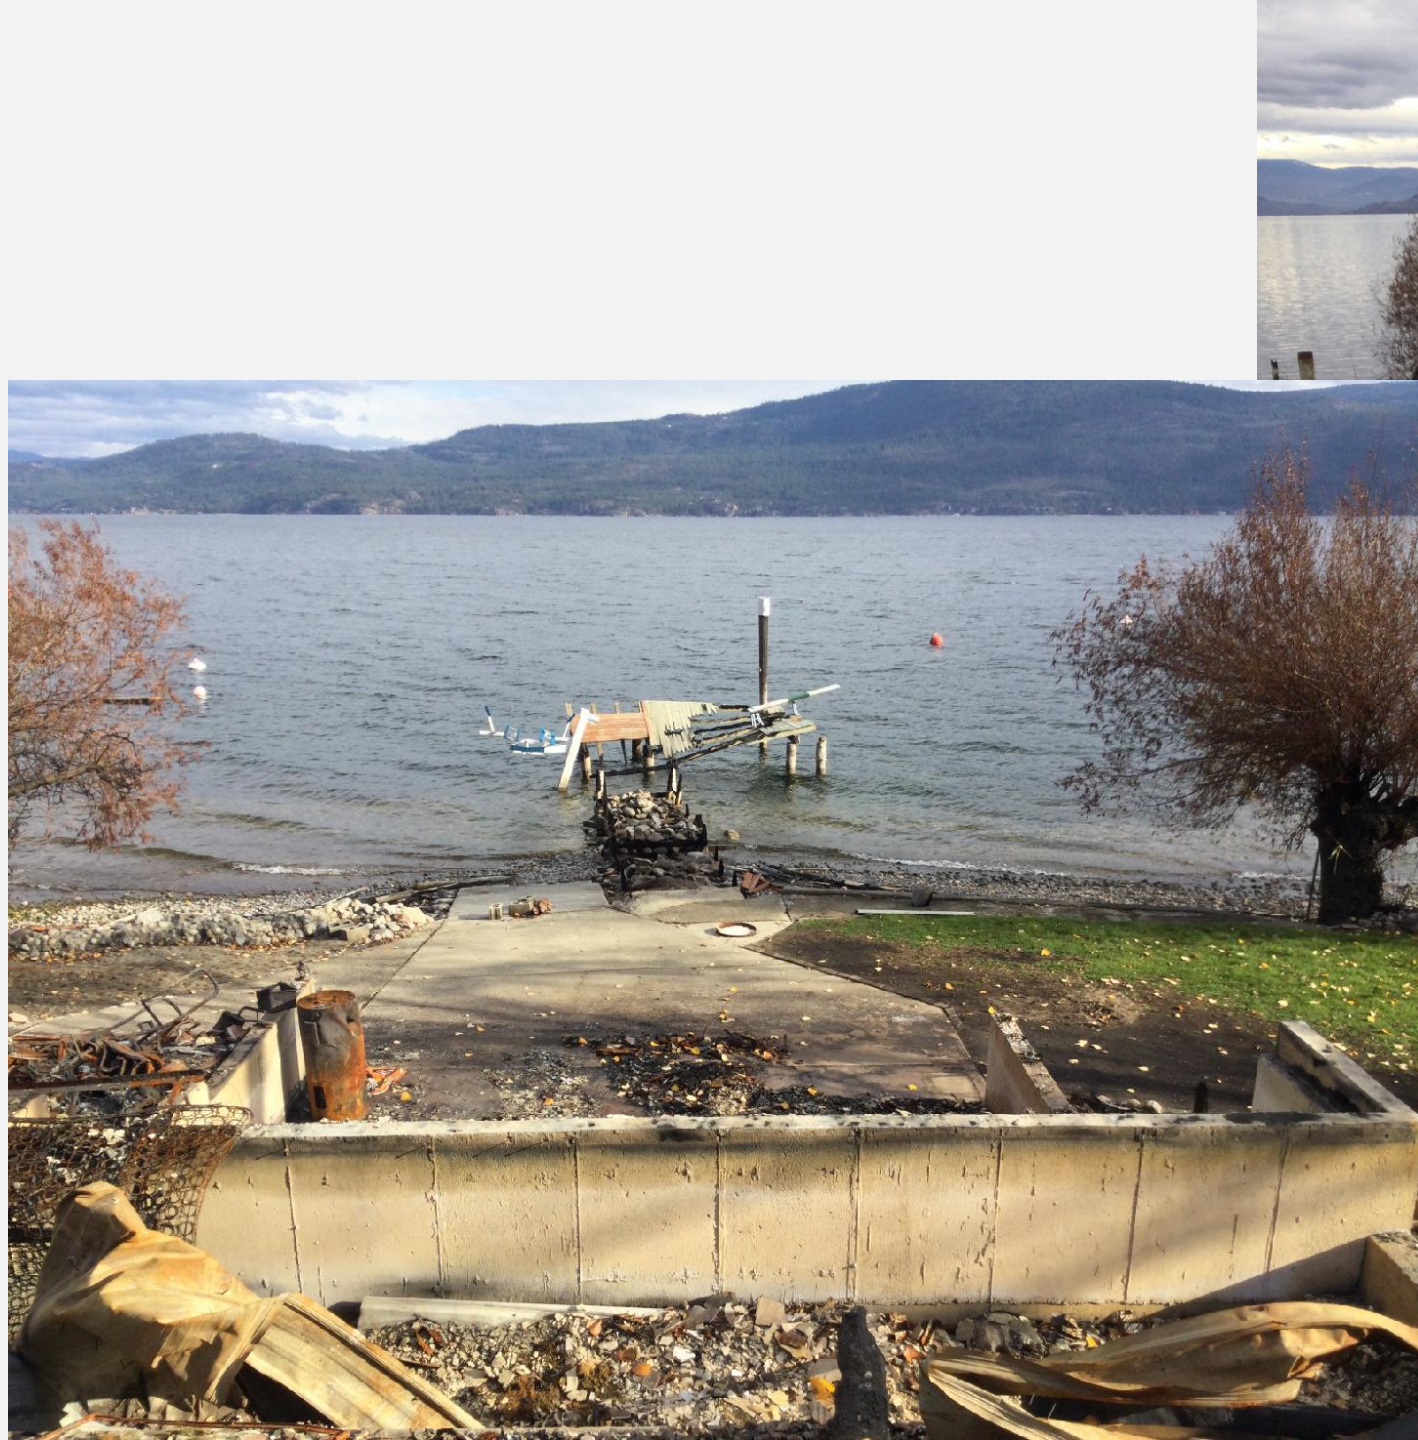
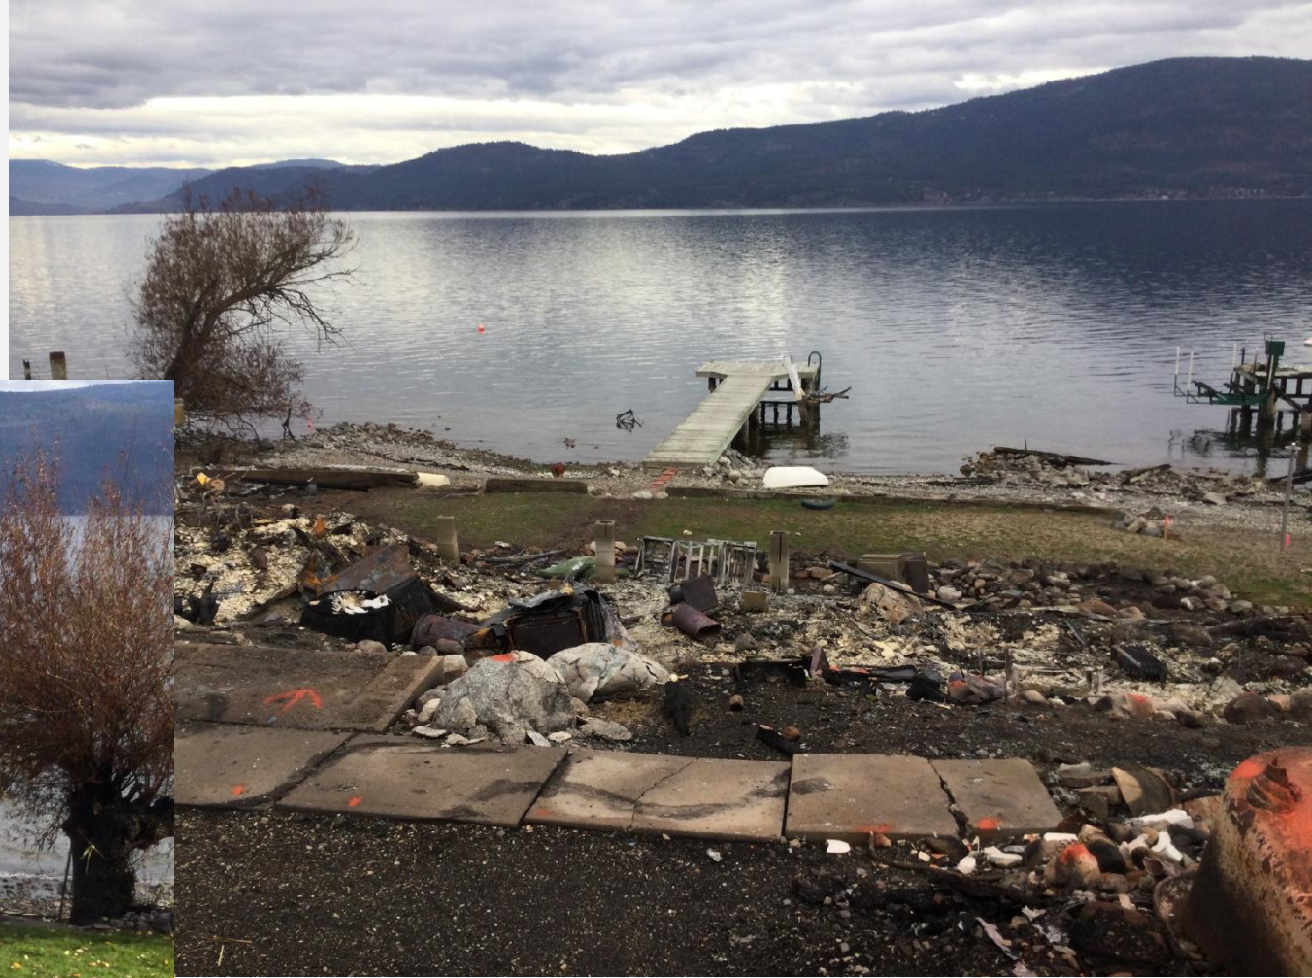
Recovery challenges –
structures within riparian
setback

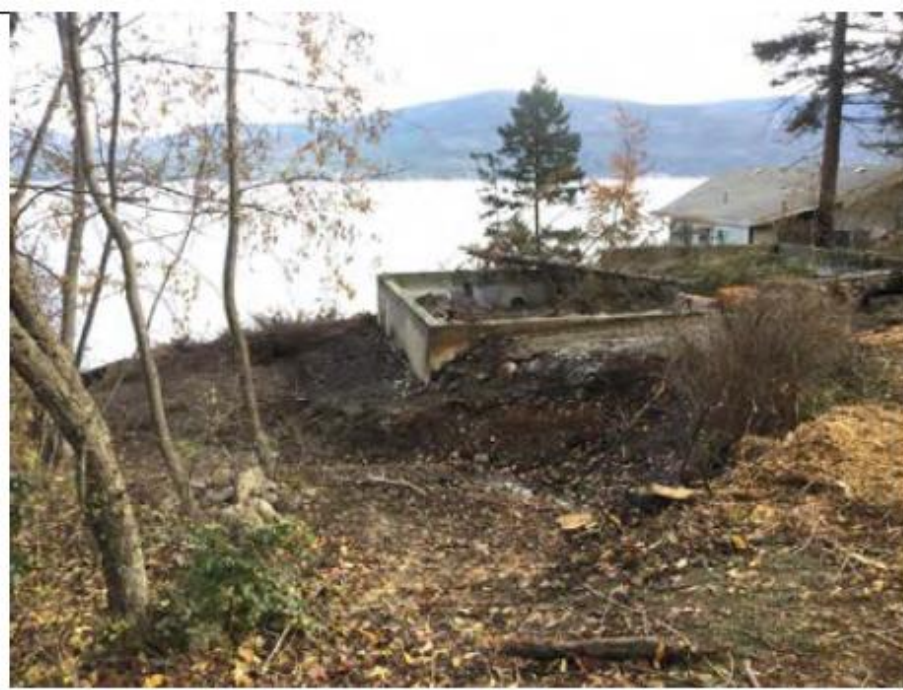
Photo 1: View of upper part of lot at 37 Nerie Rd, culvert outlet and stream flow in foreground

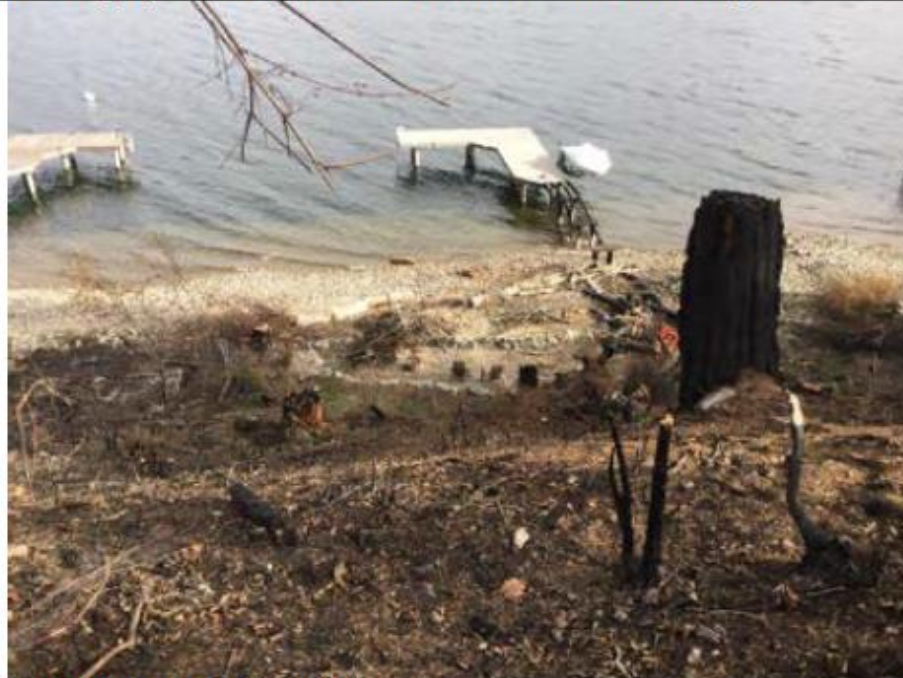
Photo 2: View of foreshore area at 37 Nerie Rd.
