Regional District of Central Okanagan Post-Wildfire Environmental / Hazardous Conditions Assessment

Property Inspection Report

Civic Address:	/ Nerio	e Rd.	Date of	Inspection:	11/5/2021
PID: 007-88		9-950	Author:		J. Clarke, P.Geo.
RDCO Area:	Estam	nont			
Domestic water supply source:		Estamont Community Water System			
Nearest Waterbody (la	ke or stream)				
Element at Risk:		Okanagan Lake			
Structures Lost:		All			
Observed Site Conditions:		Sloped lot with severa	al low retair	ning wall stru	ictures.
Soils:		Sandy gravel, fill			
Slopes:		10% to lake, short steep (70%) slope below Nerie Road to lot.			
Groundwater Observations:		No seepage noted.			
Foreshore Conditions:		Mix of natural cobbles and low (<0.5 m) cobble mortar wall, dock ok. Noted disturbance along foreshore area associated with demolition and clean up efforts.			
Setback Distance & Elevation from HWM* or Top of Bank (SHIM):		Est. >15 m setback from lake to residence; est. >1.5m elevation. To be confirmed.			
Wildfire Effects Upslope/Upstream:		Slopes above Nerie Road are burned.

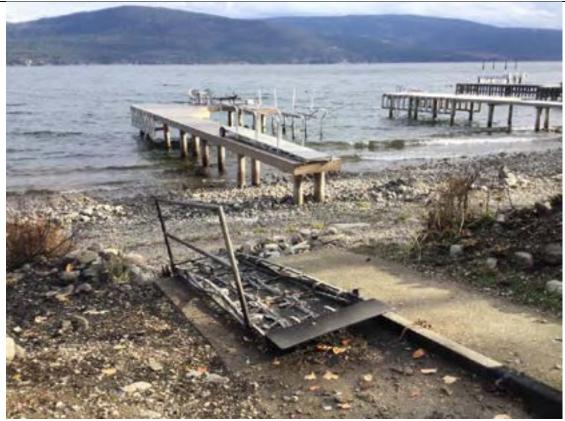
Photo 1: View of foreshore area at 7 Nerie Rd.

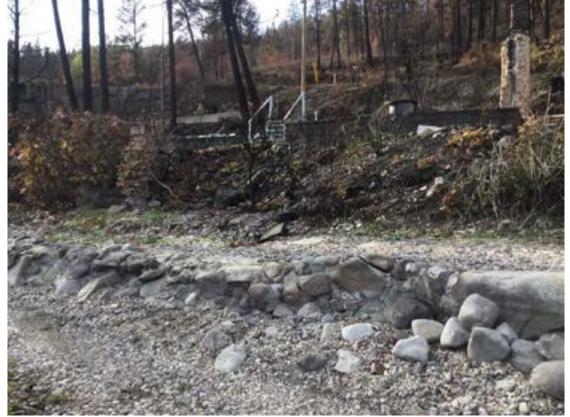
Photo 2: View from foreshore area at 7 Nerie Rd. with low mortared rock wall.
