# Environmental Inventory and Impact Assessment at #7 Nerie Rd. RDCO BC

Post Fire Rebuild

Prepared: April 14, 2022

Sage Environmental Consulting Ltd.  
#8 3101 29<sup>th</sup> St. Vernon BC V1T 5A8

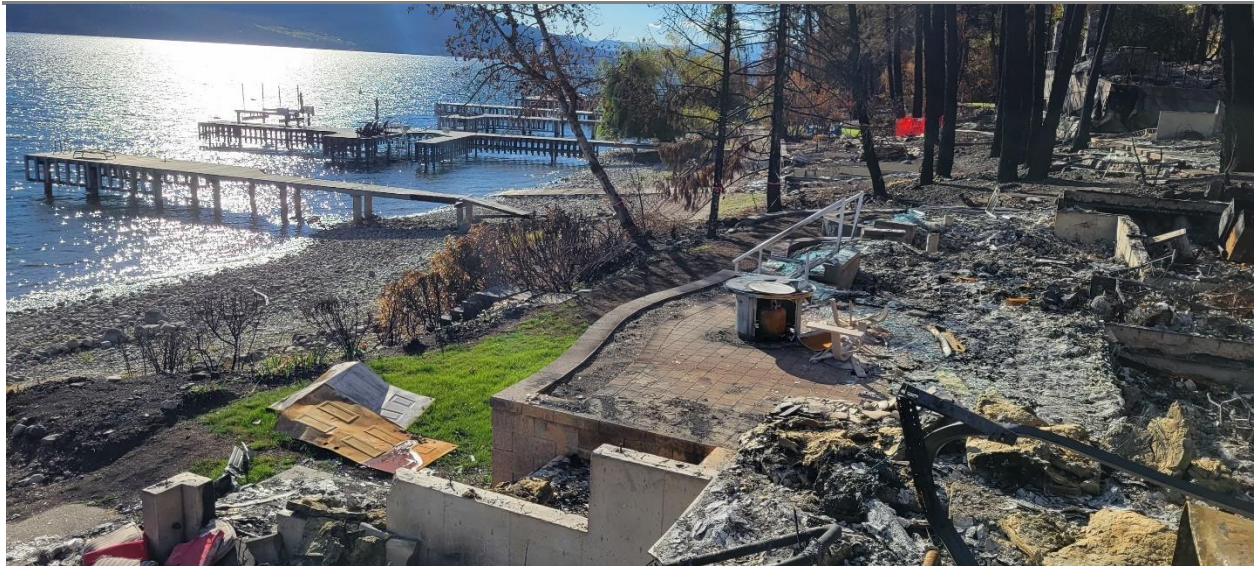
*Photo 1: Riparian portion of the Site, post-fire and pre-demolition, patio for retention in the foreground, gardens for retention in the background behind the stair rail 211006*

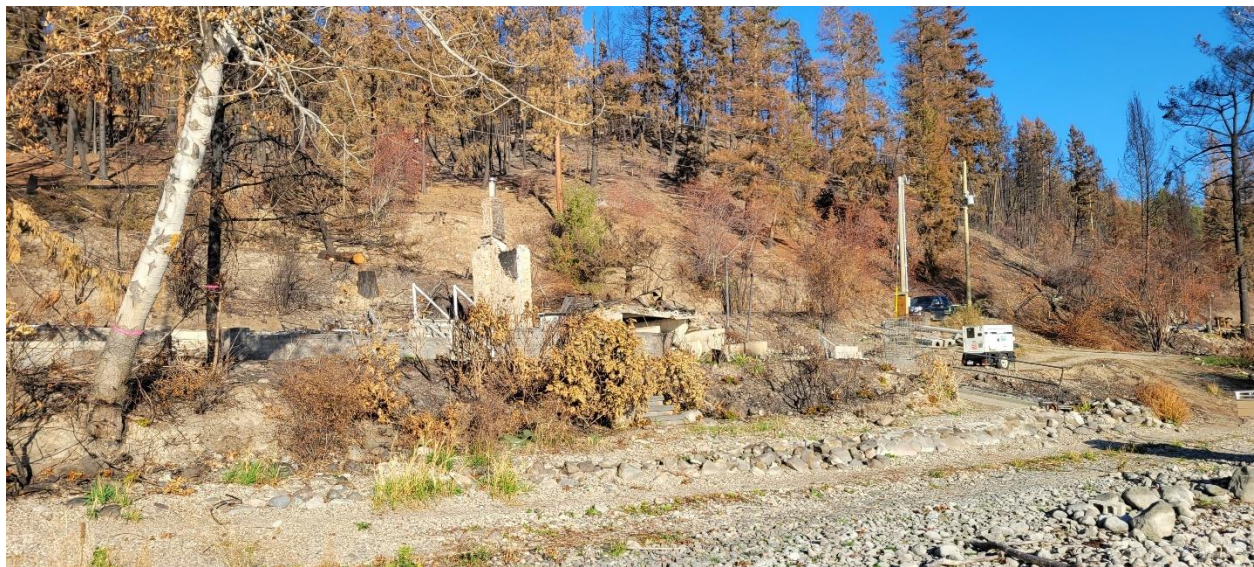
*Photo 2: Site from Shoreline 211108 Prior to Demolition*

Demolition activities have removed the house, boathouse, and foundations on this site. The paver patio and small retaining wall in the leavestrip have been retained. The house site has been returned to natural grade in preparation for construction.

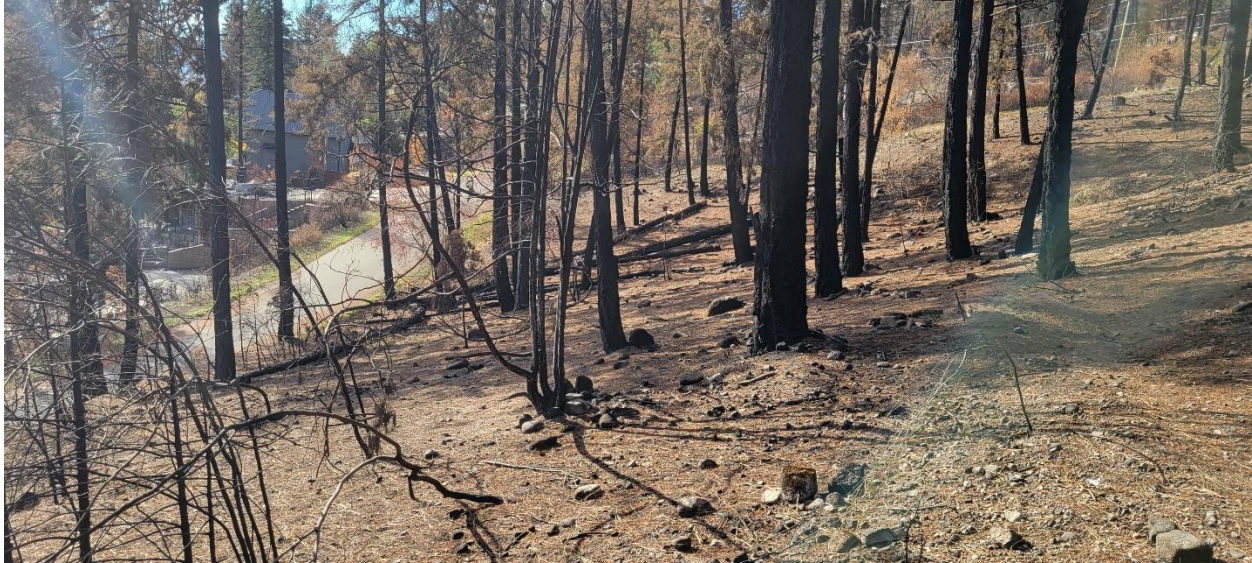
*Photo 3: Western portion of the lot Fall 2021. Shrubs, trees, and groundcover were lost but soils on the Site seem to be intact 211006*

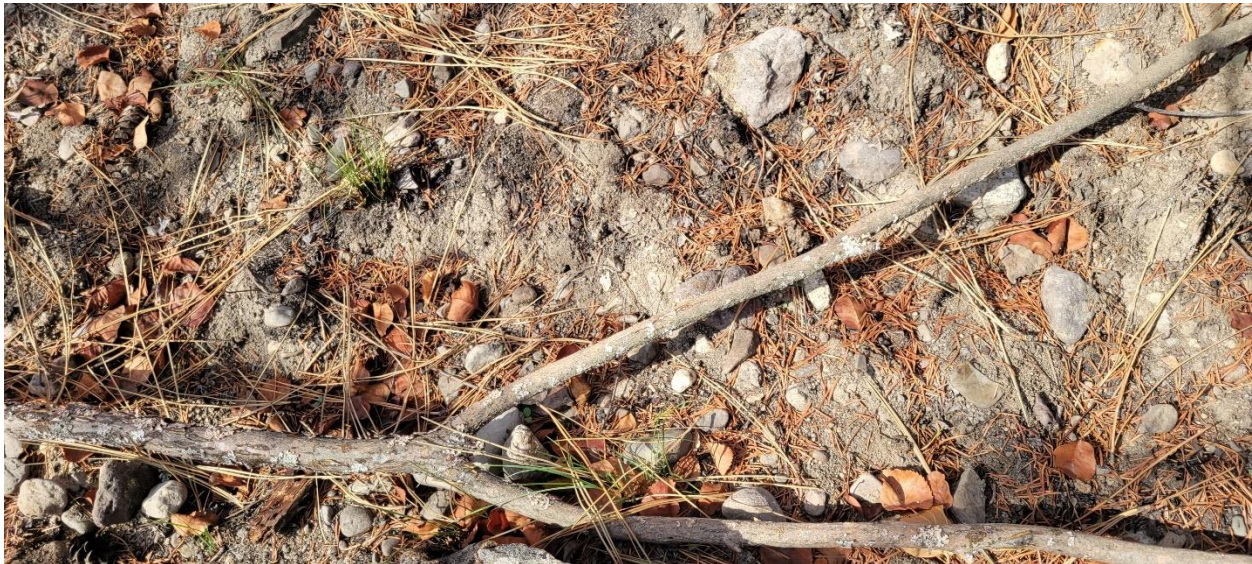
*Photo 4: Initial Regeneration Fall 2021 Bunchgrasses 211006*
