Lot 4 Lakeshore Road, Kelowna, BC
**Sensitive Terrestrial Ecosystem and Aquatic Ecosystem
Development Permit Area Environmental Impact
Assessment**

Revision History			
Project Name		Lot 4 Lakeshore Road	
Project Number		11490	
Report Title		Development Permit Environmental Impact Assessment	
Document #		K4237	
Report Author(s)		Kellen Smith	
Version	Date	Document Stage	Description/Notes
1	29Nov22	Internal Review	
2	29Nov22	Internal Review	
A	30Nov22	Client Review	
B	01Dec22	Final	
C	24Feb23	Final

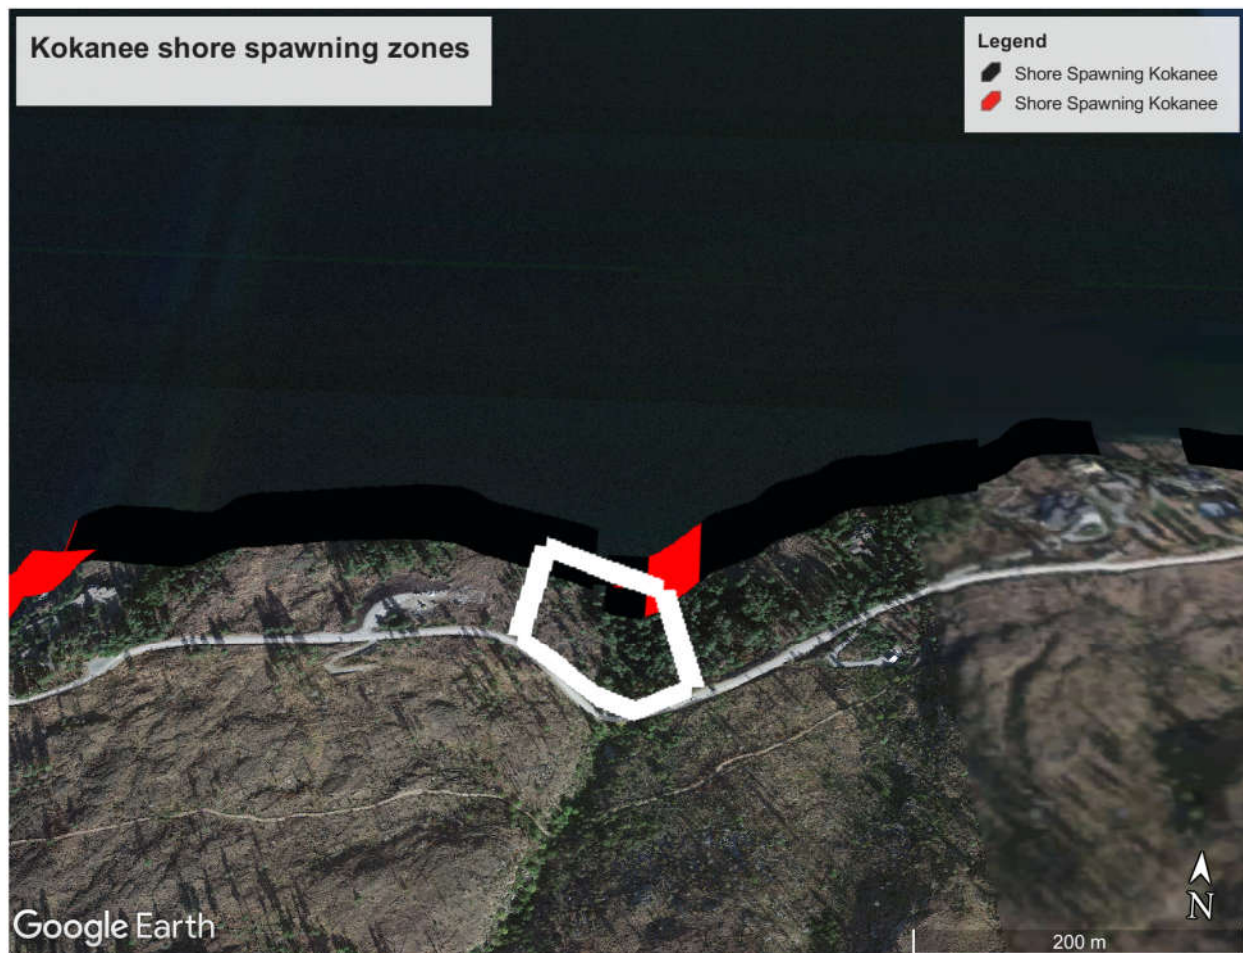
The foreshore at the Property is a combination of a Red zone and a Black zone for Kokanee shore spawners. The portion of the foreshore at the Property west of the unnamed gully is designated as a black zone and the portion of the Property is designated as a red zone according to the Okanagan Region Large Lakes Foreshore Protocol (Figure 4). Black zones are considered critical for Okanagan Lake shore spawning Kokanee and occur in areas which identify aggregates of 1,000 or greater spawning fish observed. Red zones are considered high value habitat (MFLNRORD, 2018). No development is proposed within 30 m of Okanagan Lake and no impacts to Kokanee or Kokanee habitat are anticipated.

Figure 4. Kokanee shore spawning zones at the Property (approximate Property boundary shown in white)

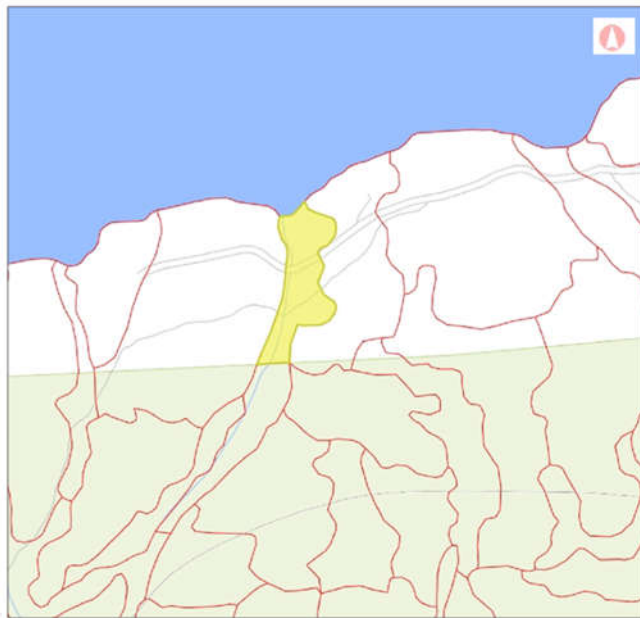
Figure 5. SEI polygon east of the unnamed gully (Source: iMapBC, 2022).

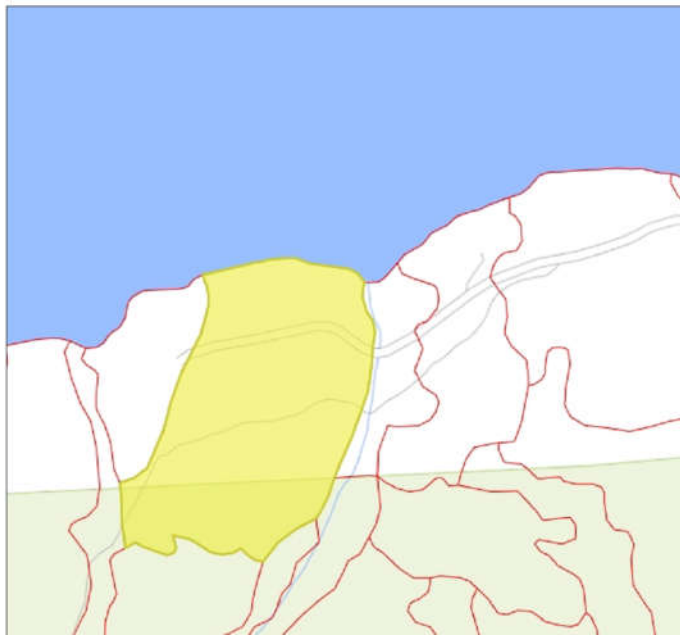
Figure 6. SEI polygon west of the unnamed gully (source: iMapBC).

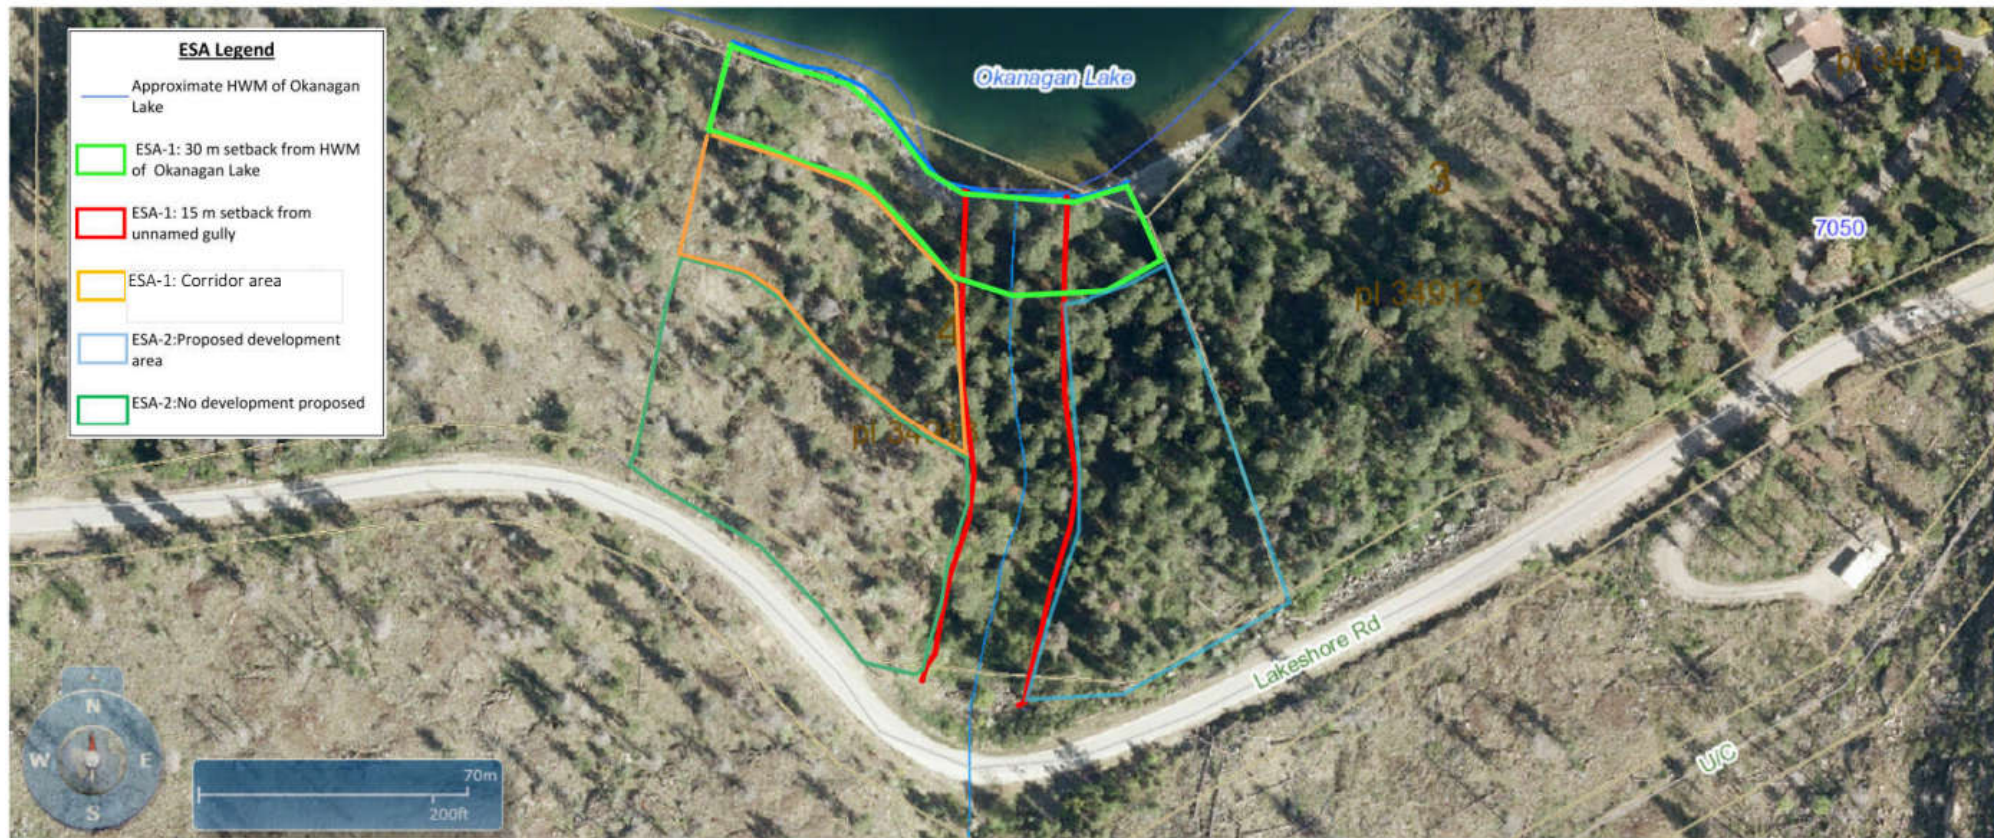
Figure 7. Proposed ESA designations for the Property

The RDCO is in support of a no-build/no-disturb environmental covenant on the ESA-1 areas and the remainder of the ESA-2 area (Figure 7) to avoid impacts to environmental values of that area and ensure connection to the unnamed gully and Okanagan Lake. No development is proposed within the setbacks identified around Okanagan Lake (30 m) and the unnamed gully (15 m). These areas have been identified as ESA-1 areas. It is also recommended that development does not occur in the portion of the Property west of the unnamed gully. Restricting development to the area east of the unnamed gully will leave most of the Property undeveloped and maintain connectivity between undeveloped areas in the vicinity of the Property, including Okanagan Mountain Provincial Park, and Okanagan Lake. An east/west travel corridor will be maintained along the lower portion of the Property at the foreshore of Okanagan Lake within the 30 m setback.

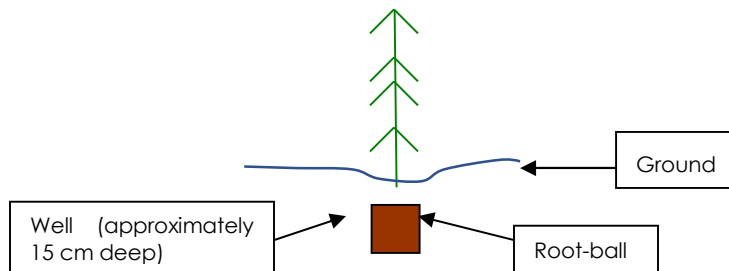
- Grass seed will be placed after the movement of fill. Additional seeding may be required in the following years to reduce noxious weeds.
- Each plant hole will be approximately twice the size of the plant's root-ball and deep enough to make a depression or "well" at the base of each plant (Figure 8).

Figure 8. Picture of planted tree with well to catch moisture.
