2019

EMP for FILL REMOVAL and NATURALIZATION PLAN 2677 WESTSIDE RD

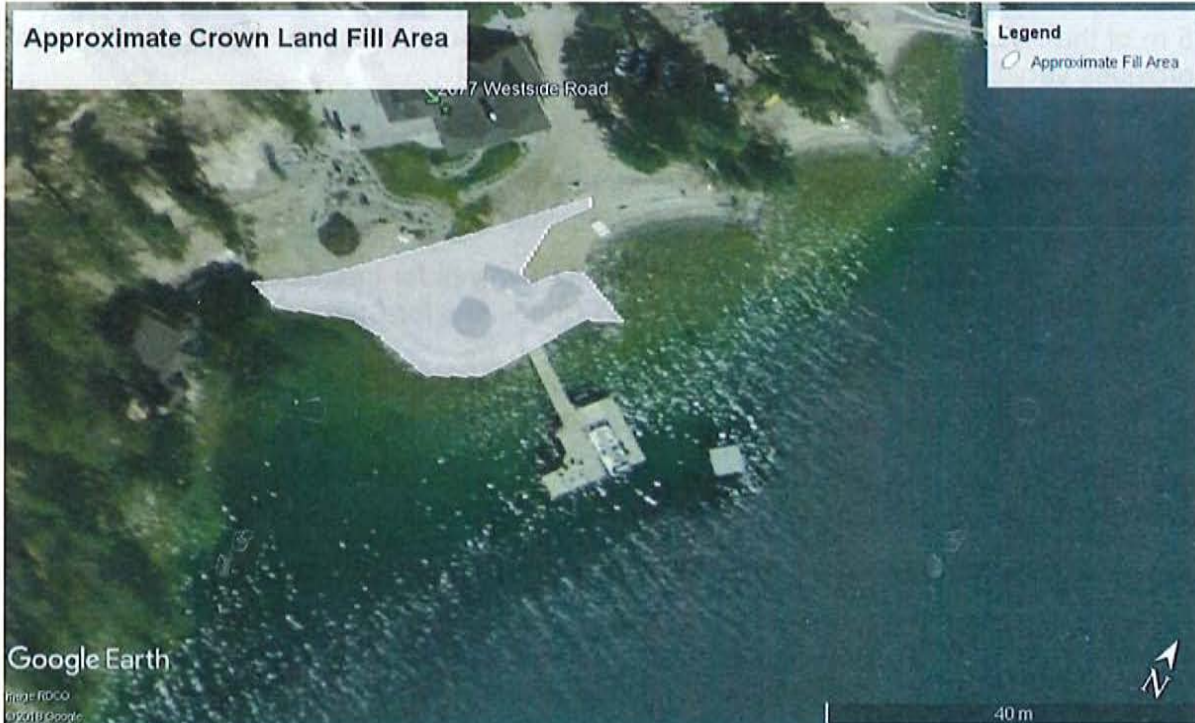
Photo 1. View of the approximate fill area in the lake fronting 2677 Westside Road. The dock and shoreline remain virtually unchanged in 2019 as seen in the air photo.

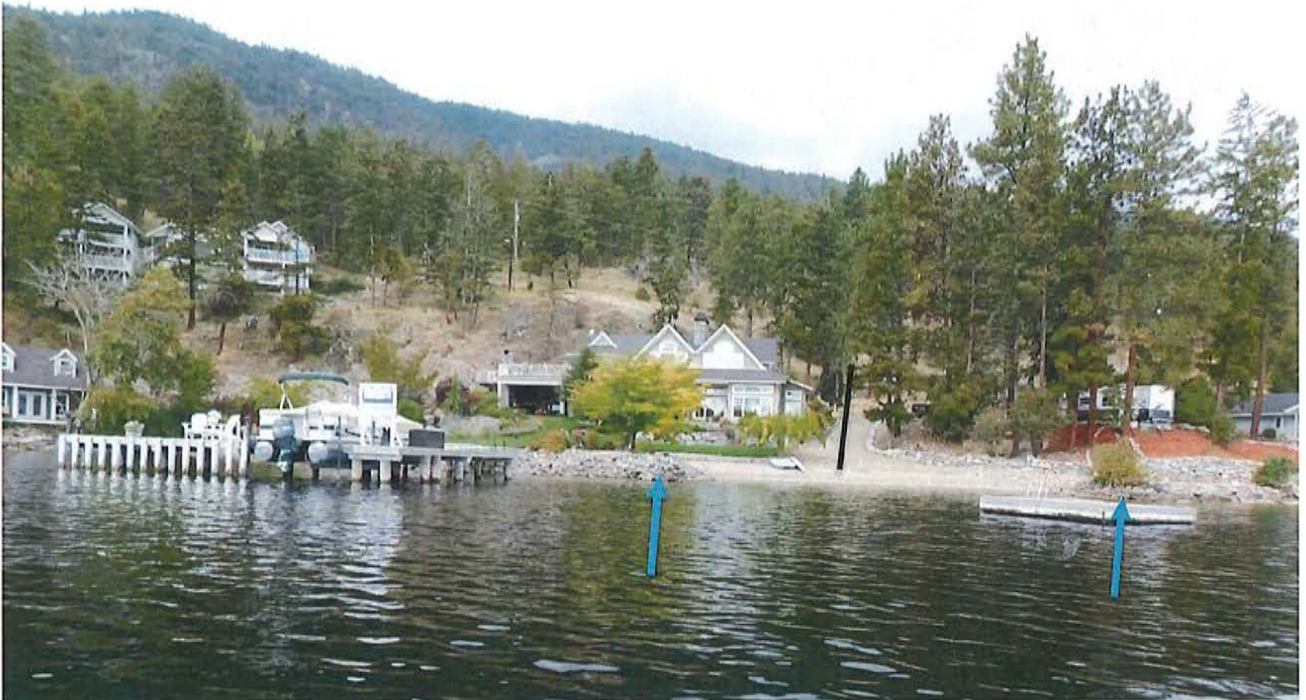
Photo 1. 2677 Westside Road is the property on the left side of the picture. Black line is approximate property boundary. There are two rock groynes marked in the Foreshore Inventory Mapping database, and indicated by arrows.

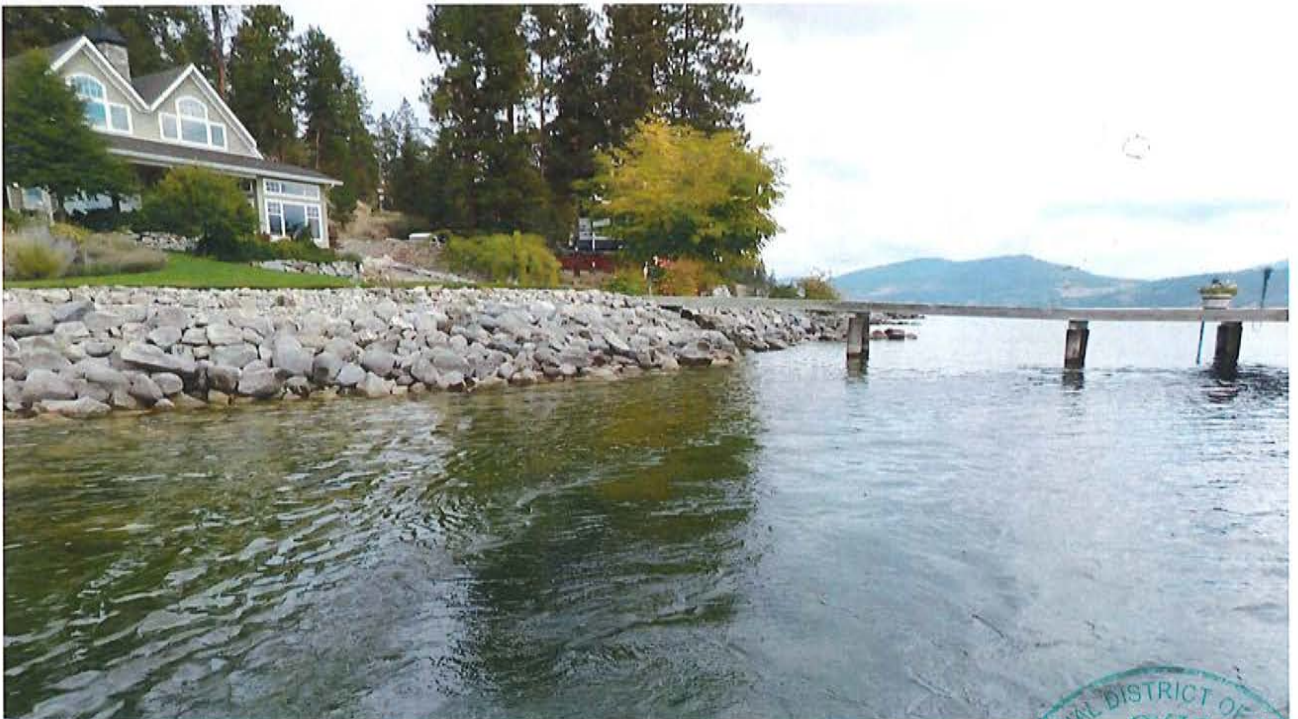
Photo 2. Fill area and dock at 2677 Westside Road. The plan is to remove some of the fill and create flood benches to enhance fish and wildlife habitat.

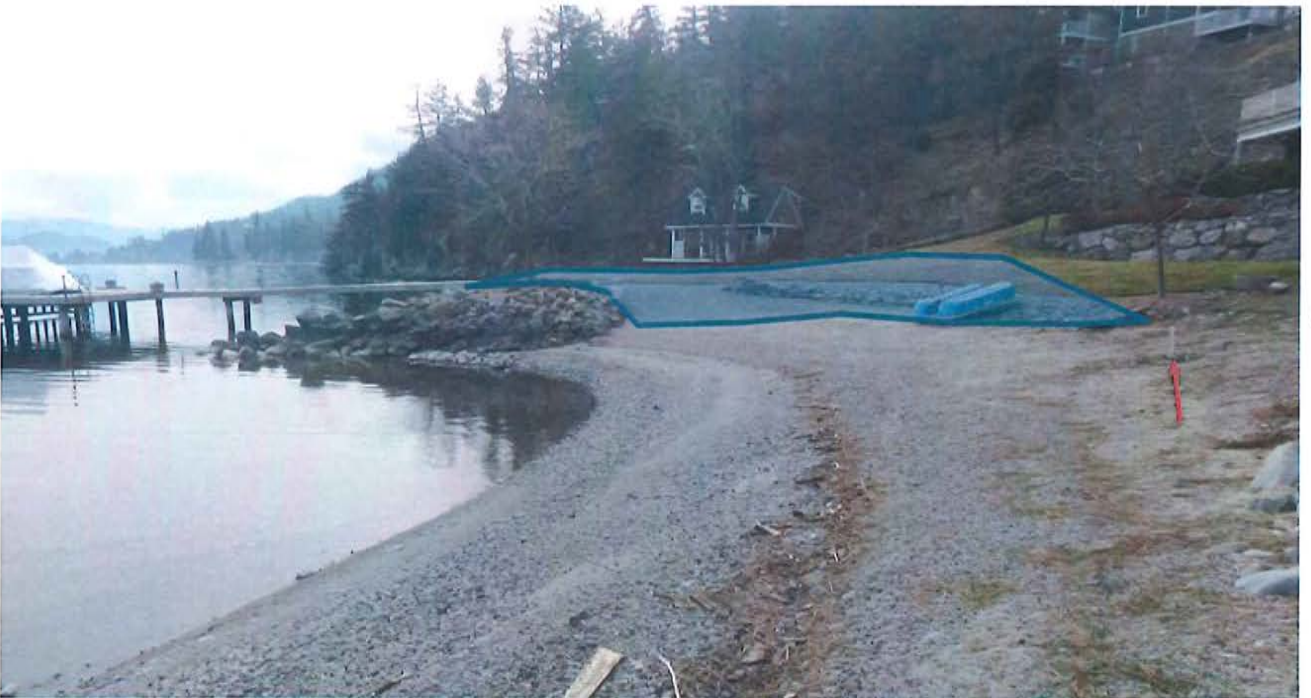
Photo 4. View of Crown Land fill area to the left of the property pin at the right side of the picture (see arrow). The fill removal area is approximately within the marked polygon.

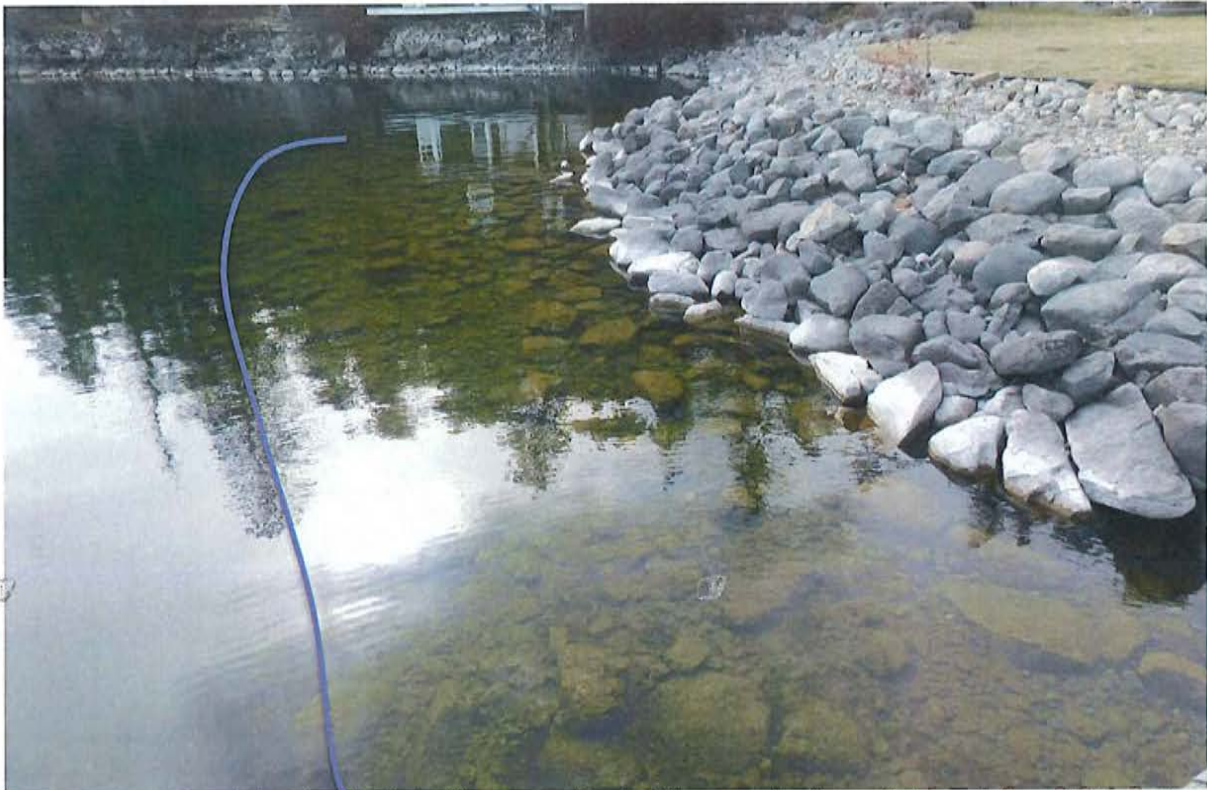
Photo 5. View of the existing shoreline that will be removed to about the same elevation as that seen in the water to create a 10 to 15 m wide Kokanee spawning shelf, expanding on the size of the shelf that can be seen in the photo. No materials will need to be deposited in the lake. The existing slope edge, indicated by the line, was created during spring 2007. It is anchored by large rocks.

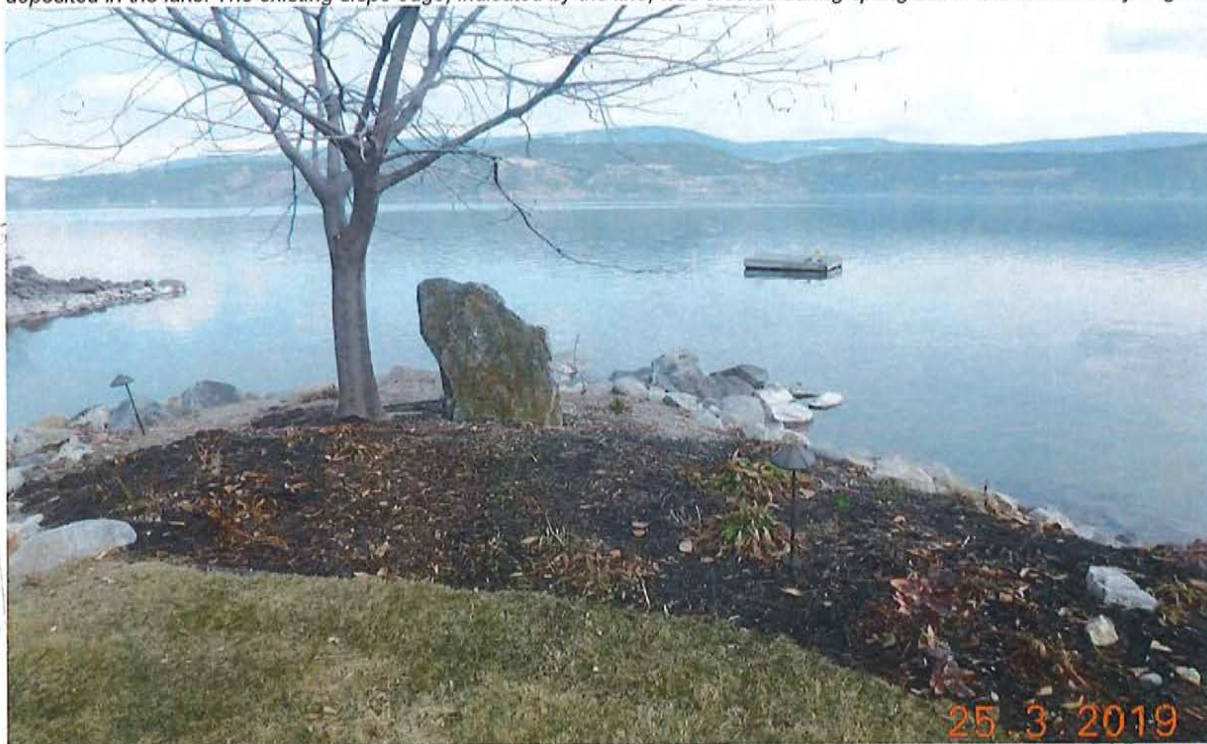
Photo 6. The existing rock groyne, with tree, will be retained so that existing Kokanee spawning habitat is not lost. The groyne will effectively become an island at high water levels. Native trees that are adapted to water will be planted on the island.

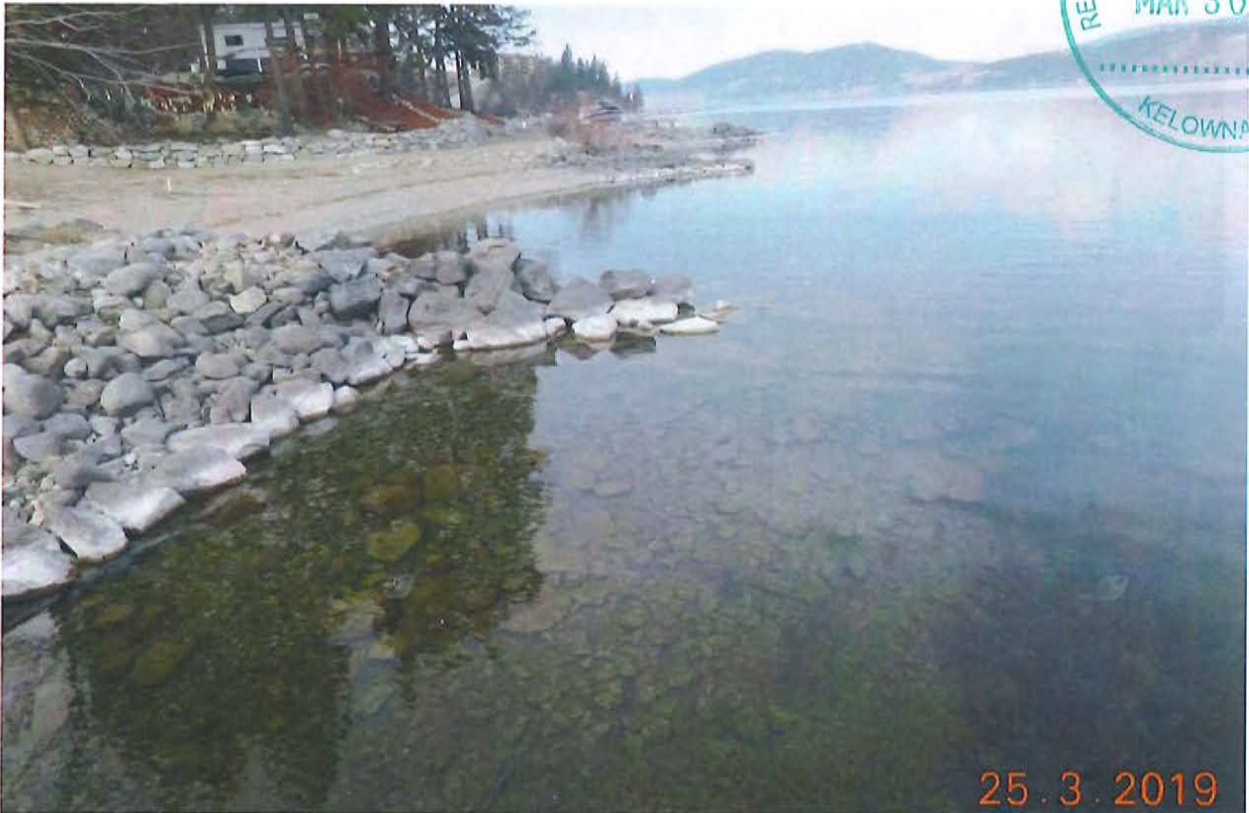
Photo 7. This photo shows the high value Kokanee spawning habitat that has been retained by the rock groyne. Similar-size gravel will be placed as is normally found in Black-zone Kokanee spawning areas (e.g., Paul's Tomb shoreline).

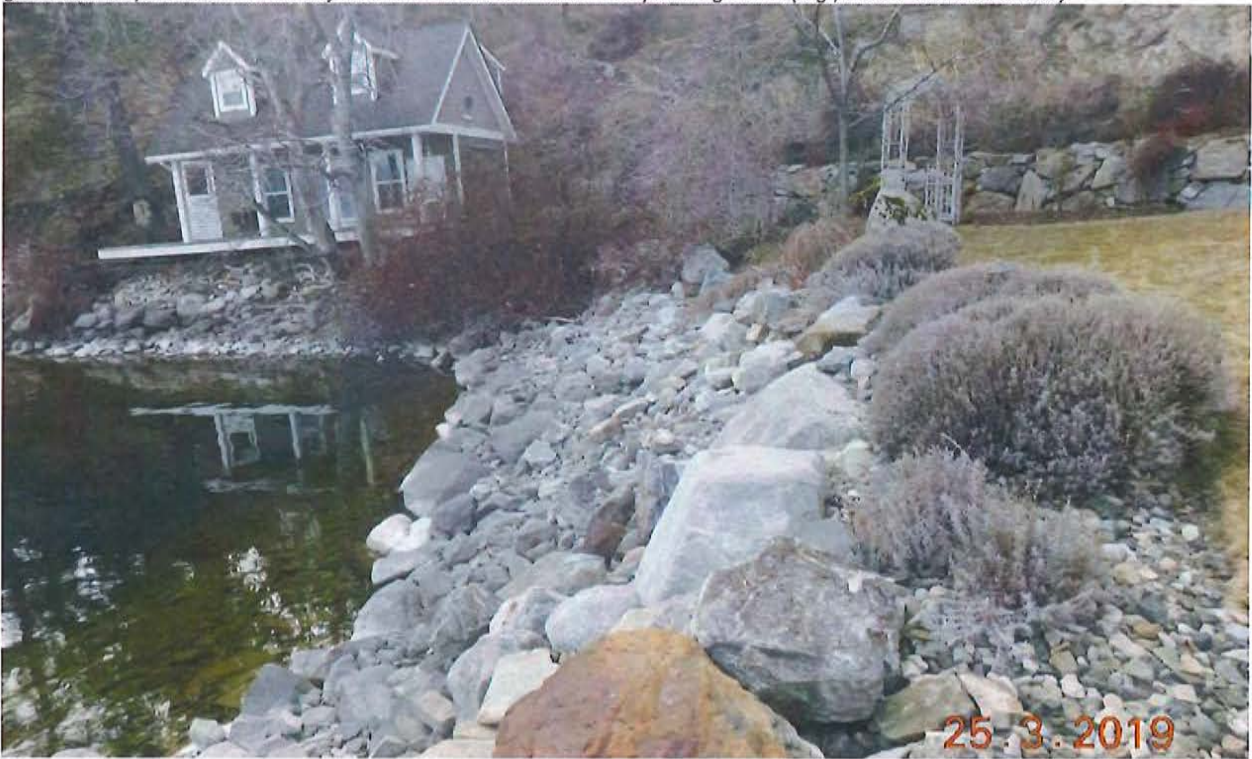
Photo 8. After fill is removed, the shoreline will match the natural shoreline that can be seen fronting the cabin in the left of the photo. Native shrubs and trees will be planted to restore the area to native ecosystem condition.

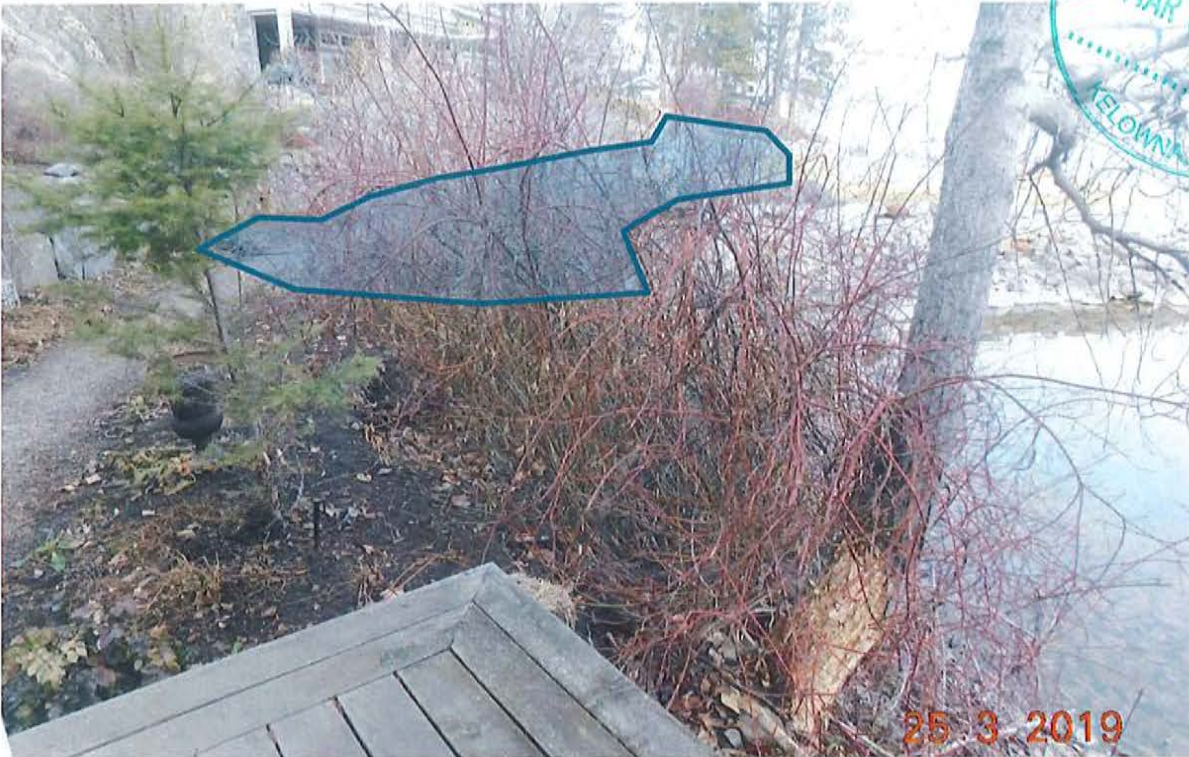
Photo 9. Native riparian vegetation consists of red-osier dogwood, Oregon grape, and Nootka rose shrubs and black cottonwood, ponderosa pine, and Douglas fir trees. These same species will be used to restore the riparian area (outlined) on the reclaimed lake edge.

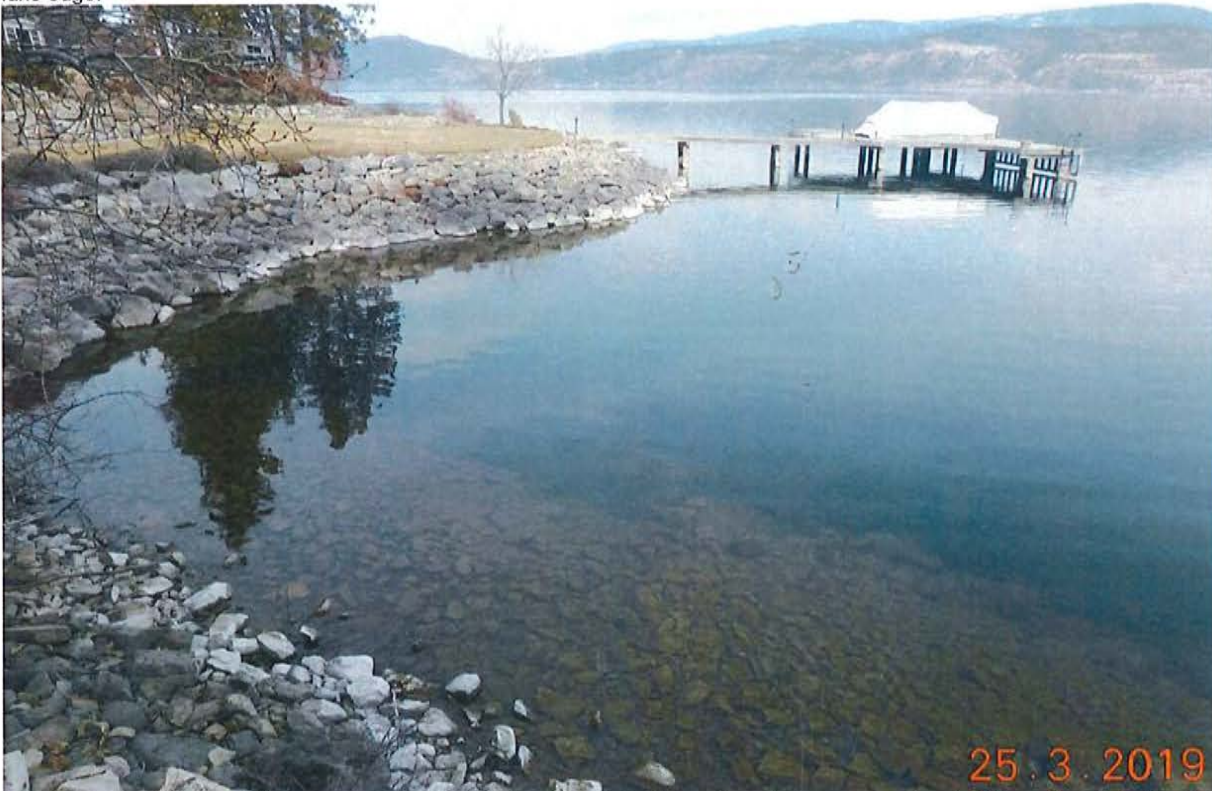
Photo 10. The fill area will become a series of flood benches that will vary from being underwater at all times to only being flooded during extreme events (like that seen during spring 2017). There will be a net habitat improvement.

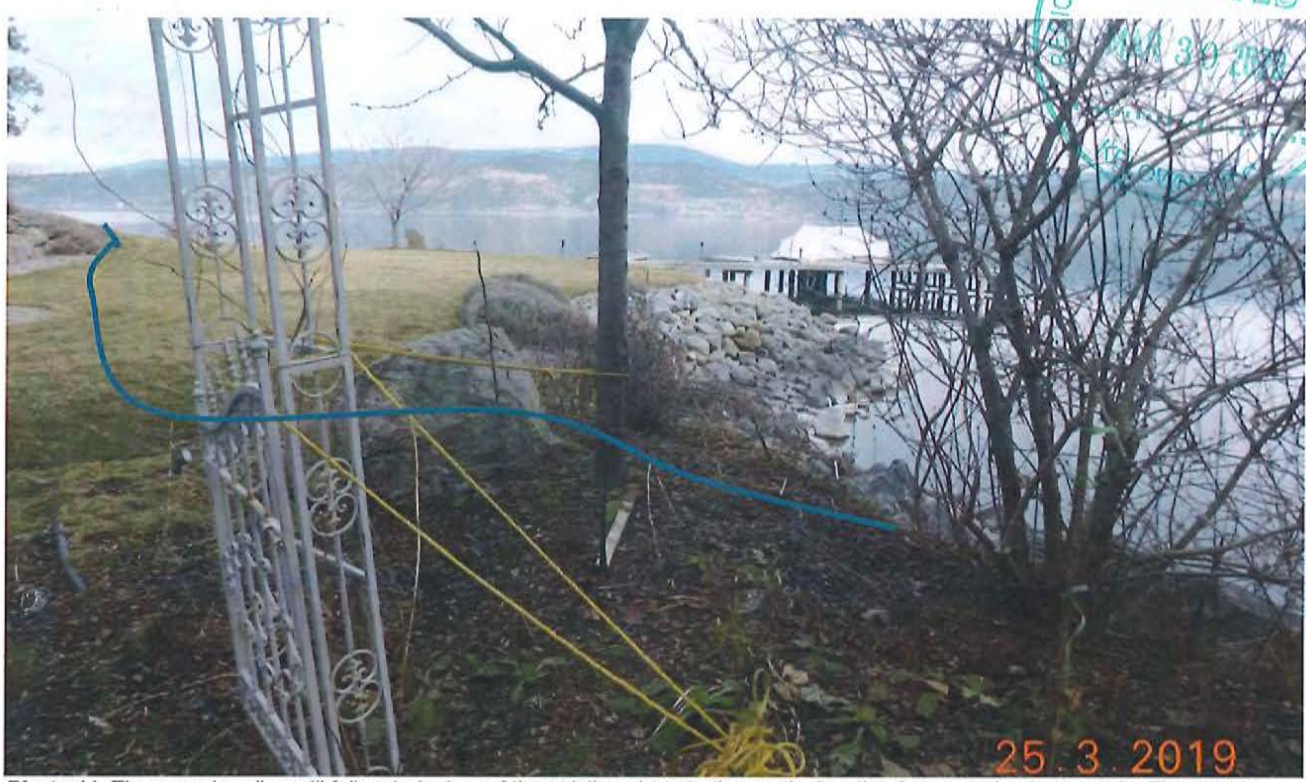
Photo 11. The new shoreline will follow trajectory of the existing shore to the south. See line for approximate example. The area to the right of the line will be a series of four flood benches and a Kokanee spawning bench.

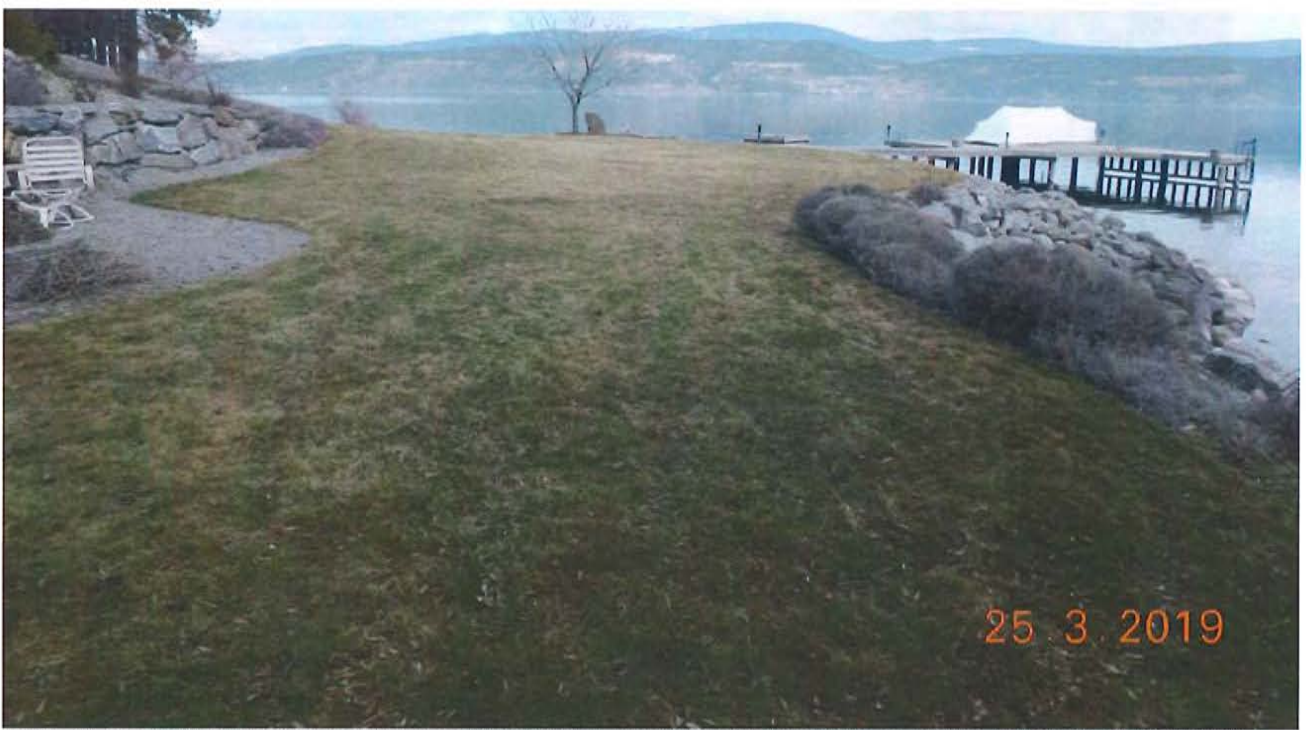
Photo 12. Areas above the average lake level of 342.15 m will be naturalized with large woody debris, large rocks (picked from the existing rip-rap), and native plants that are suitable to the flood regime. See detailed grading plan.
