FILE: ENG.KGEO03138-01

March 21, 2019

Geotechnical Assessment for Proposed Development at Lake Okanagan Resort

2751 Westside Road, Kelowna, BC - Revision 2

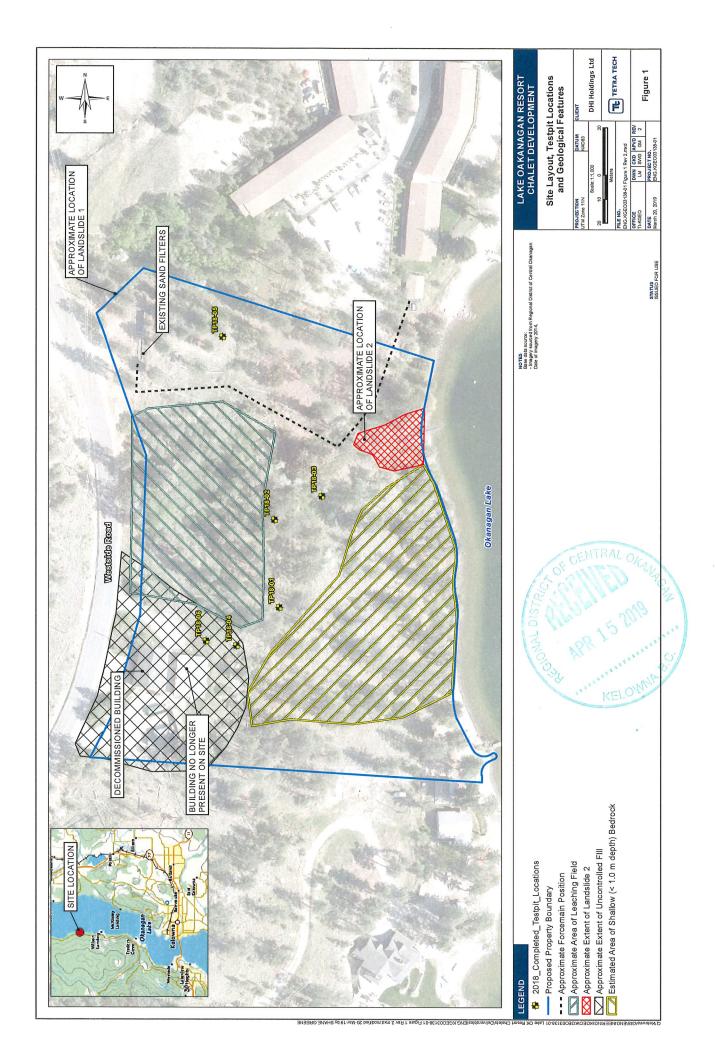
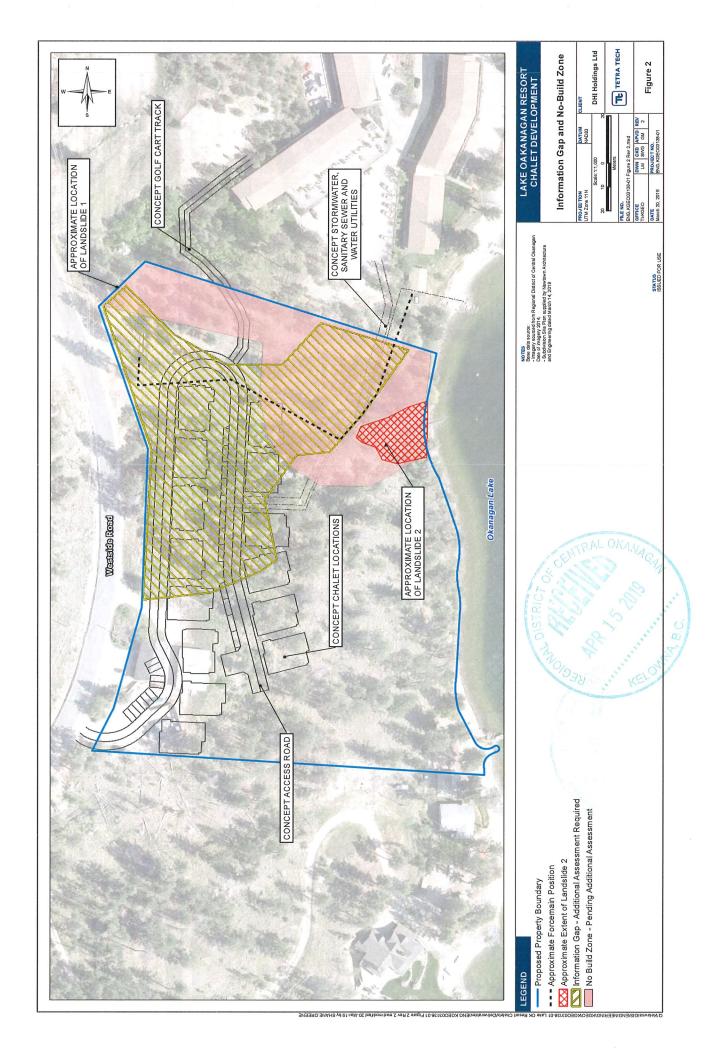
Figure 2 Information Gap and No-Build Zone

Based on our understanding of the proposed development and observed site geology, Tetra Tech considers that, from a geotechnical perspective, the southern part of the site is generally suitable for the intended purpose. However, slope stability concerns and an information gap in the central and northern parts of the site mean that further geotechnical work is recommended during detailed design for the development to proceed in these areas. Figure 2 shows an area where we consider there to be insufficient information as well as a "no-build" zone pending further assessment.
