MEMORANDUM

To: Dan Plamondon, Director Planning Services, RDCO

From: Don Dobson and Michelle Cook

Subject: Shorts Creek Risk Assessment

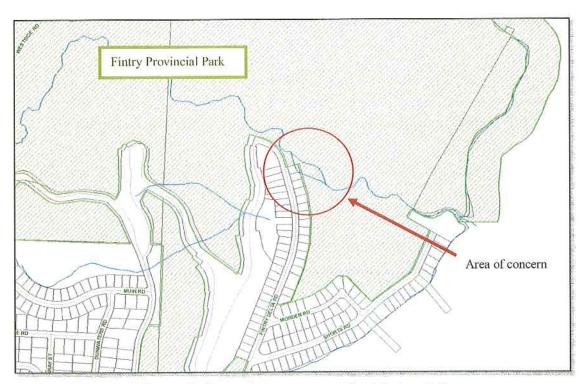
Figure 2. Area of concern on the Fintry delta

The lower section of Shorts Creek, at the Fintry Delta is located in the Regional District of Central Okanagan on the west side of Okanagan Lake about 35km north of the William R. Bennett Bridge off Westside Road (refer to Figure 1). The area of substantial erosion that was assessed is located on the east side of Fintry Delta Road, below the road bridge into Fintry Provincial Park (refer to Figure 2).

The Shorts Creek channel upstream and downstream of the assessment area is located within Fintry Provincial Park. The area of erosion has shifted the Shorts Creek channel into the private property on the east side of Fintry Delta Road.

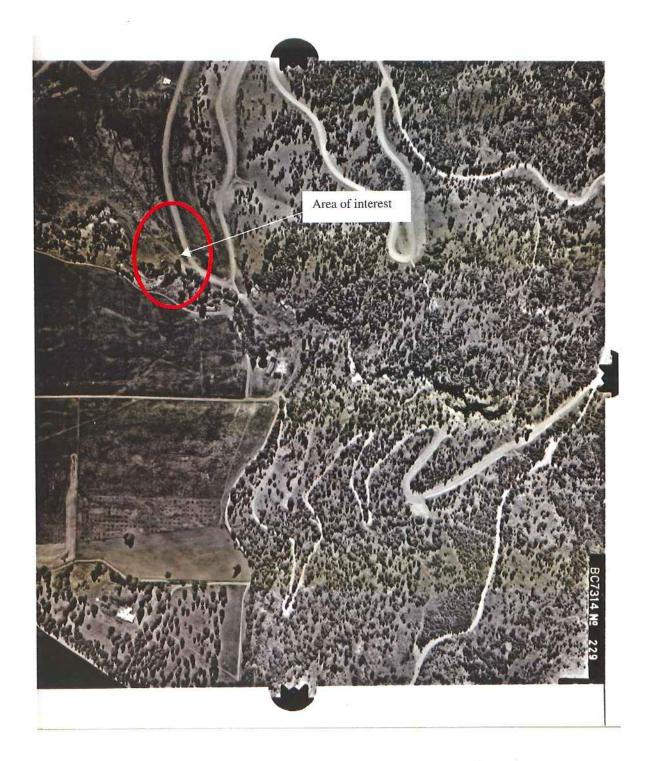
Figure 2. 1973 Air photograph (BC7314_229) of Shorts Creek fan.

A review of air photographs of the Fintry fan for 1973 (Figure 2), 1984 (Figure 3), and 1992 (Figure 4) with those for 2004 (Figure 5) confirmed that the channel was well north of Lot 88 in 1984. Based on the information provided

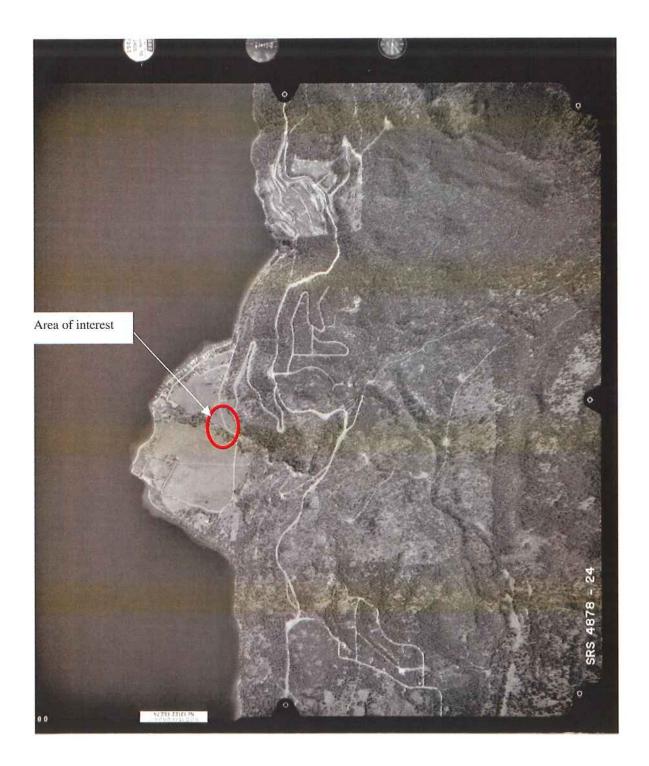
Figure 4, 1992 Air photograph (SRS 4878-24) of Shorts Creek fan.

collected during the 2009 Dobson report, indicate that until 1992 the active channel was to the north of the private lots and the alignment of the south bank was generally uniform with no active erosion (refer to Figure 2, 3, 4 in Appendix A).

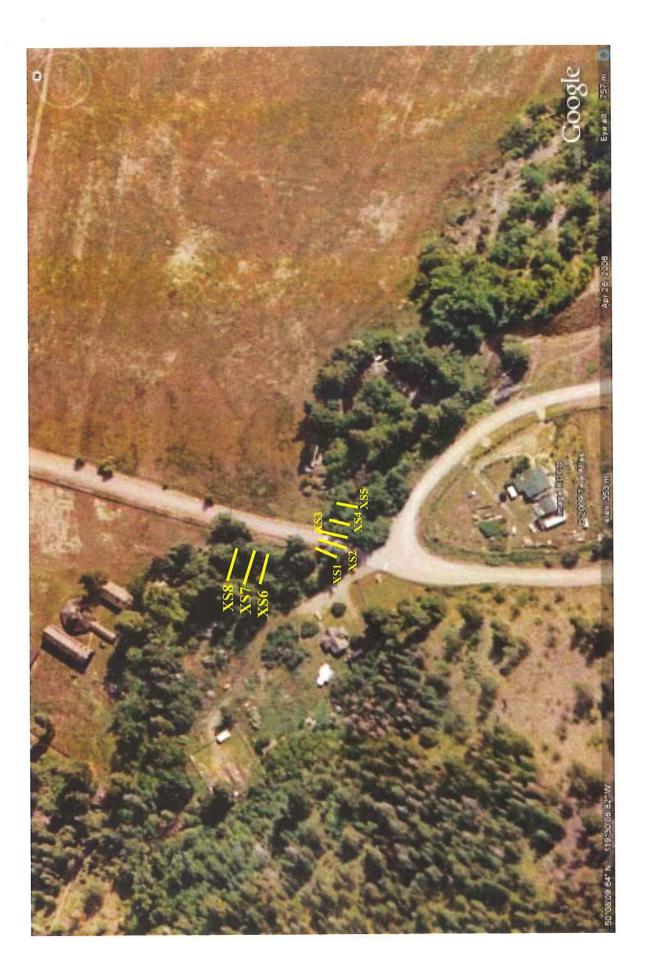
Figure 6. Shorts Creek channel survey cross section locations.

In May 2009 Dobson completed a survey of the channel from ~60 m upstream of the new bridge to ~20 m downstream (Figure 6). In total three cross-sections were surveyed upstream of the bridge, three cross-sections at the bridge and two cross-sections downstream. Manning's Equation was used to estimate the water level for the 1997 estimated peak maximum daily discharge of 33 cubic meters per second. The results indicated that the 1997 peak flow would have been contained within the channel upstream of the bridge except at cross-section 6 near the dwelling on the south bank upstream of the bridge where it would likely have overtopped the bank. Water levels were estimated through the bridge, the first was through the existing channel with the riprap in place, the second was for the estimated original channel cross-section without the riprap. The results indicate that the water level through the existing channel would likely have been approximately 0.30 m higher than they might have been if the riprap had been placed to maintain the original channel cross-section.
