CLARKE GEOSCIENCE LTD.

POST-WILDFIRE ENVIRONMENTAL AND HAZARDOUS CONDITIONS ASSESSMENT OF THE NORTH WESTSIDE ROAD AREA

Dated: February 1, 2022
Presented To: Regional District of Central Okanagan
Attention: Brittany Nichols, Environmental Planner
CGL Project # 21-0115 EOC #A21-674

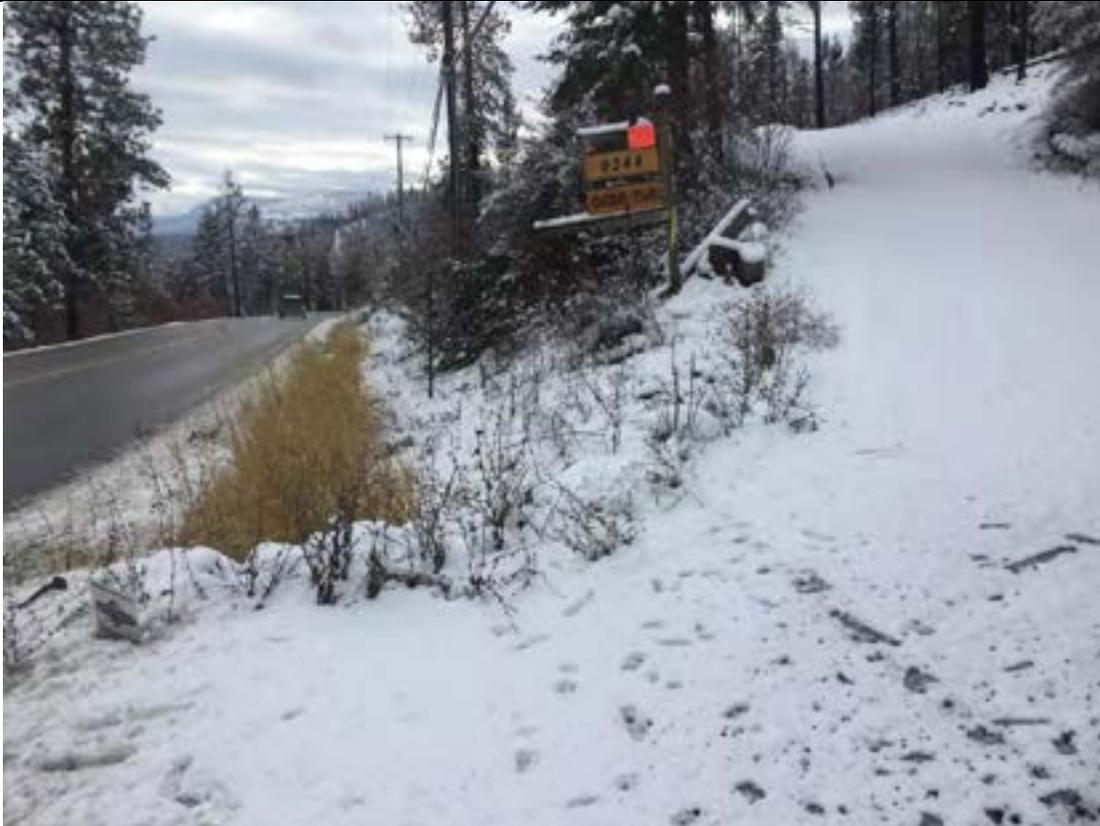
Photo 1: View of driveway entrance at 9344 Westside Road, stream flows south through culvert under driveway

Recommended Recovery Response and Considerations for Future Development:	Short term (pre-freshet): Ensure full clearance of driveway culvert and ditch along Westside Road. Monitor and be prepared to respond to overflow and/or blockage.	
	Long term: Complete hydrotechnical engineering assessment of berm and hydrology assessment of pond and outlet structures. Consider options to restore natural drainage.

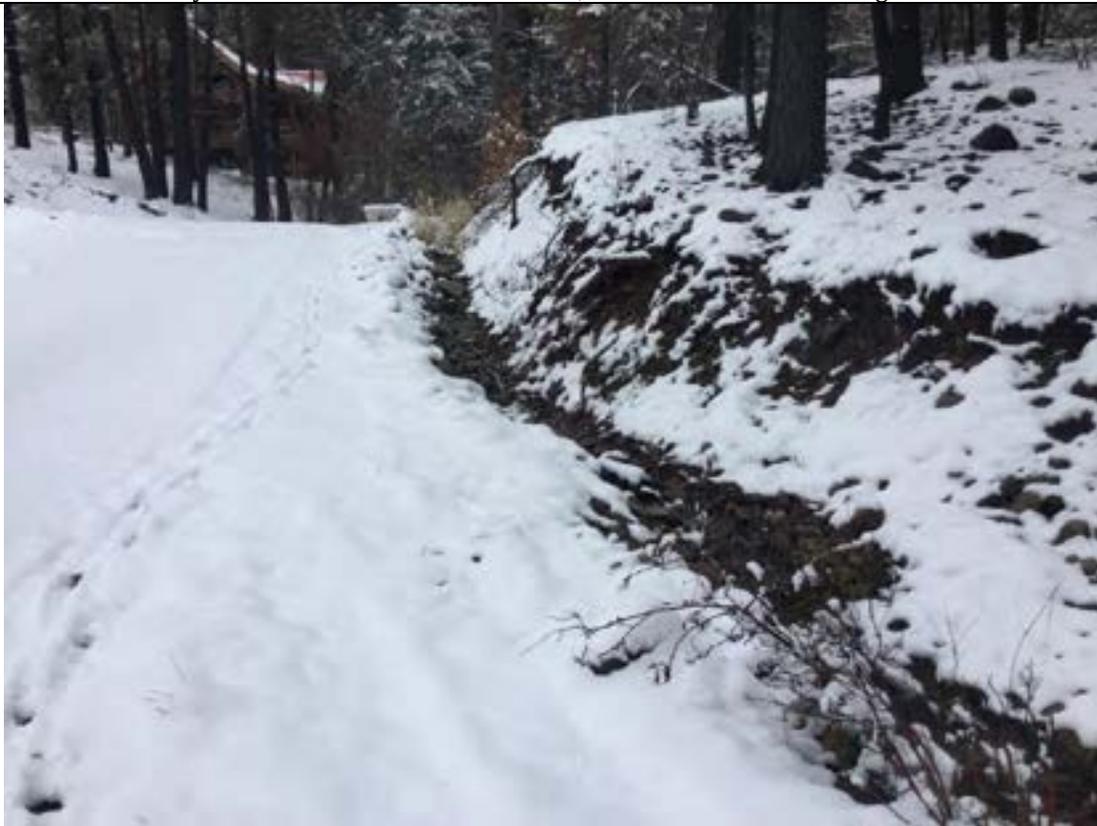
Photo 2: View of stream that flows along the north property boundary of 9344 Westside Rd.

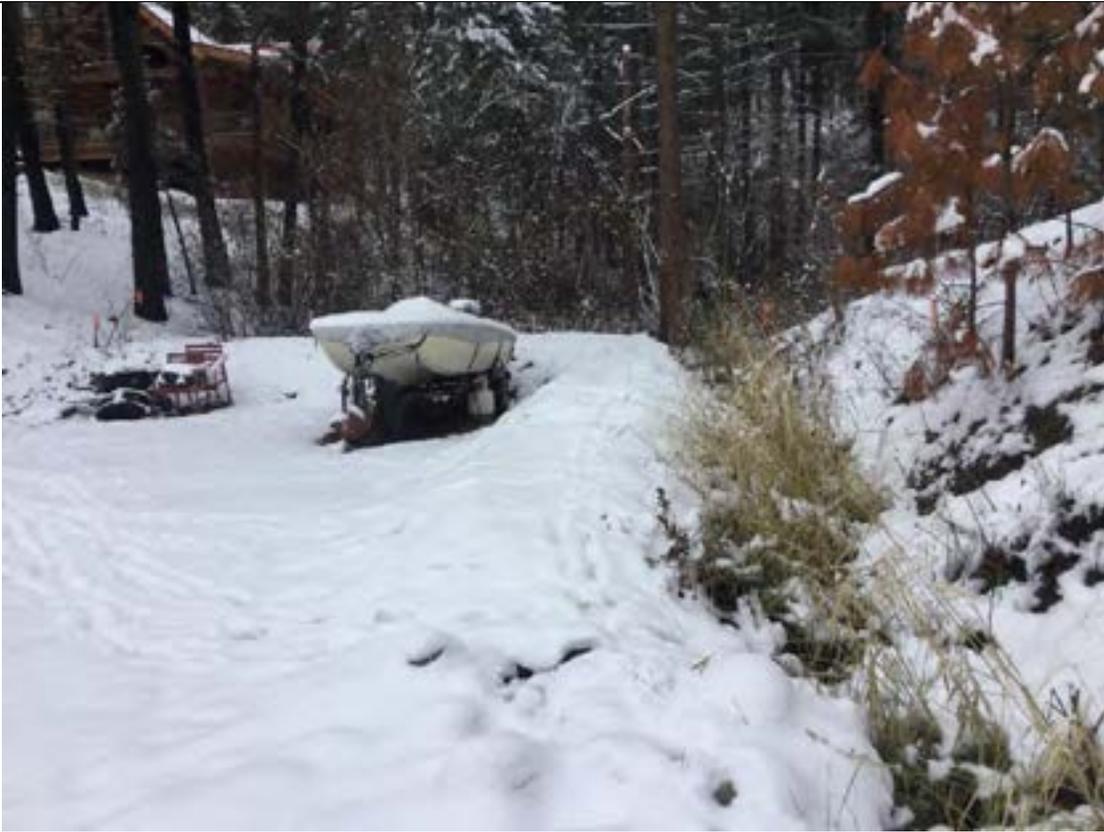
Photo 3: View of berm surrounding small pond located just upslope of 9344 Westside Rd.

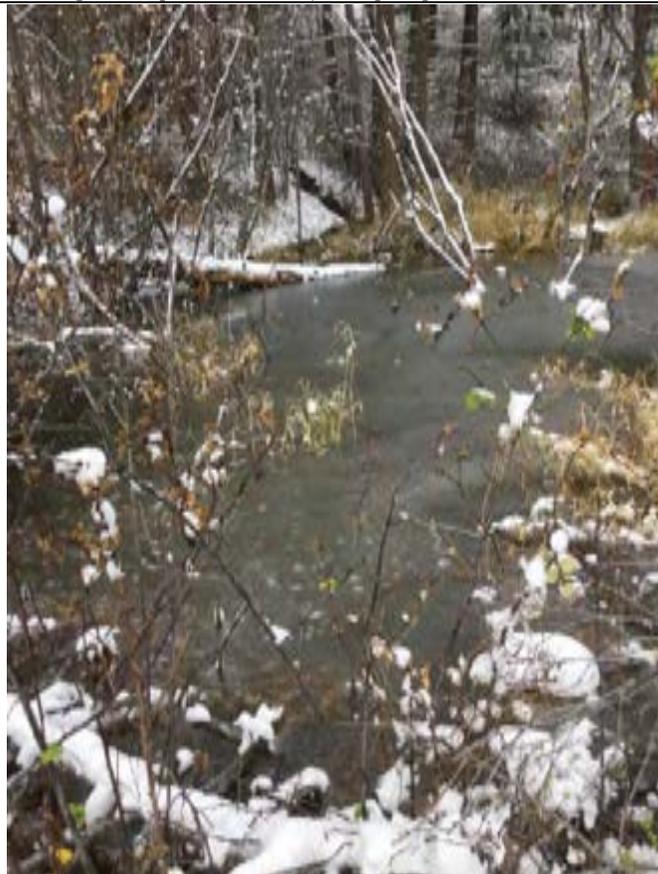
Photo 4: View of small pond located upslope of 9344 Westside Road. Water level controlled by elevation of outlet.

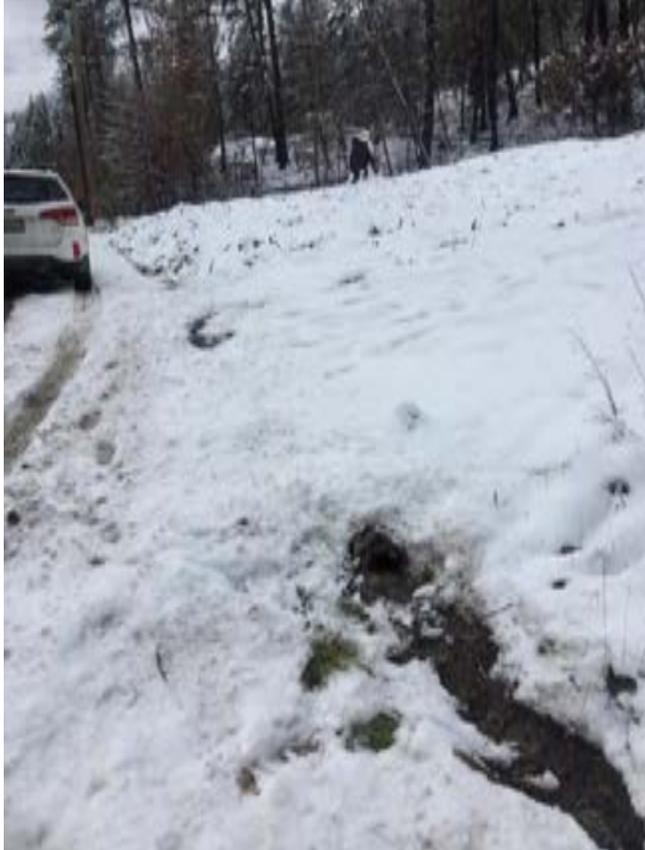
Photo 1: View of driveway entrance at 654 Udell Rd, culvert under driveway visible

Recommended Recovery Response and Considerations for Future Development:	Short term (pre-freshet): Ensure full clearance of driveway culvert and ditch along Udell Road and culvert under Udell Road. Monitor and be prepared to respond to overflow and/or blockage.	
	Long term: Consider groundwater seepage assessment and soils/geotechnical assessment for future development.

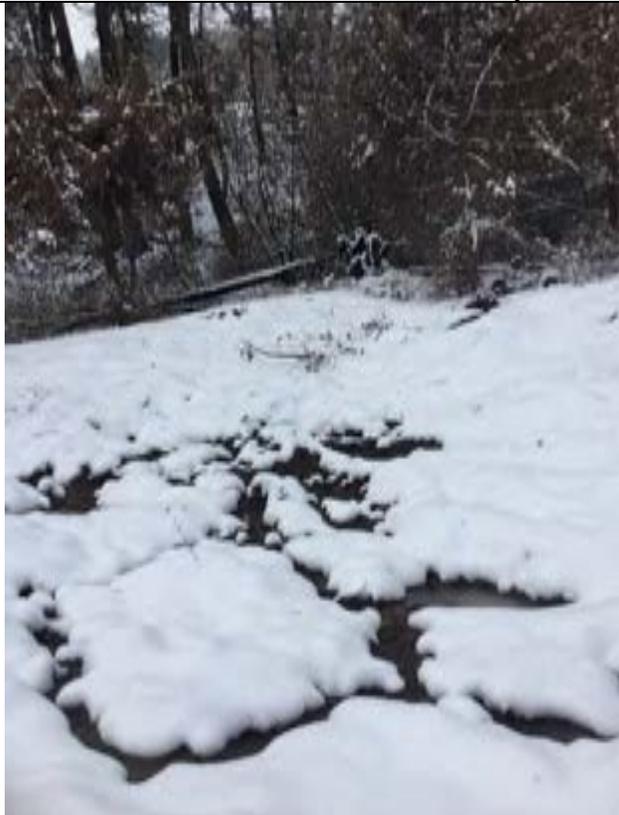
Photo 2: View of seepage across property and view towards stream (Norris Creek) in background along south property line.

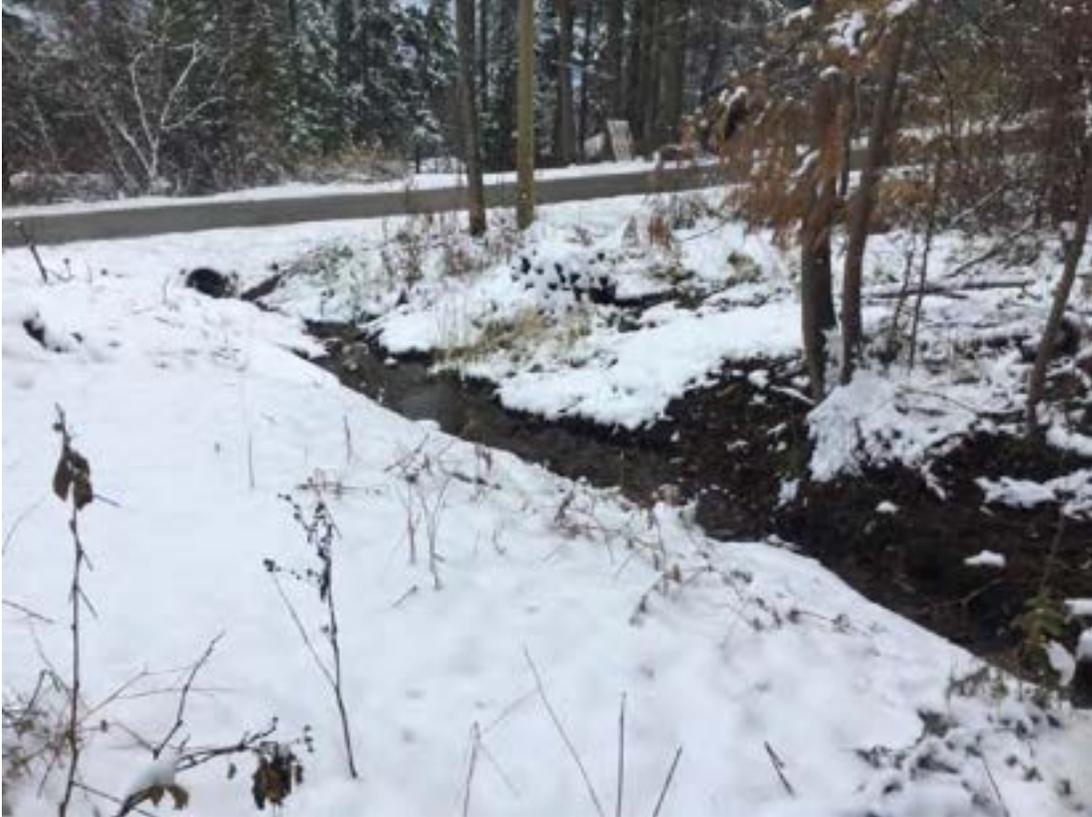
Photo 3: View of stream that flows along the south property boundary of 654 Udell Rd to culvert under Udell Rd..

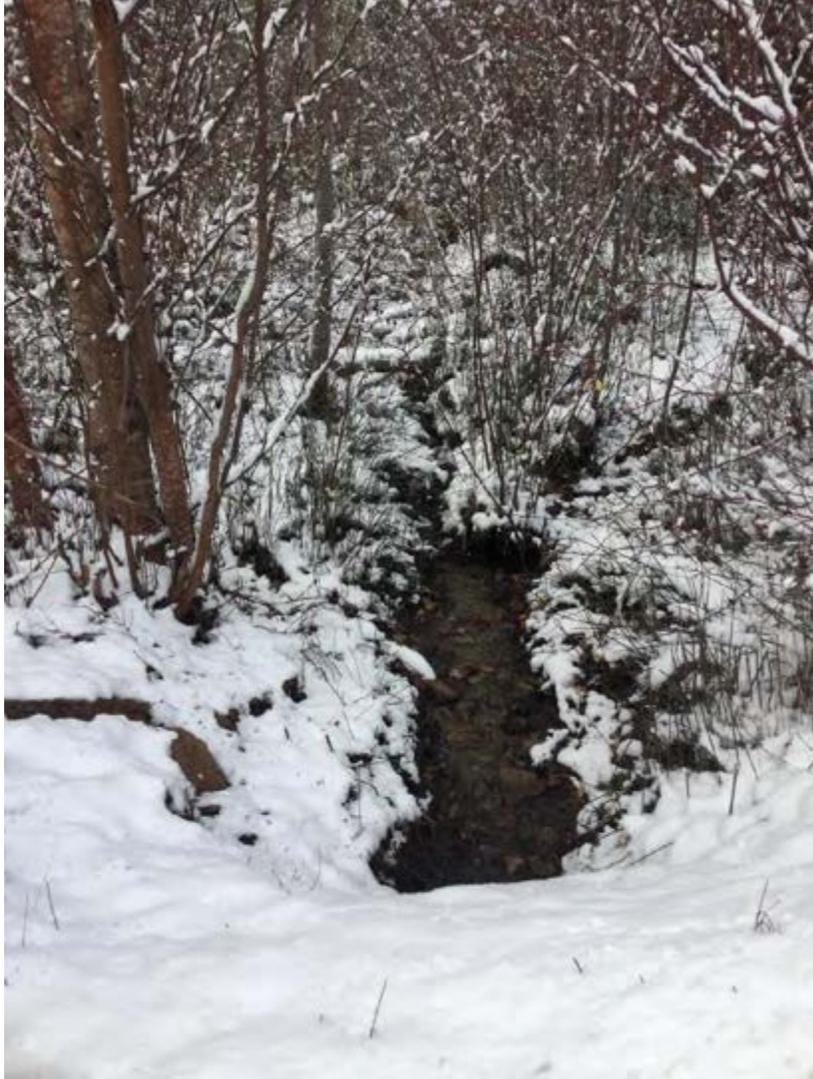
Photo 1: View downstream along stream that flows along north boundary of 664 Udell Rd, from culvert under Keithley Rd.

Recommended Recovery Response and Considerations for Future Development:	Short term (pre-freshet): Ensure full clearance of culvert under Udell Road. Monitor and be prepared to respond to overflow and/or blockage.
--	--

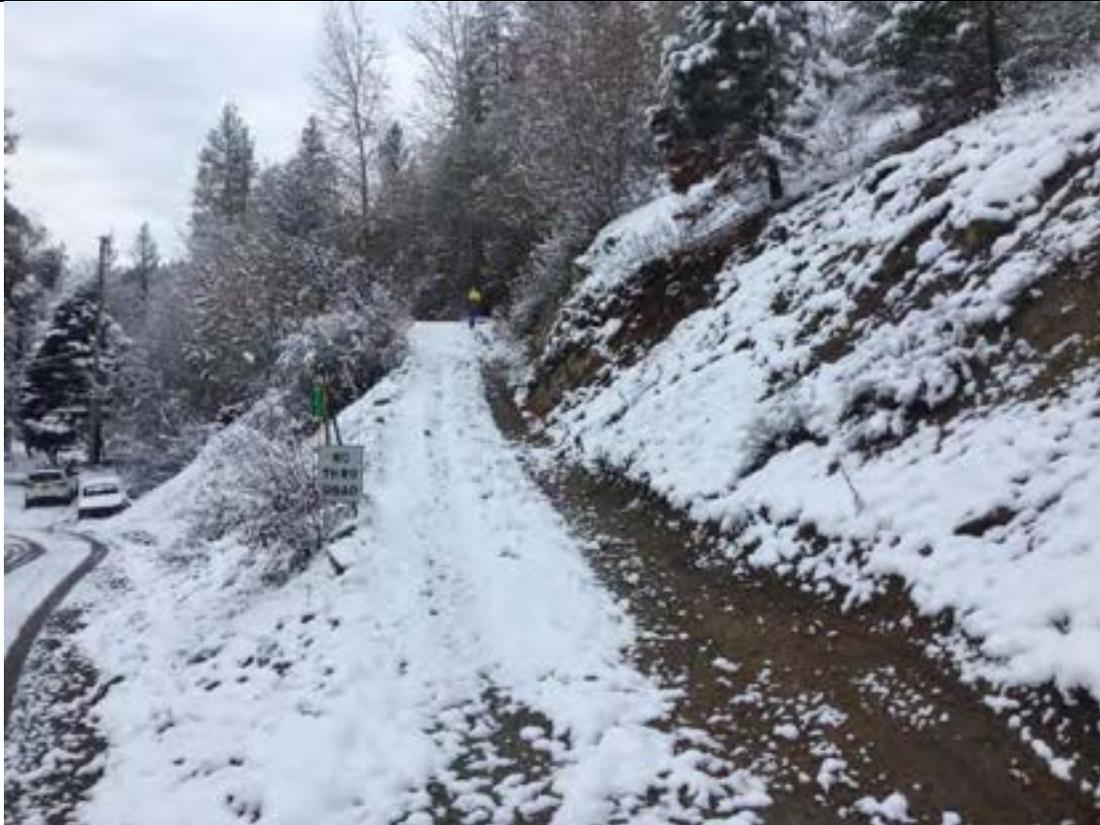
Photo 1: View of driveway access from Hodges Road (at 9304 Hodges Rd)

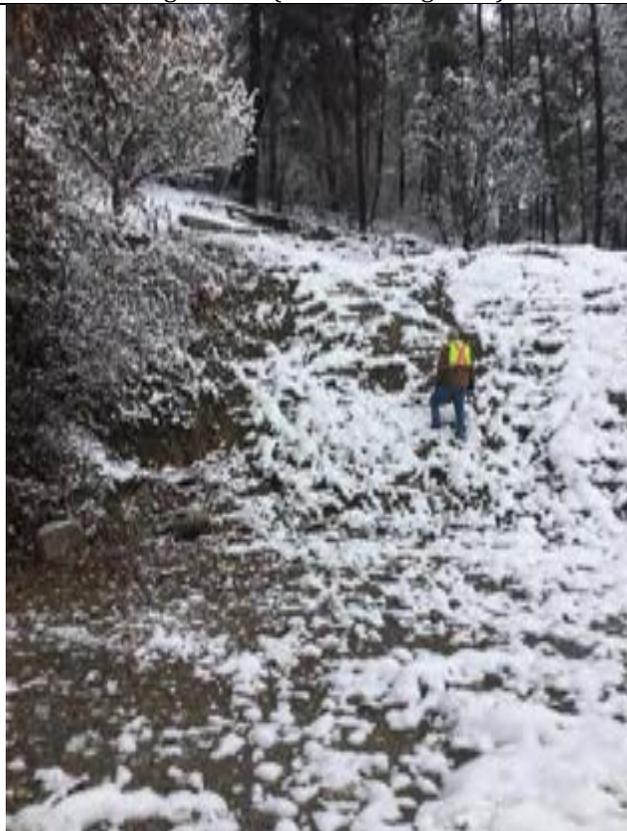
Photo 2: View towards upper part of lot from driveway at 9304 Hodges Rd.

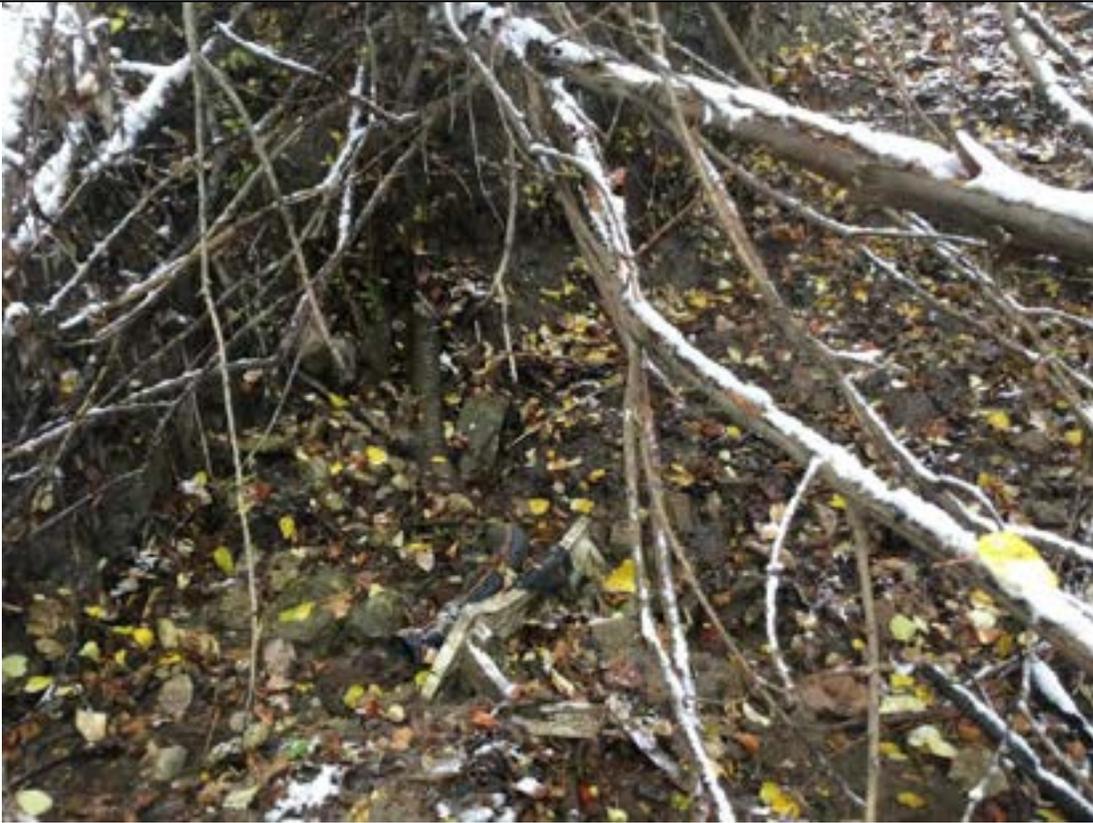
Photo 3: View of water course (Norris Creek) along south boundary of 9304 Hodges Rd.

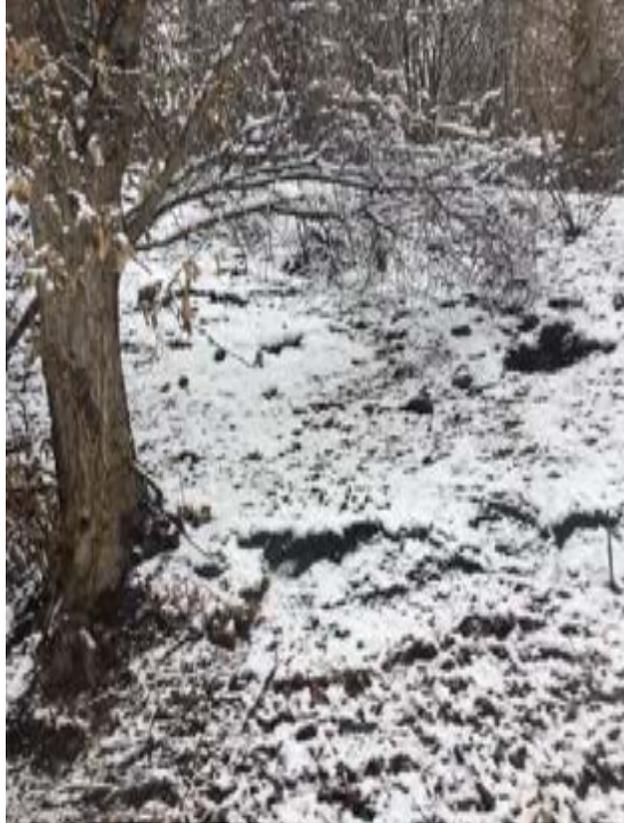
Photo 1: View upslope from driveway access right of way at 9294 Hodges Rd.

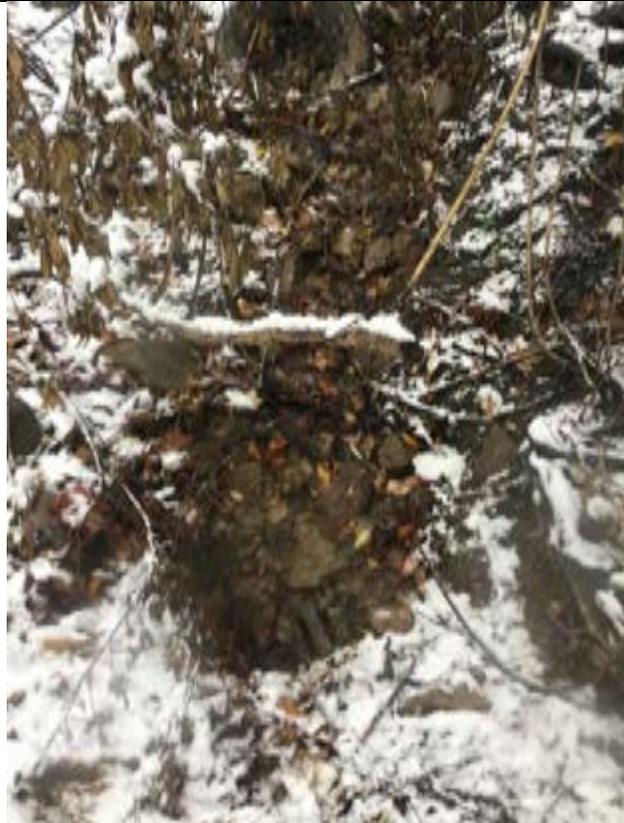
Photo 2: View of partly obstructed culvert inlet under driveway access (Norris Creek) below 9294 Hodges Rd.

Recommended Recovery Response and Considerations for Future Development:	Short term (pre-freshet): Ensure full clearance of culvert under Hodges Road. Monitor and be prepared to respond to overflow and/or blockage.	
	Long term: Consider groundwater seepage assessment and soils/geotechnical assessment for future development.

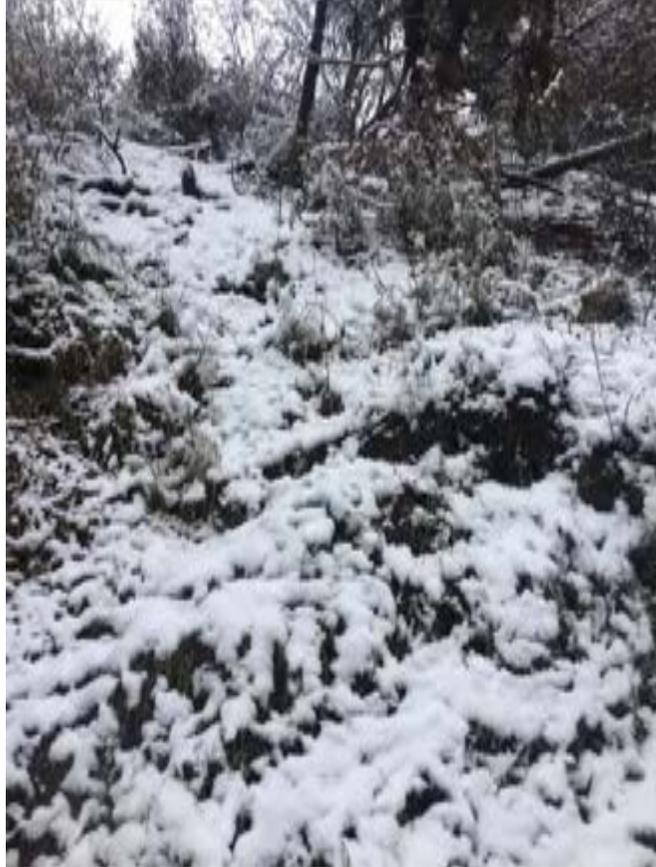
Photo 1: View upslope from driveway access right of way at 9284 Hodges Rd.

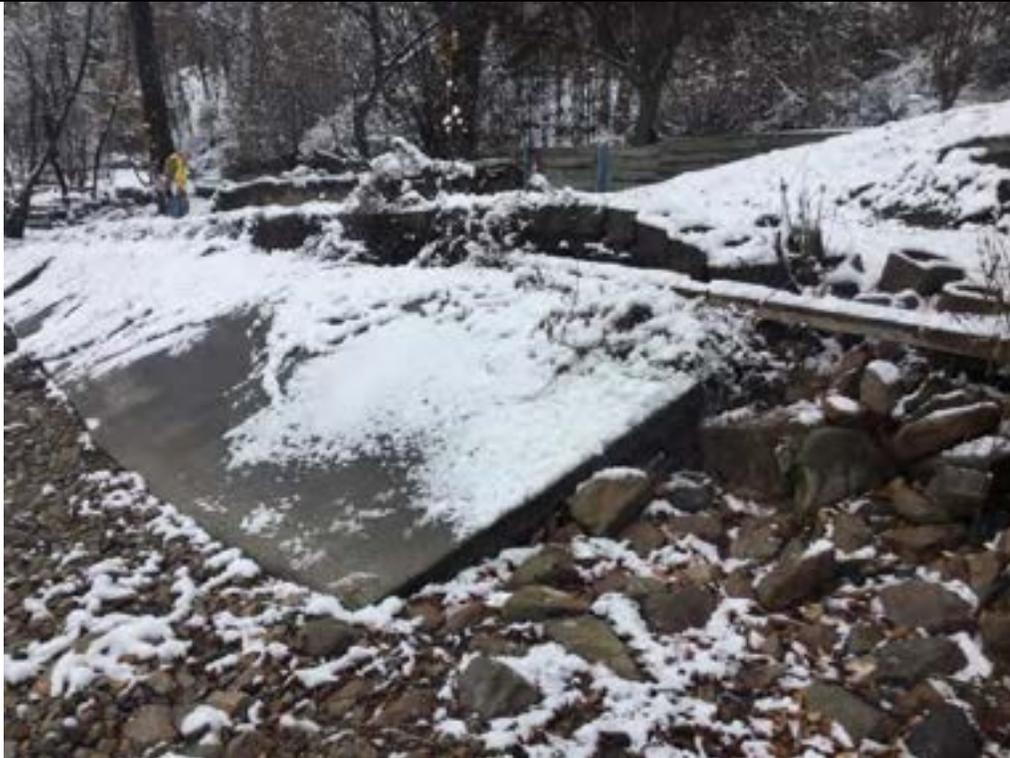
Photo 2: View of concrete apron along foreshore, with wood retaining wall in background of photo at 9284 Hodges Rd.

Recommended Recovery Response and Considerations for Future Development:	
	Long term: Consider soils/geotechnical assessment for future development.

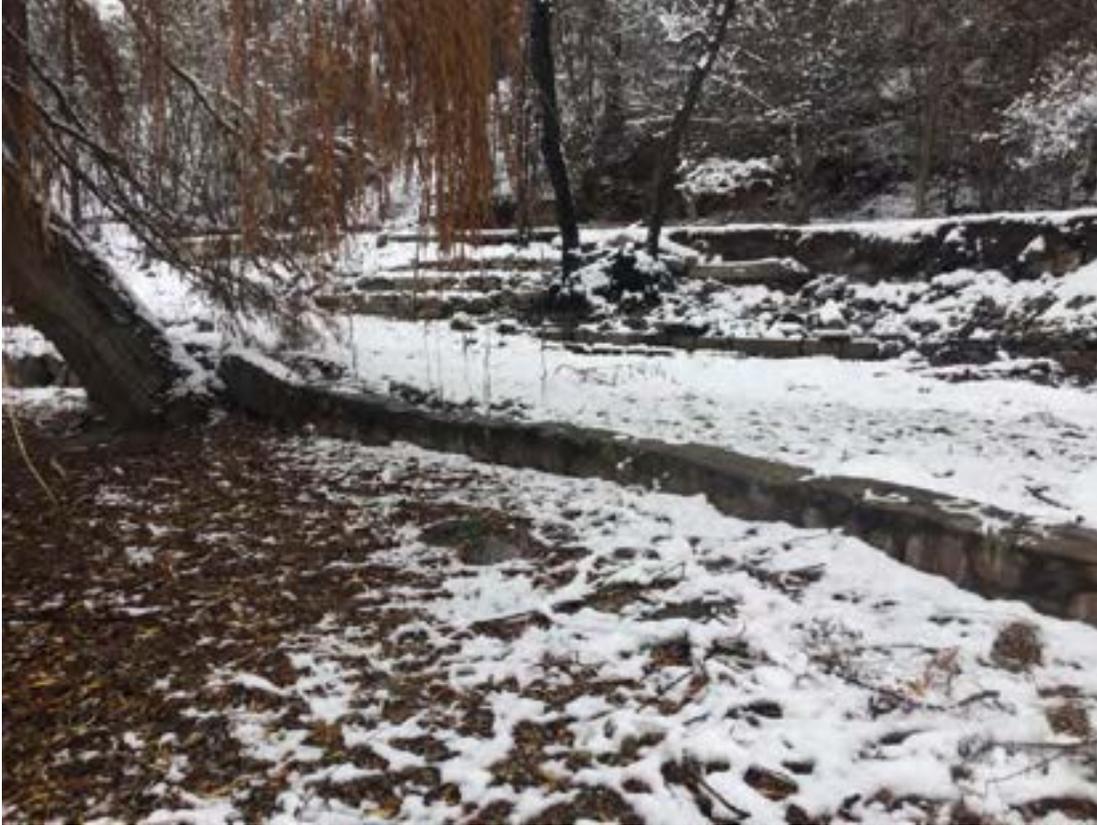
Photo 1: View upslope of foreshore area from the lake, concrete retaining wall and burned wood retaining wall

Recommended Recovery Response and Considerations for Future Development:	
	Long term: Consider soils/geotechnical assessment for future development.

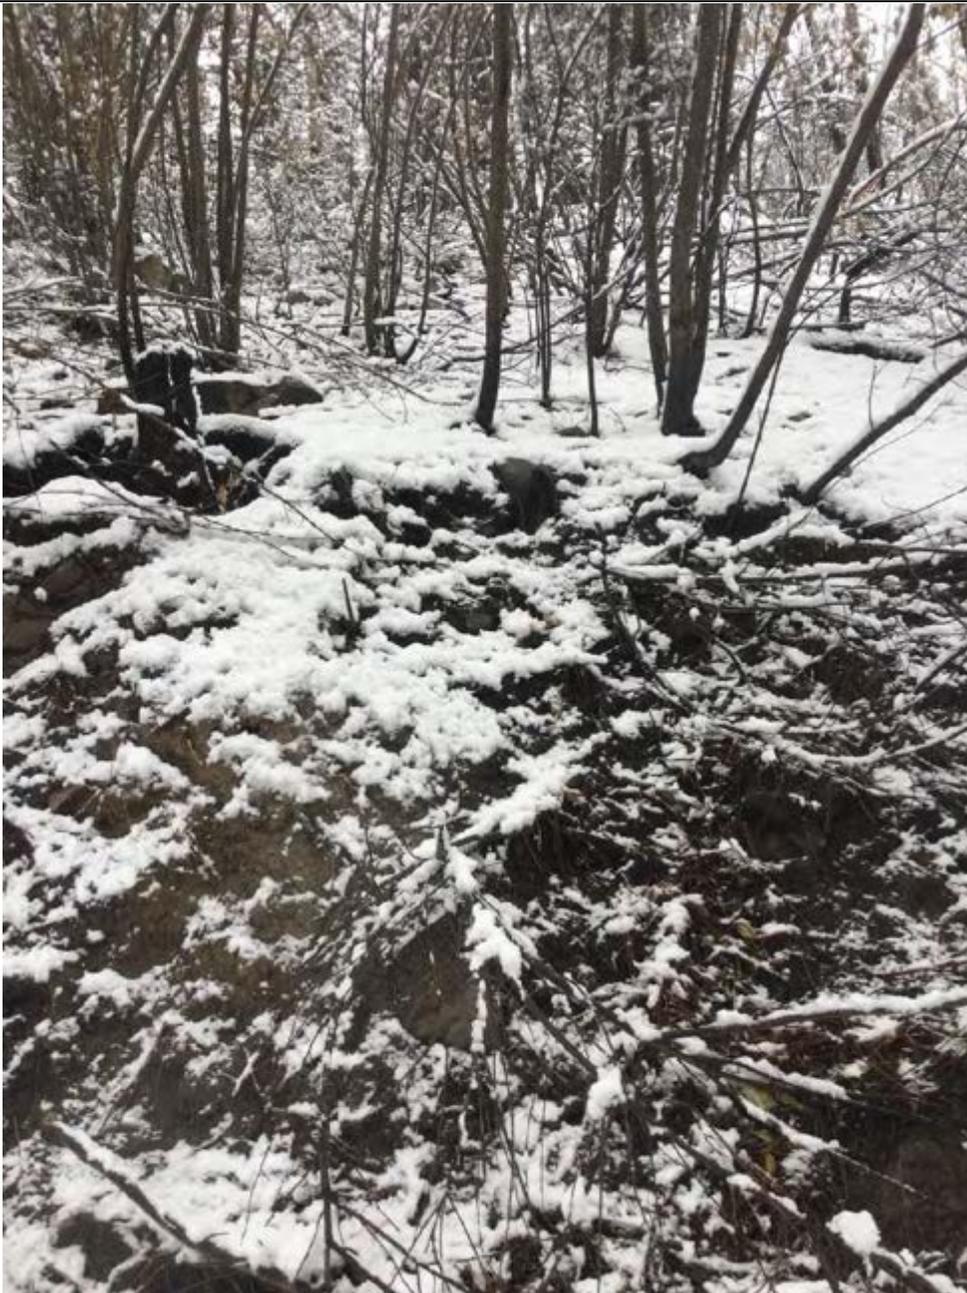
Photo 3: View of steep slopes above foreshore area at 55 Killarney Pl.

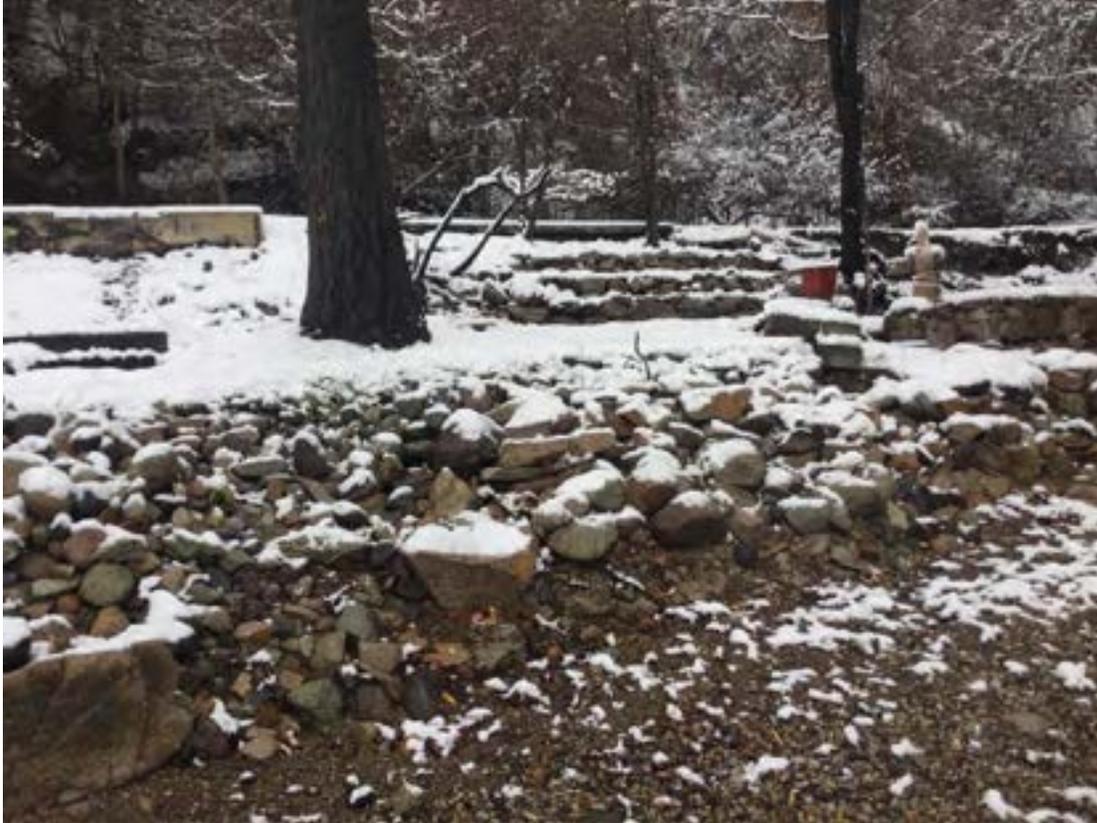
Photo 1: View upslope of foreshore area and low rock wall from the lake

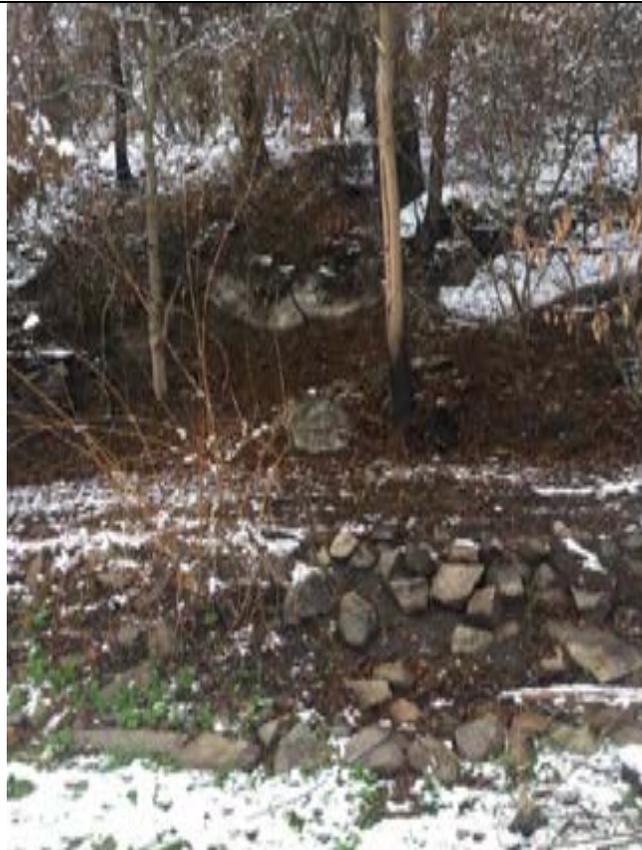
Photo 2: View of slope above foreshore area with rock retaining wall and driveway access trail above.

Recommended Recovery Response and Considerations for Future Development:	
	Long term: Consider soils/geotechnical assessment and drainage plan along access driveway for future development.

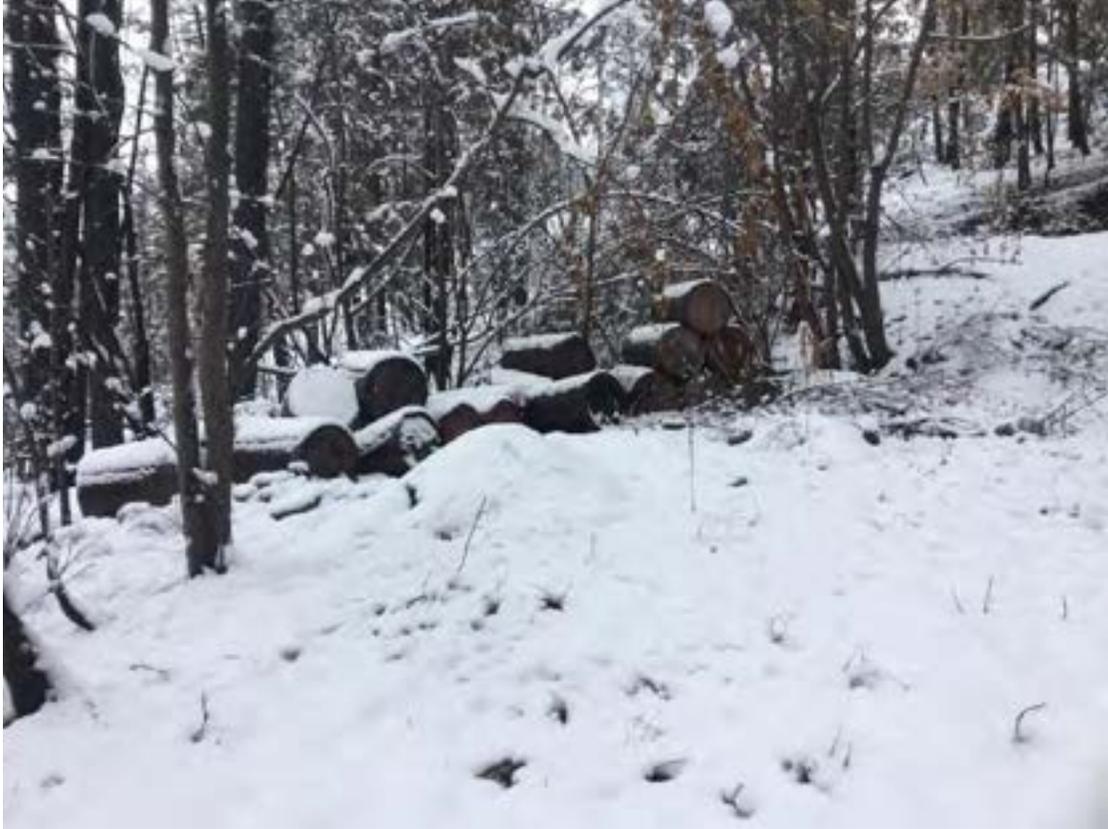
Photo 3: View of discarded drums on slope of 57 Killarney Pl.

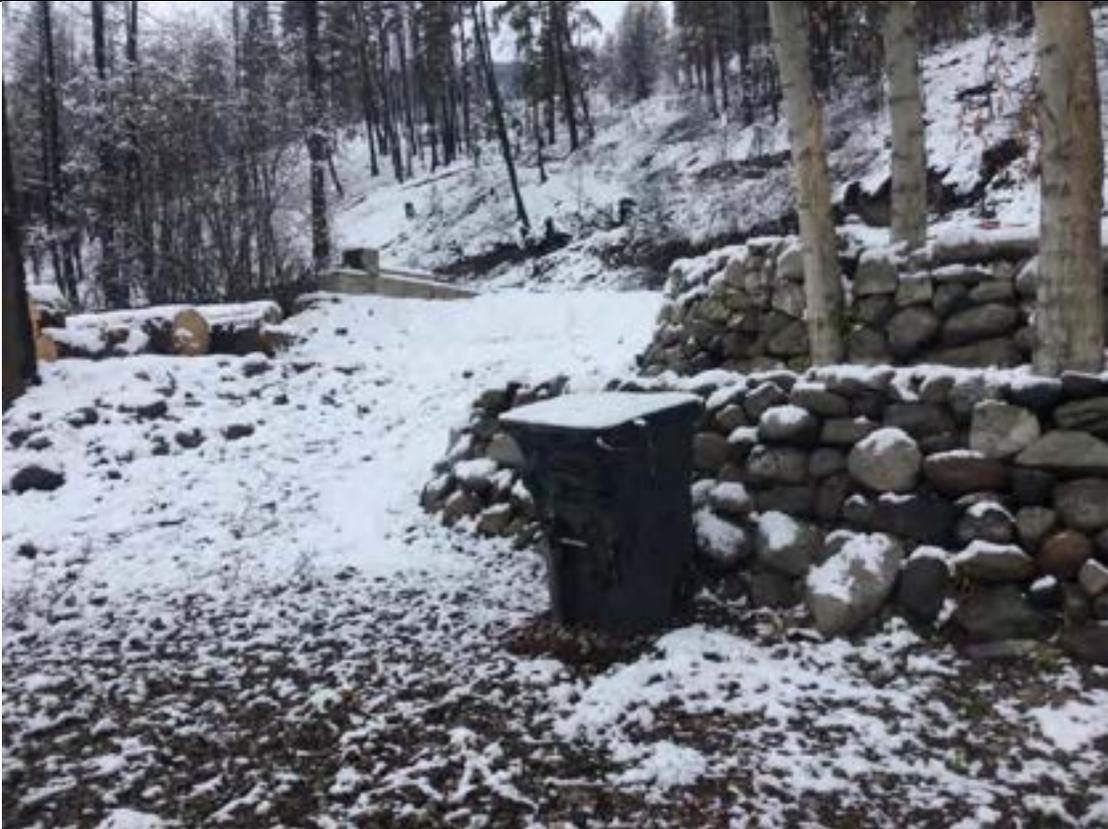
Photo 1: View of stepped rock walls from the foreshore at 58 Killarney Pl

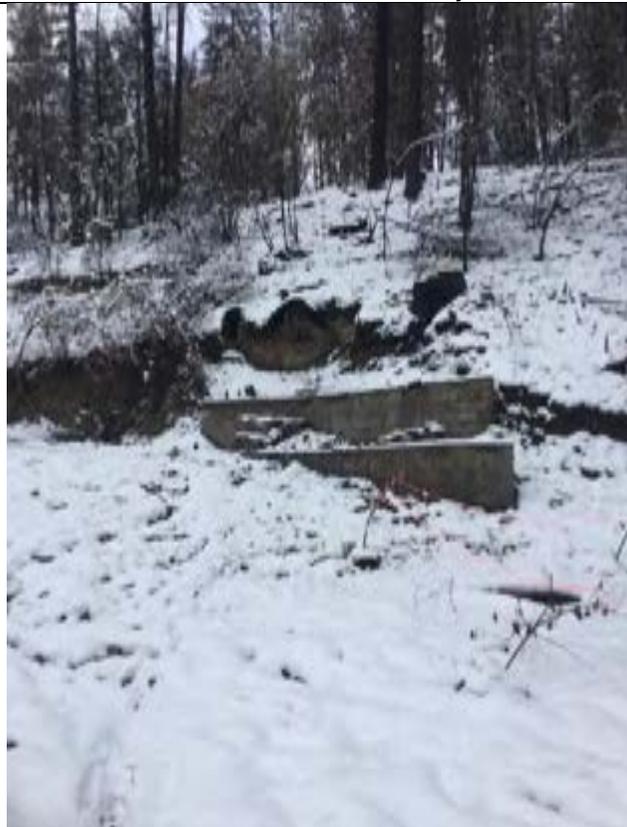
Photo 2: View of slope above foreshore area with block retaining wall along toe of slope

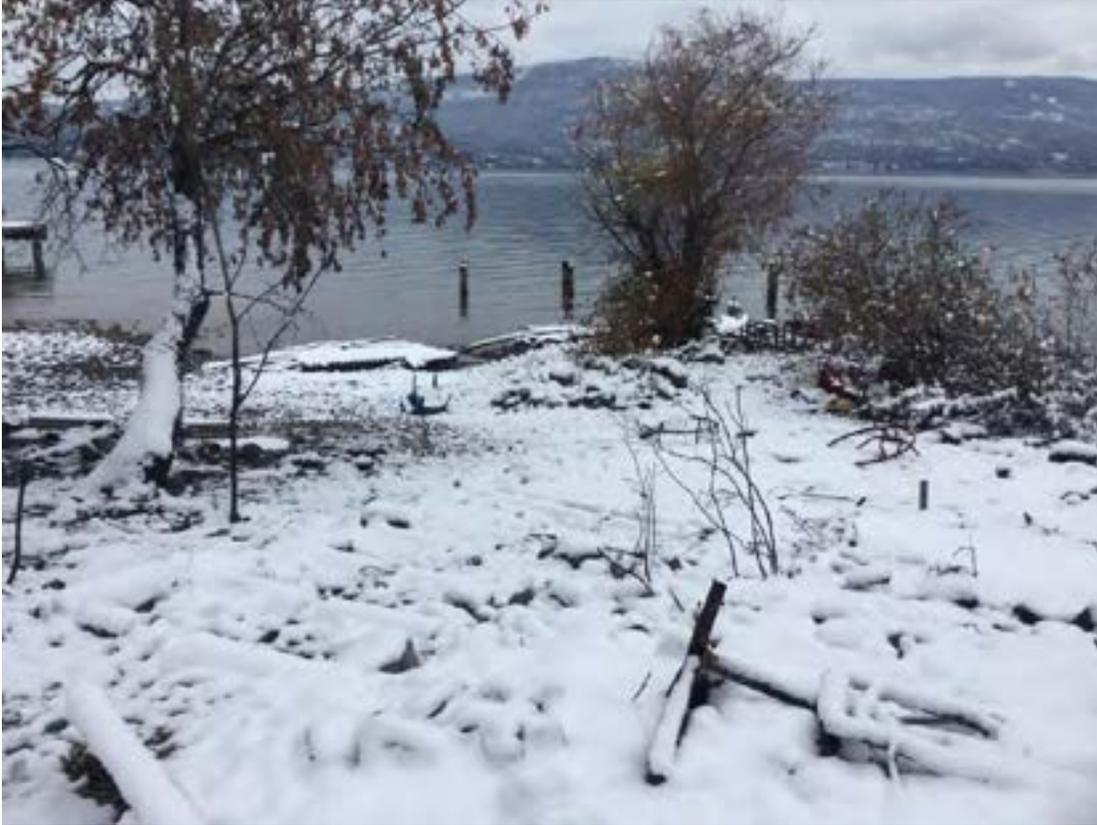
Photo 1: View towards Okanagan Lake 66 Killarney Pl.

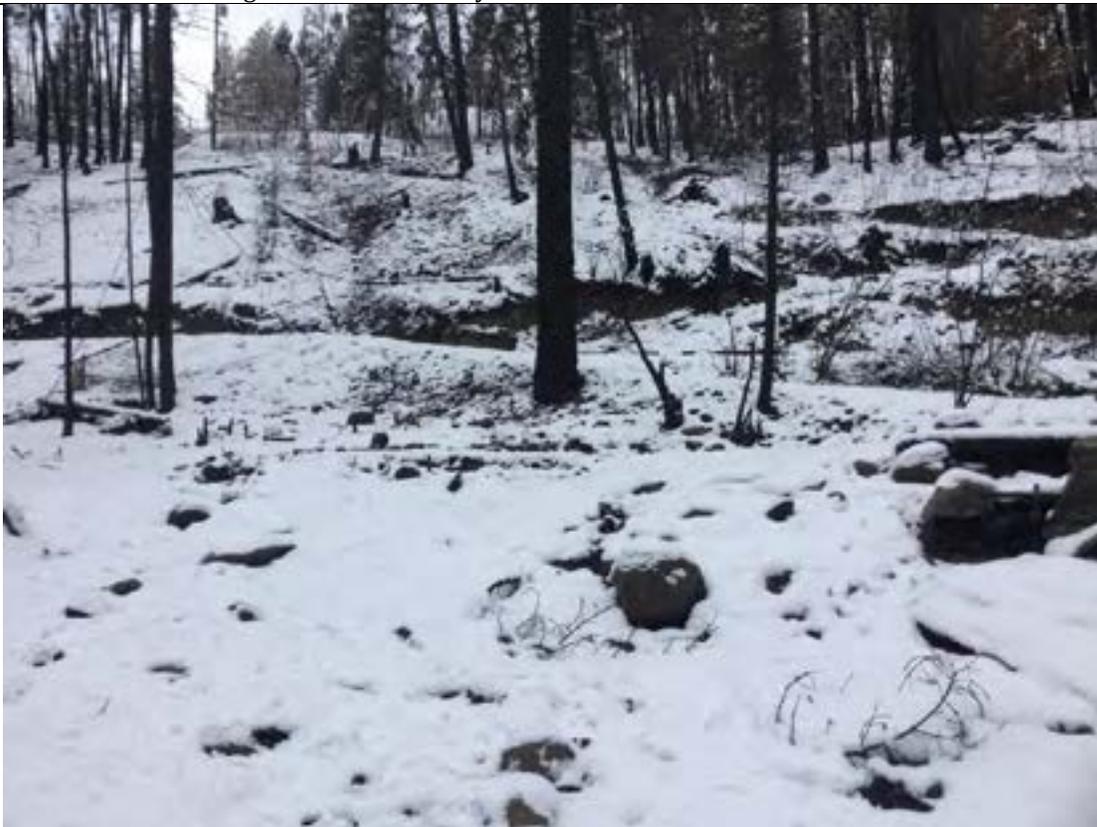
Photo 2: View of slope above foreshore area at 66 Killarney Pl.

Recommended Recovery Response and Considerations for Future Development:	
	Long term: Consider soils/geotechnical assessment along access driveway for future development.

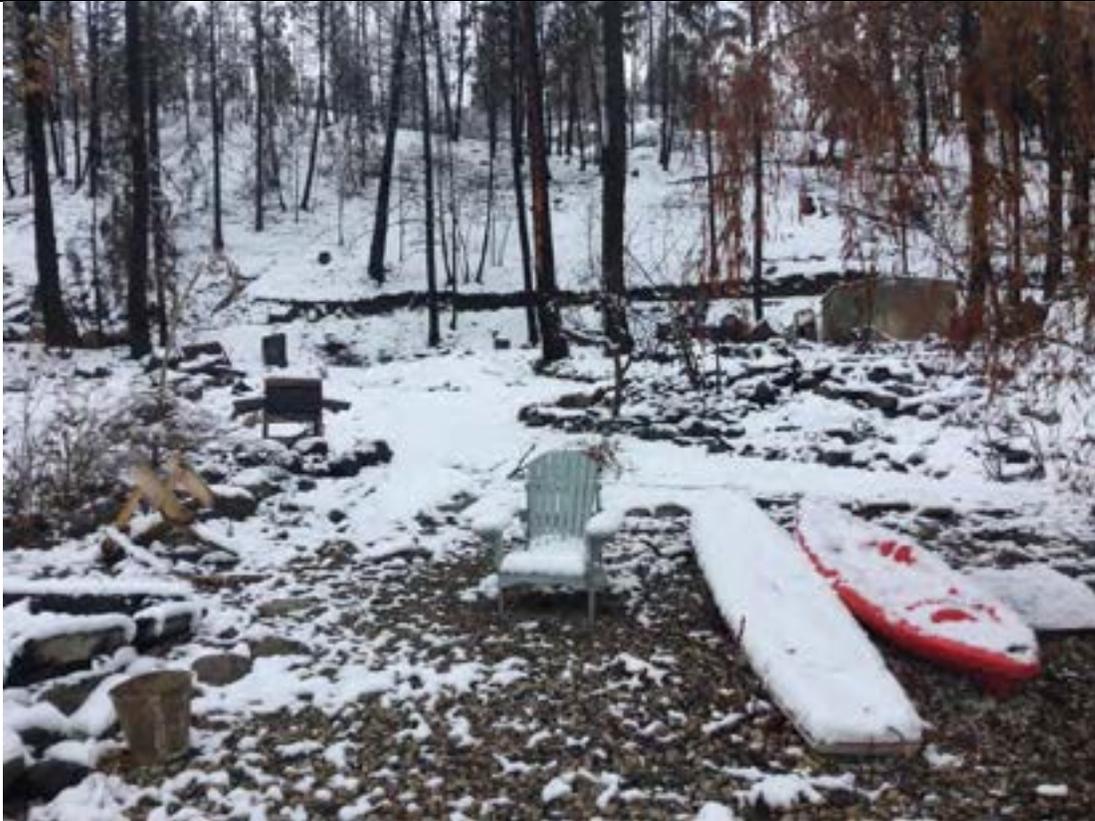
Photo 1: View of foreshore area towards slope at 75 Killarney Pl.

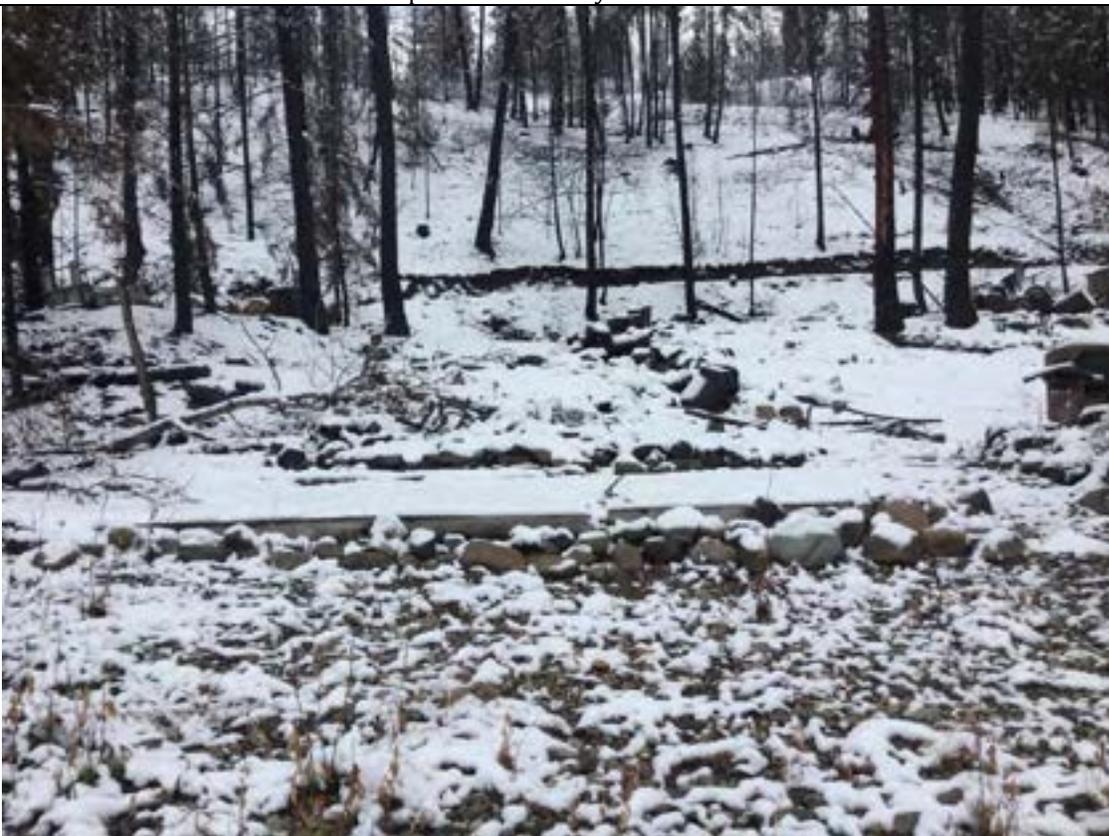
Hazards Noted:	None. Potential for runoff concentration and diversion along the driveway access trail.	
Spatial Likelihood:	Low potential for sediment delivery to Okanagan Lake.	
Hazard Level: LOW	Spatial Likelihood: LOW	Risk Level: VERY LOW

Photo 2: View of slope above foreshore area at 75 Killarney Pl.

Recommended Recovery Response and Considerations for Future Development:	
	Long term: Consider drainage plan for driveway access.

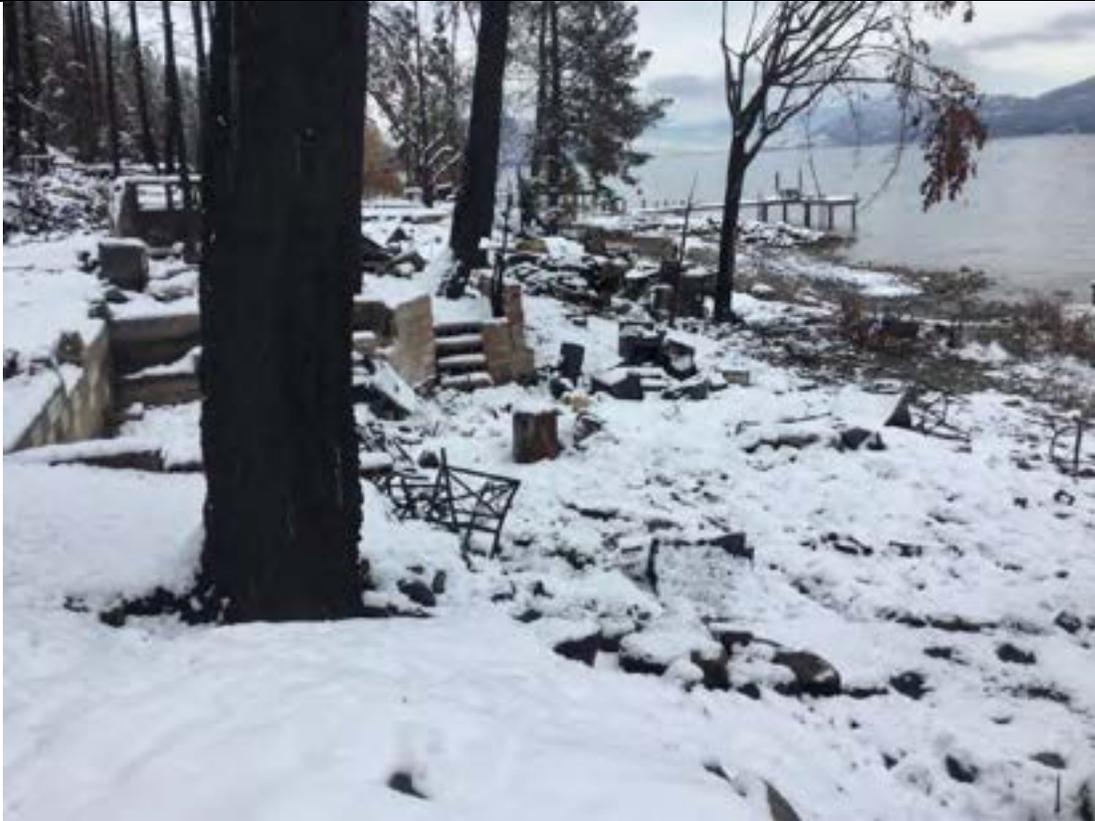
Photo 1: View of foreshore area at 81 Killarney Pl.
