CLARKE GEOSCIENCE LTD.

POST-WILDFIRE ENVIRONMENTAL AND HAZARDOUS CONDITIONS ASSESSMENT OF THE NORTH WESTSIDE ROAD AREA

Dated: February 1, 2022
Presented To: Regional District of Central Okanagan
Attention: Brittany Nichols, Environmental Planner
CGL Project # 21-0115 EOC #A21-674

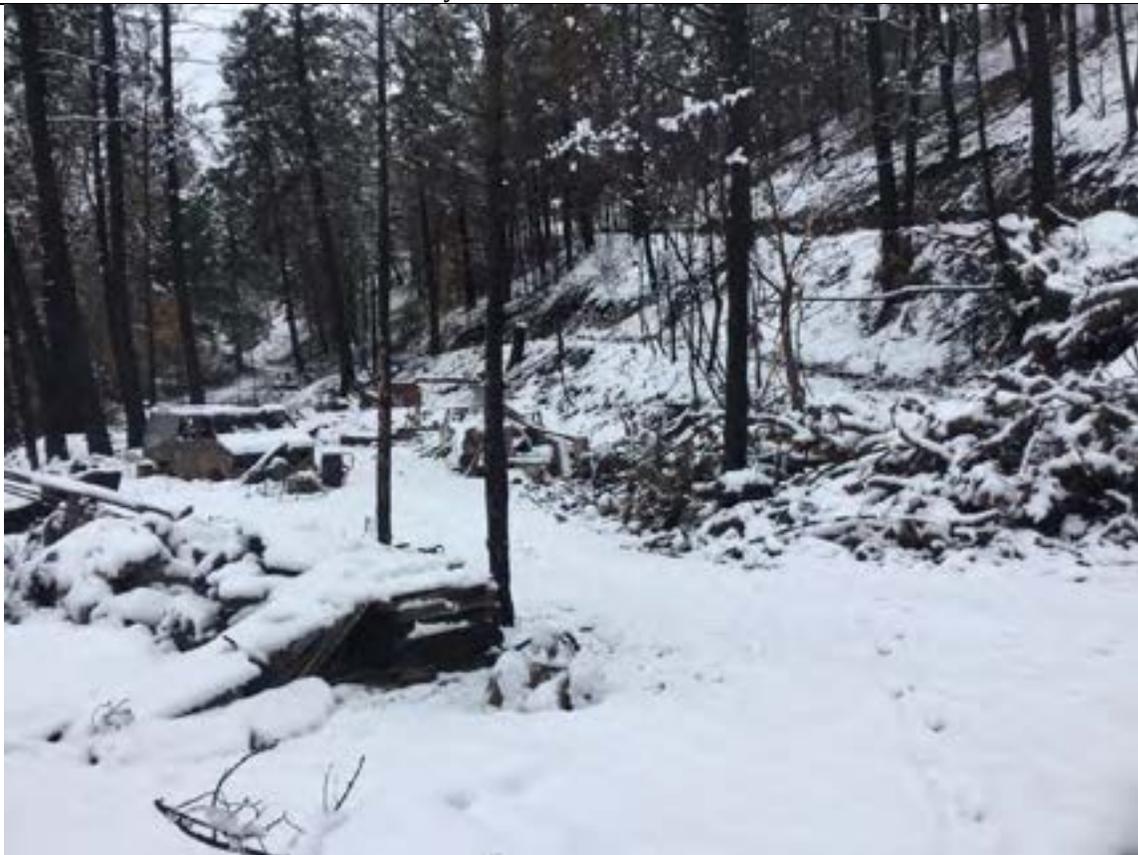
Hazards Noted:	Potential sediment input from slopes and trail above. Limited soil disturbance.	
Spatial Likelihood:	Low potential for sediment delivery to Okanagan Lake.	
Hazard Level: MODERATE	Spatial Likelihood: LOW	Risk Level: LOW

Photo 2: View of slope above foreshore area at 81 Killarney Pl.

Recommended Recovery Response and Considerations for Future Development:	Short term: Be prepared for higher than usual runoff and associated soil erosion from slopes above.	
	Long term: Consider geotechnical assessment and drainage plan for access trail.

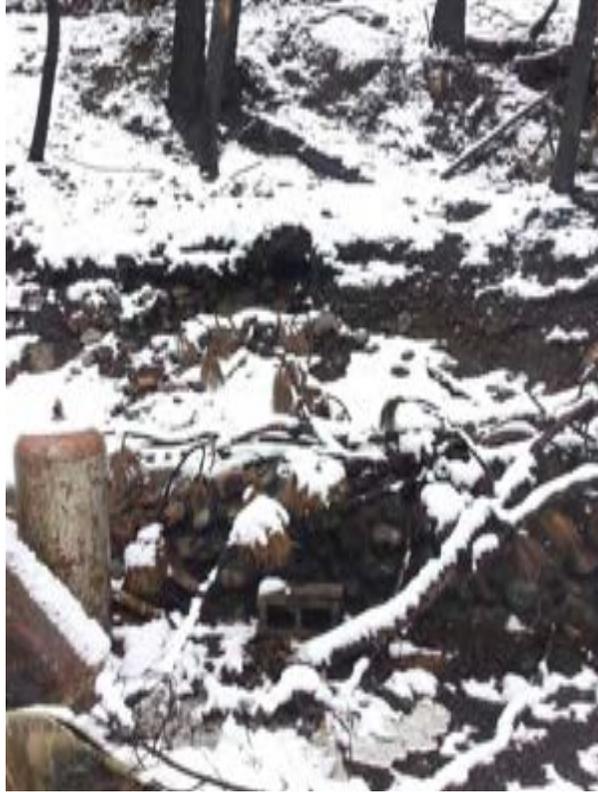
Photo 3: View of slope above foreshore area at 81 Killarney Pl.

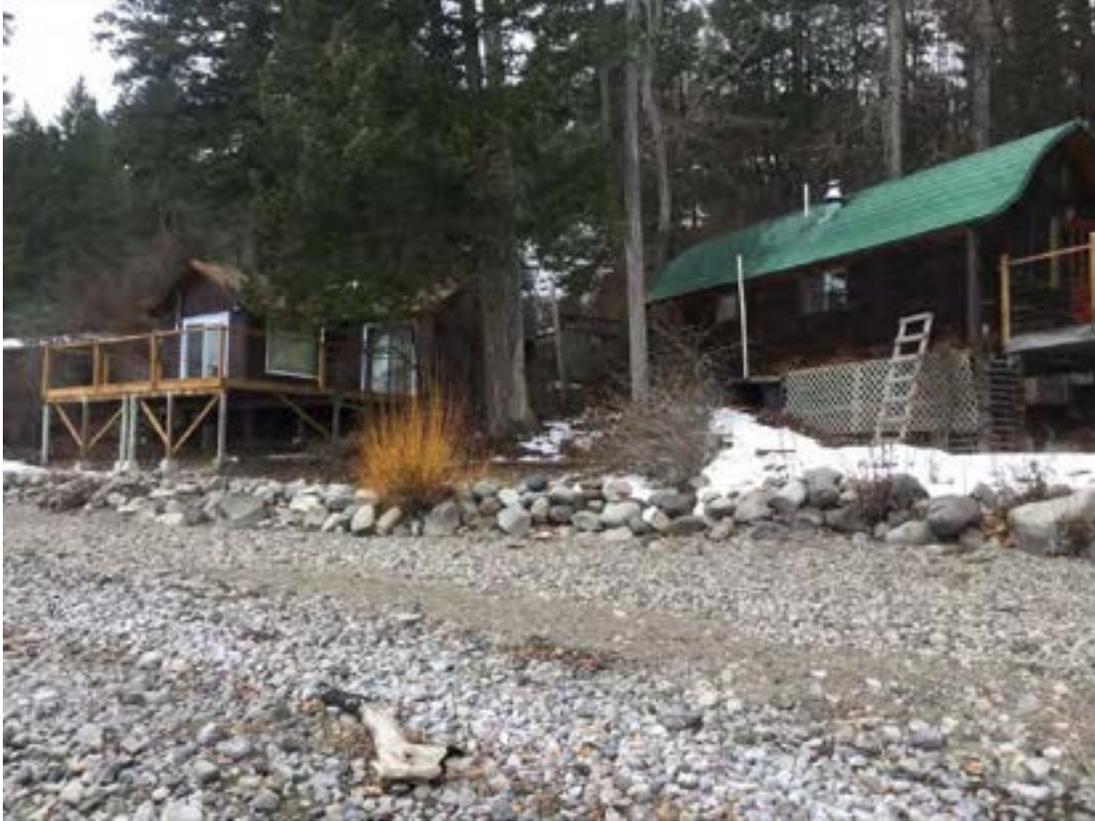
Foreshore Conditions:	Two small cottages on piled wood foundations at the lakeshore. No damages to building apparent. No dock. Beach area relatively natural.		
Setback Distance & Elevation from HWM* or Top of Bank (SHIM):	Current cabins <15 m setback from lake; elevation to be confirmed.		
Wildfire Effects Upslope/Upstream:	Mod to severe burn severity, burned gully shows recent sediment transport but very limited runout at toe of slope. Fire affected catchment areas upslope.

Photo 1: View of foreshore area at 90 Killarney Pl. Note two small dwellings along foreshore area.

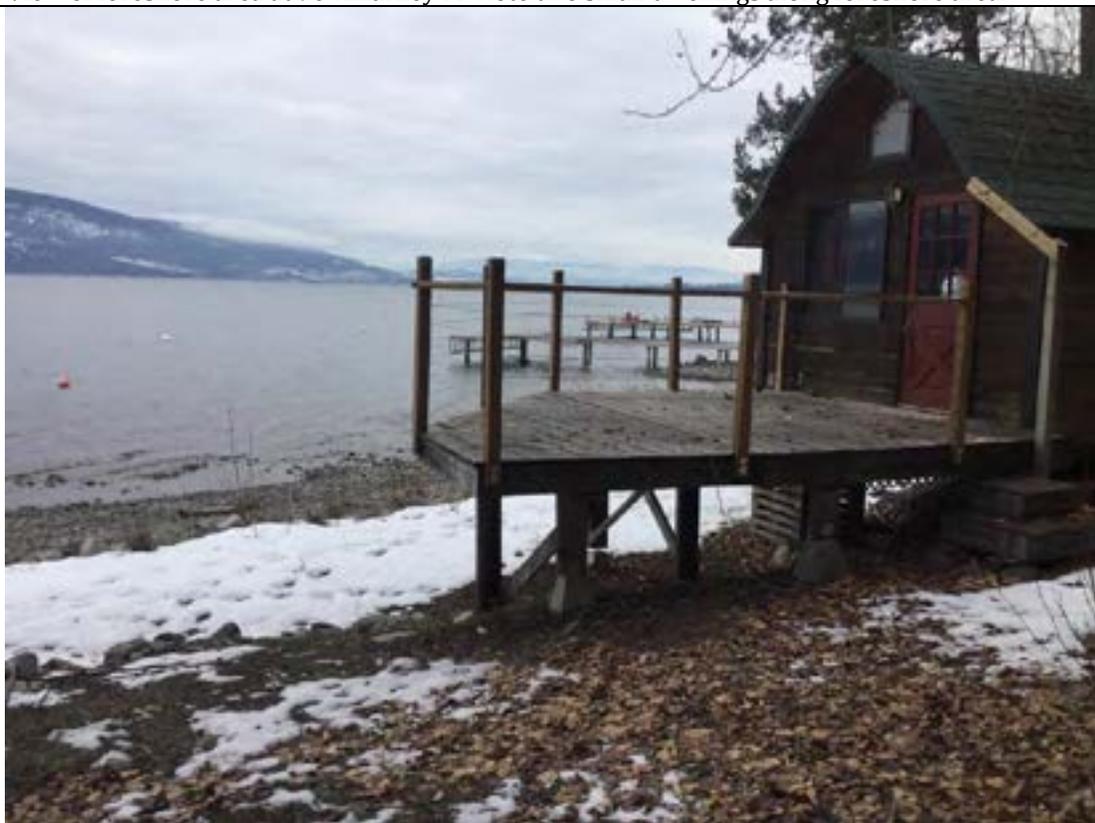
Photo 2: View of foreshore area at 90 Killarney Pl.

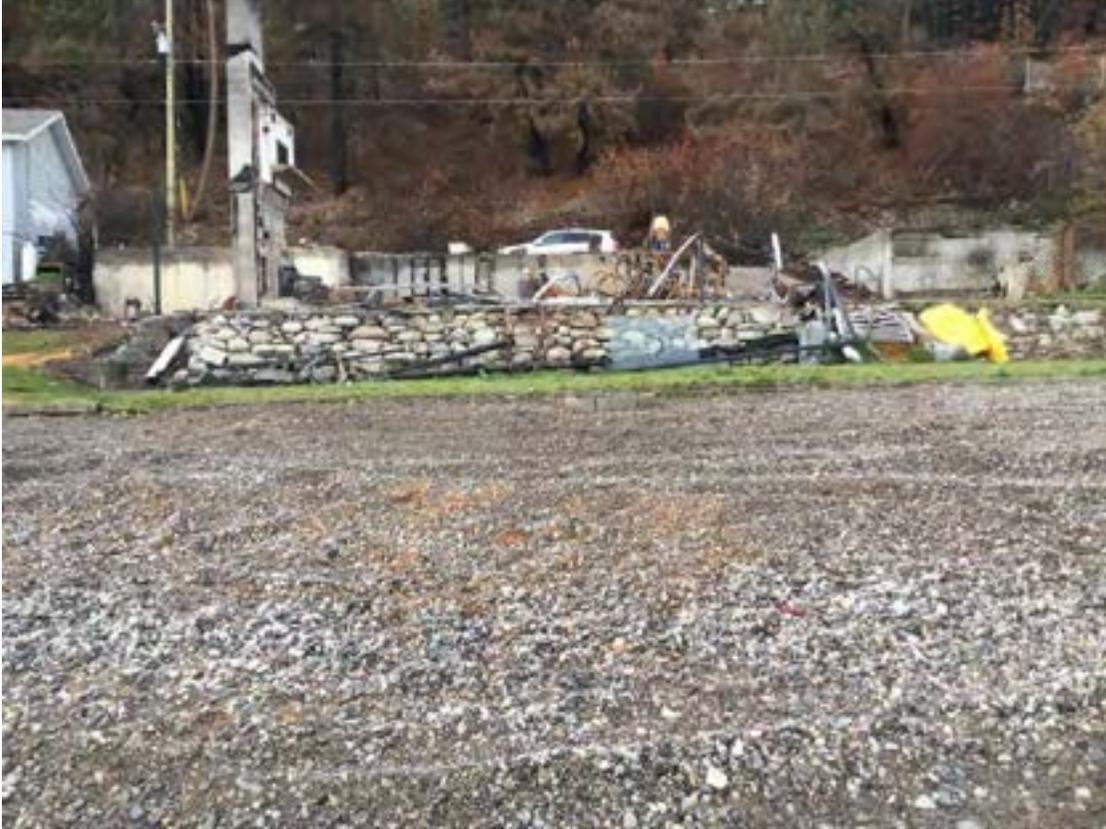
Photo 1: View of 43 Beachwood from Okanagan Lake

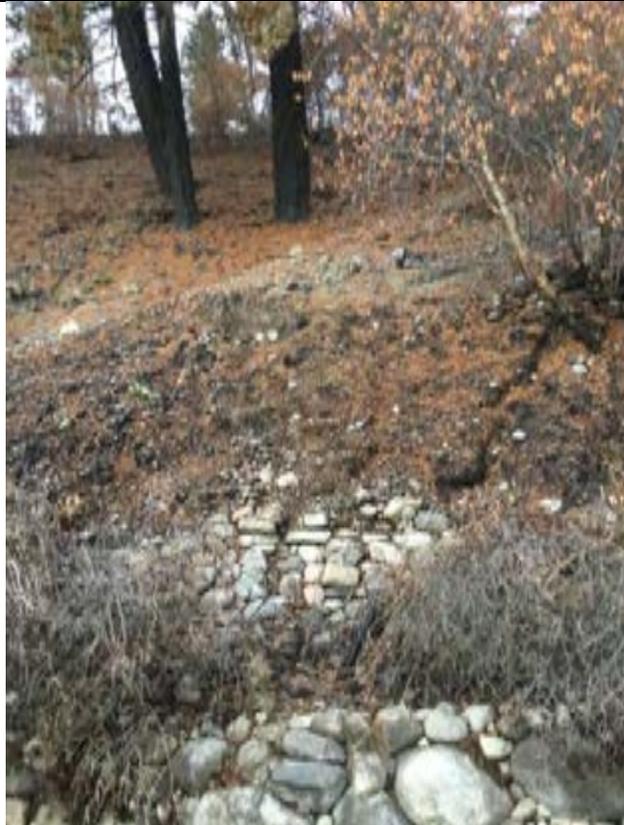
Wildfire Effects Upslope/Upstream:	Vegetation burn severity is moderate, small green shoots visible. Middle lot is steep with exposed mineral soils, signs of surface erosion.

Hazards Noted:	Observed soil erosion and shallow soil slump/landslide.	
Spatial Likelihood:	Potential sediment delivery to Beachwood Rd and downslope properties.	
Hazard Level: MODERATE	Spatial Likelihood: HIGH	Risk Level: HIGH

Photo 2: View upslope from lower part of Beachwood Rd.

Recommended Recovery Response and Considerations for Future Development:	Short term: Be prepared for higher than usual runoff and associated soil erosion from slopes above. Maintain ditches along Beachwood Road.
	Long term: Consider restoration plan for burned slopes.

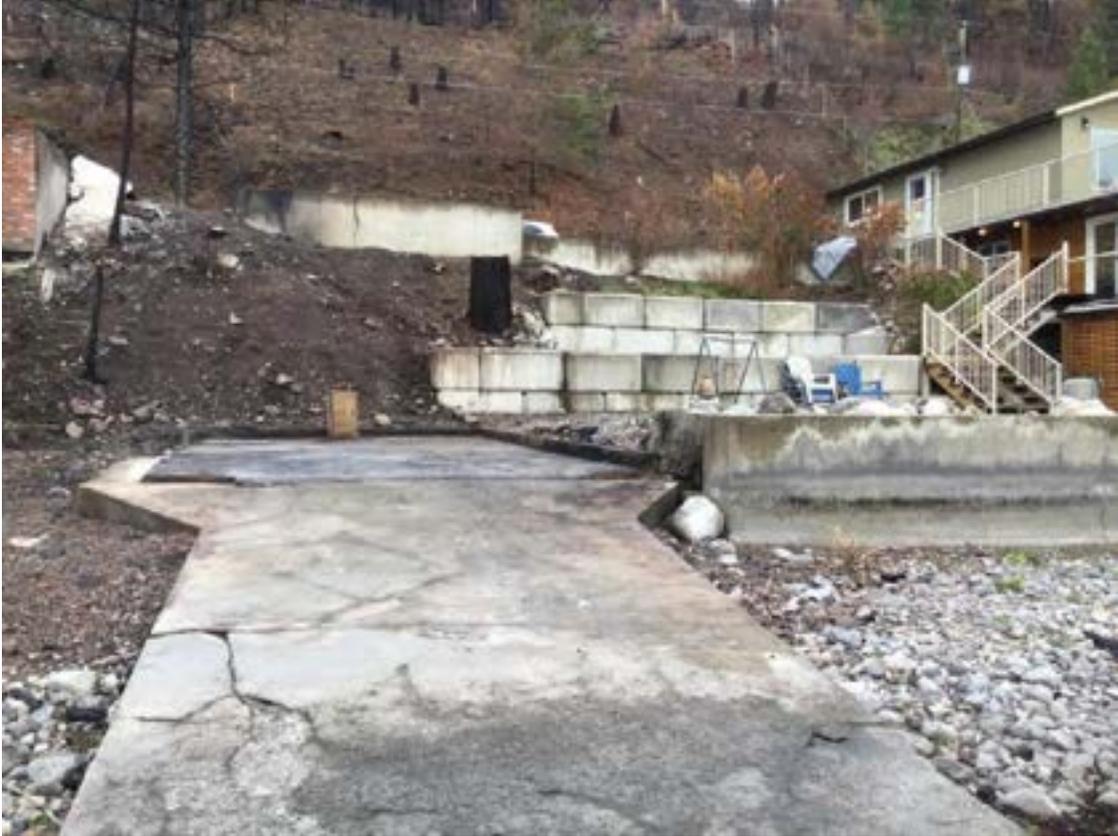
Photo 1: View of 67 Beachwood from Okanagan Lake

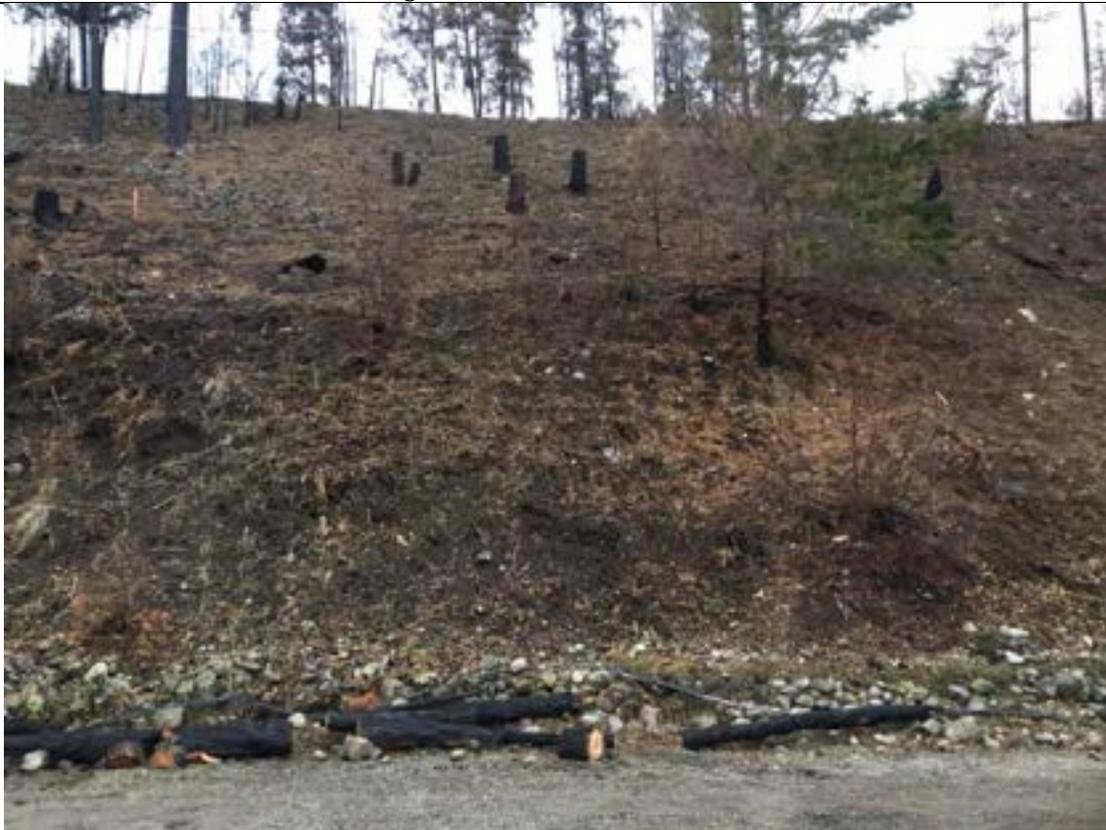
Wildfire Effects Upslope/Upstream:	Burned open forest, trees removed, mineral soil exposed, steep slopes, ravelling disturbed soils observed.

Hazards Noted:	Observed soil erosion and shallow soil slump/landslide.	
Spatial Likelihood:	Potential sediment delivery to Beachwood Rd and downslope properties.	
Hazard Level: MODERATE	Spatial Likelihood: HIGH	Risk Level: HIGH

Photo 2: View upslope from lower part of Beachwood Rd.

Recommended Recovery Response and Considerations for Future Development:	Short term: Be prepared for higher than usual runoff and associated soil erosion from slopes above. Maintain ditches along Beachwood Road.
	Long term: Consider restoration plan for burned slopes.

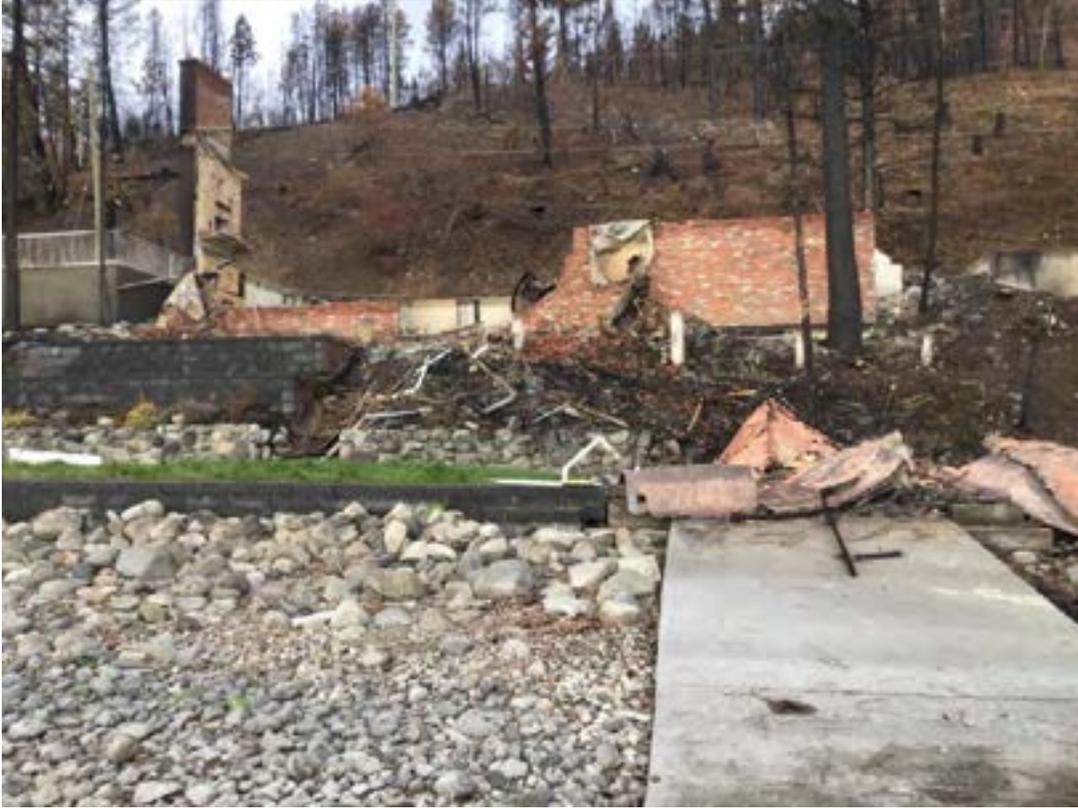
Photo 1: View of 73 Beachwood from Okanagan Lake

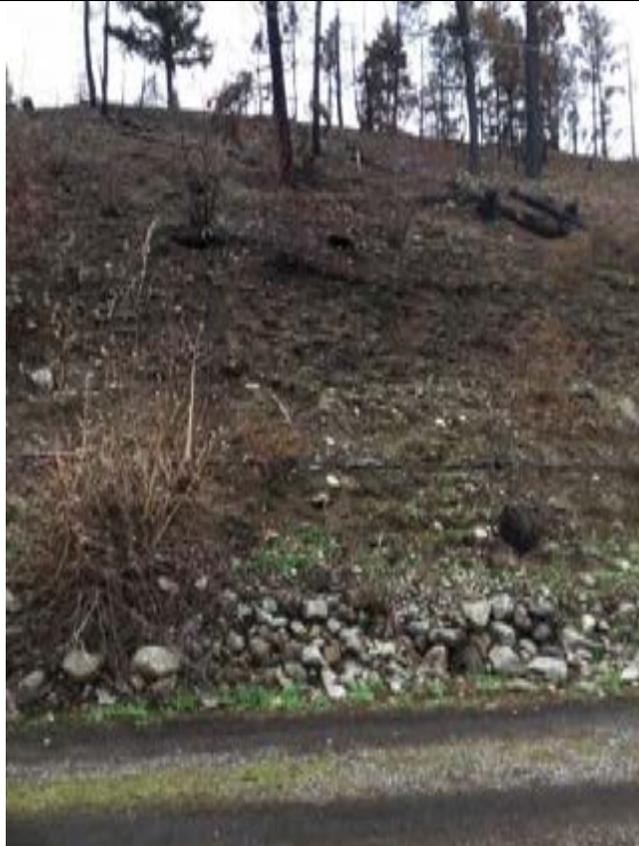
Wildfire Effects Upslope/Upstream:	Burned and cleared upslope, 70% slope above lot, exposed sands and gravels, shallow soil ravelling observed.

Hazards Noted:	Observed soil erosion and shallow soil slump/landslide.	
Spatial Likelihood:	Potential sediment delivery to Beachwood Rd and downslope properties.	
Hazard Level: MODERATE	Spatial Likelihood: HIGH	Risk Level: HIGH

Photo 2: View upslope from lower part of Beachwood Rd.

Recommended Recovery Response and Considerations for Future Development:	Short term: Be prepared for higher than usual runoff and associated soil erosion from slopes above. Maintain ditches along Beachwood Road.
	Long term: Consider restoration plan for burned slopes.

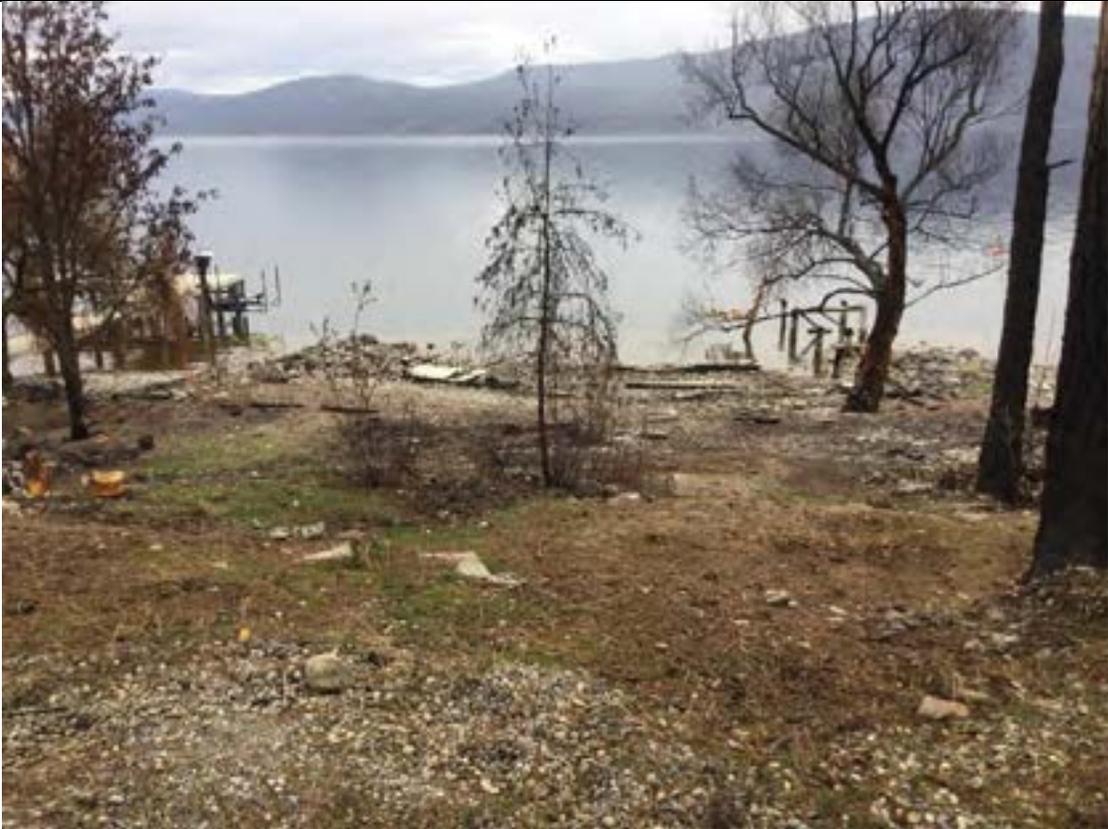
Photo 1: View of 79 Beachwood towards Okanagan Lake

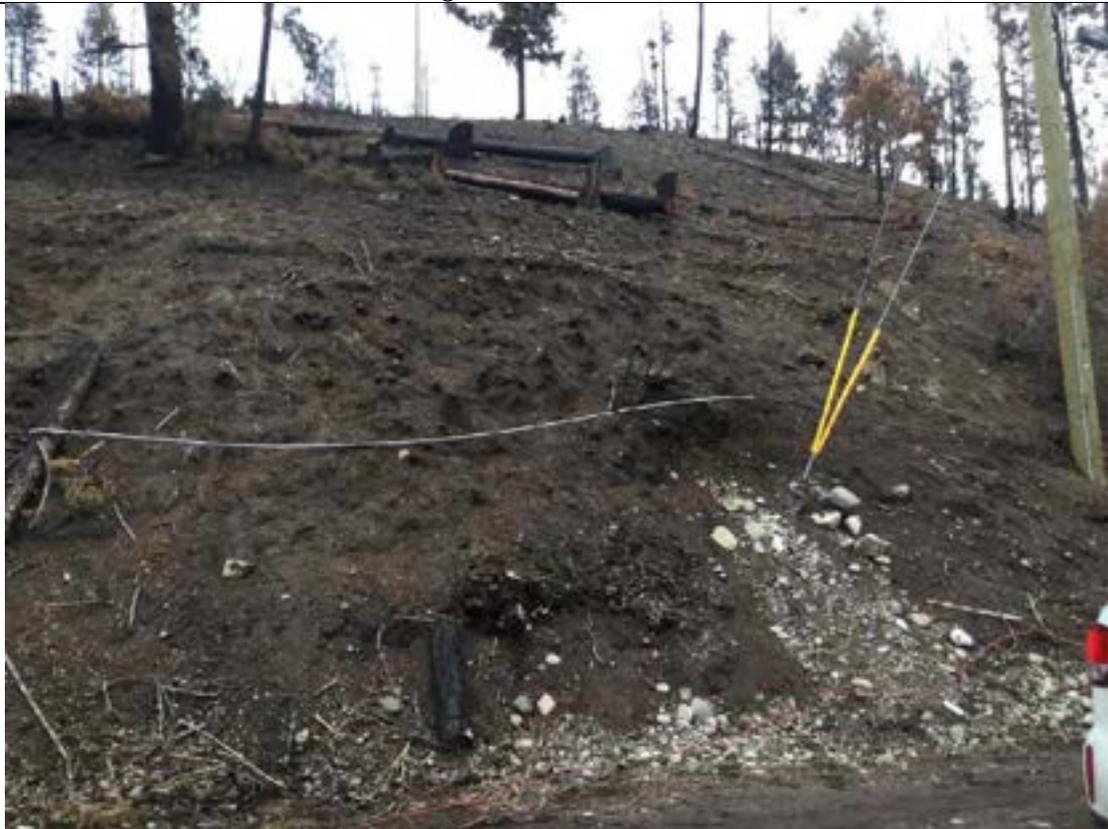
Hazards Noted:	Observed soil erosion and shallow soil slump/landslide.	
Spatial Likelihood:	Potential sediment delivery to Beachwood Rd and downslope properties.	
Hazard Level: MODERATE	Spatial Likelihood: HIGH	Risk Level: VERY HIGH

Photo 2: View upslope from lower part of Beachwood Rd.

Recommended Recovery Response and Considerations for Future Development:	Short term: Be prepared for higher than usual runoff and associated soil erosion from slopes above. Maintain ditches along Beachwood Road.
	Long term: Consider restoration plan for burned slopes.

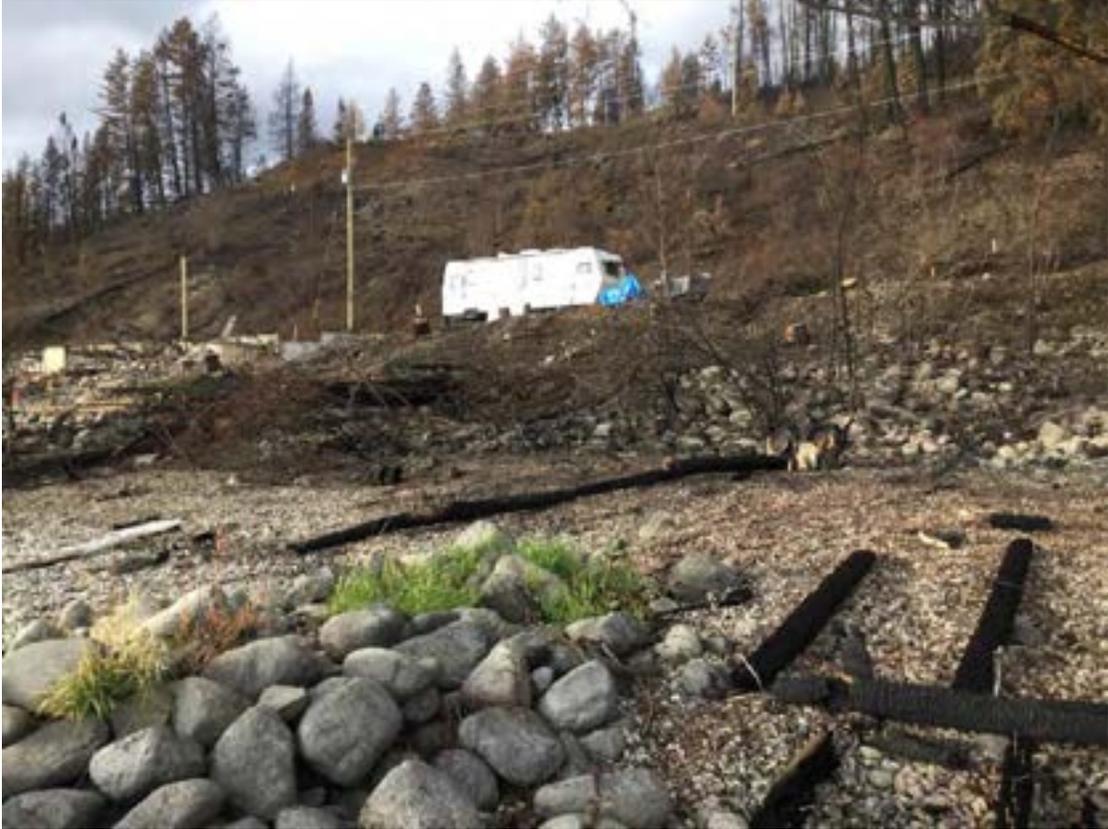
Photo 1: View of 85 Beachwood from Okanagan Lake

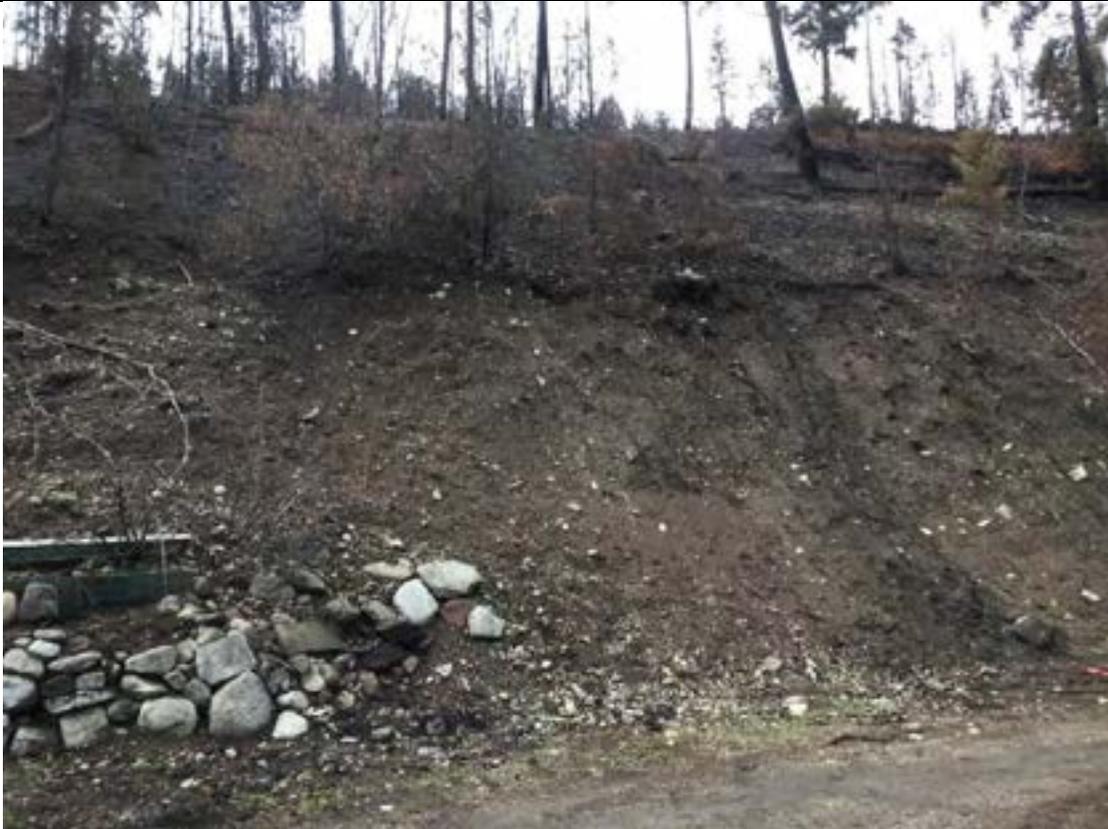
Wildfire Effects Upslope/Upstream:	Burned, steep slopes above, 60% slope, 2:1 cutslope above Beachwood exposes sandy gravel soils. Observed shallow soil instability upslope of Beachwood.		
Hazards Noted:	Observed soil erosion and shallow soil slump/landslide.		
Spatial Likelihood:	Potential sediment delivery to Beachwood Rd and downslope properties.		
Hazard Level: MODERATE	Spatial Likelihood: HIGH	Risk Level: HIGH	
Recommended Recovery Response and Considerations for Future Development:	Short term: Be prepared for higher than usual runoff and associated soil erosion from slopes above. Maintain ditches along Beachwood Road.		
	Long term: Consider restoration plan for burned slopes.

Photo 2: View upslope from lower part of Beachwood Rd.

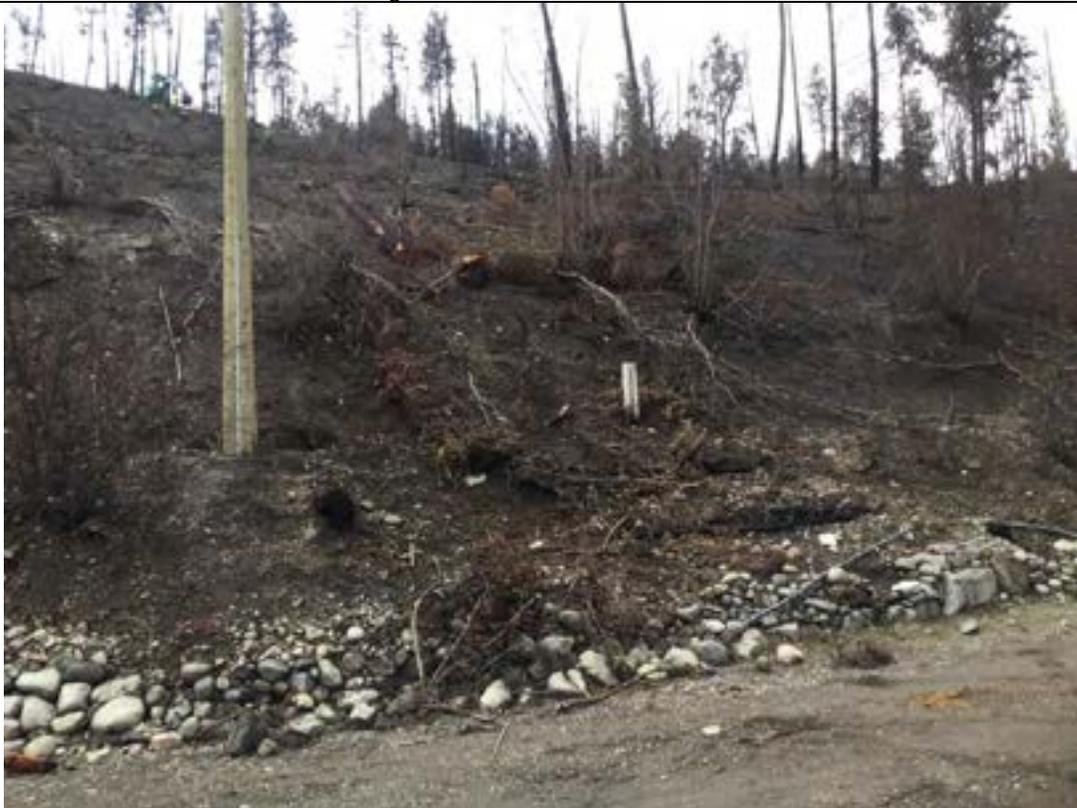
Hazards Noted:	Observed soil erosion and shallow soil slump/landslide. Recent planting and seeding reduces hazard.	
Spatial Likelihood:	Potential sediment delivery to Beachwood Rd and downslope properties.	
Hazard Level: MODERATE	Spatial Likelihood: HIGH	Risk Level: HIGH

Photo 2: View upslope from lower part of Beachwood Rd.

Recommended Recovery Response and Considerations for Future Development:	Short term: Be prepared for higher than usual runoff and associated soil erosion from slopes above. Maintain ditches along Beachwood Road.
	Long term: Consider soils/geotechnical assessment for burned slopes. (planting completed in late fall 2021)

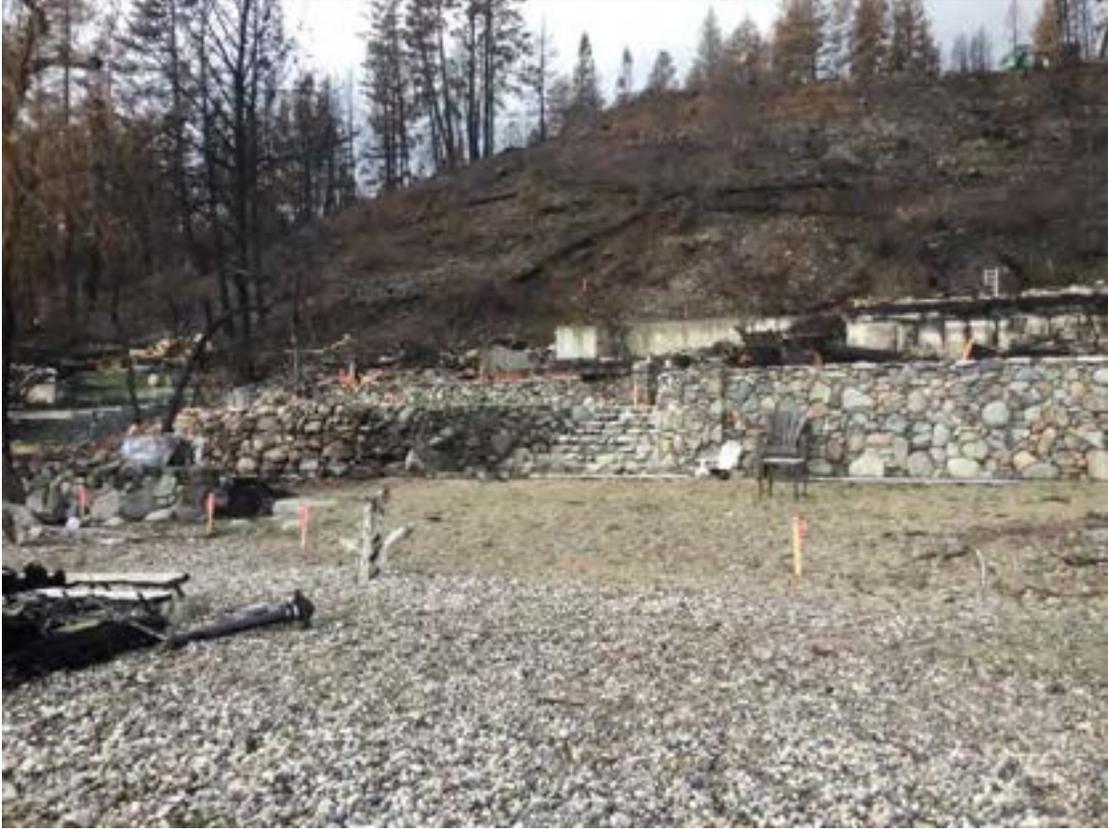
Photo 1: View of 95 Beachwood from Okanagan Lake

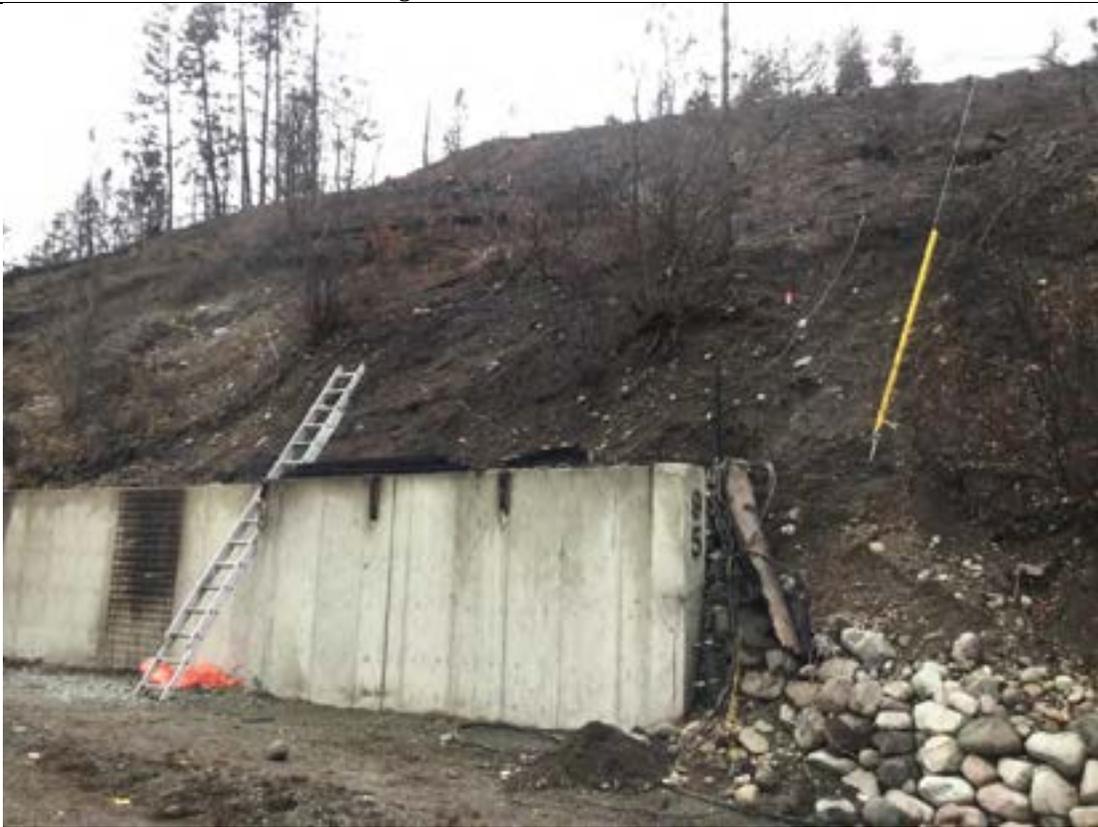
Wildfire Effects Upslope/Upstream:	High burn severity, exposed soils, potentially unstable, 2.5 m concrete retaining wall at toe of slope, 60% slope, sandy gravels, Cutslope

Photo 2: View upslope from lower part of Beachwood Rd.

Recommended Recovery Response and Considerations for Future Development:	Short term: Be prepared for higher than usual runoff and associated soil erosion from slopes above. Maintain ditches along Beachwood Road.	
	Long term: Consider soils/geotechnical assessment for burned slopes. (planting completed in late fall 2021)

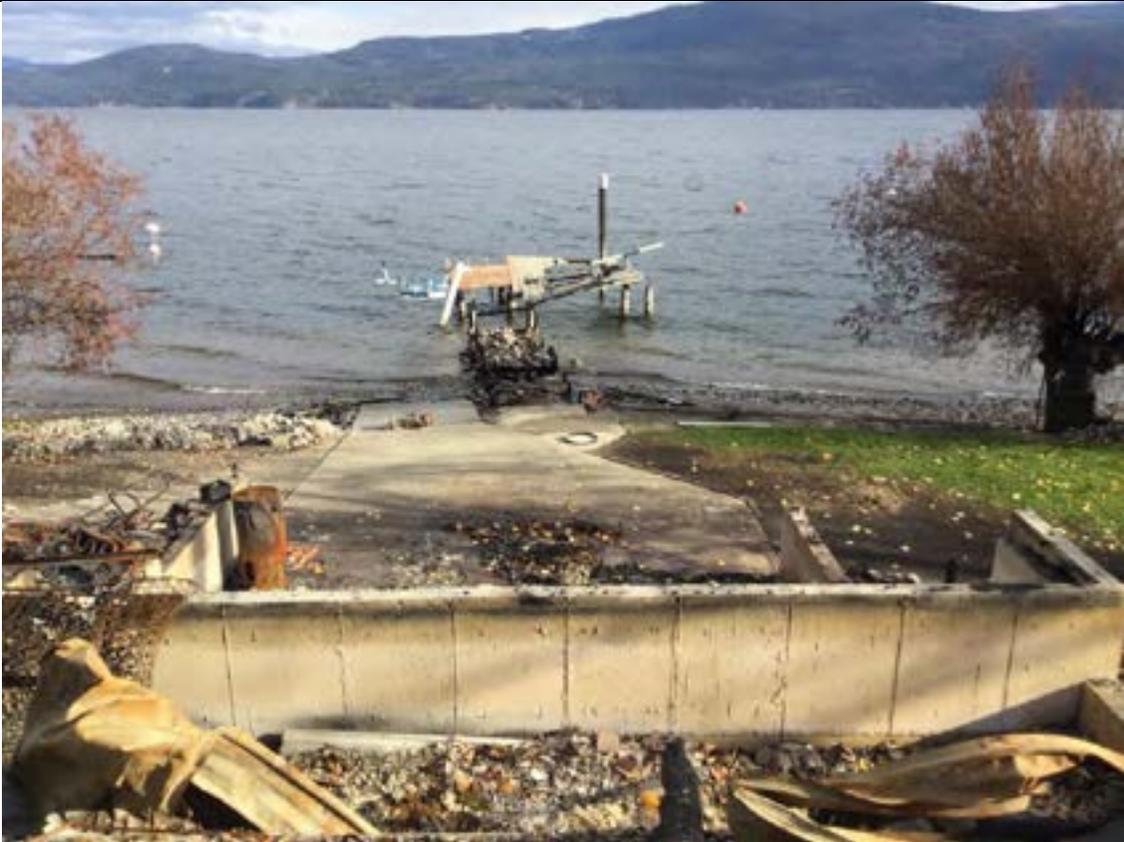
Photo 1: View towards lake at 2 Nerie Rd.

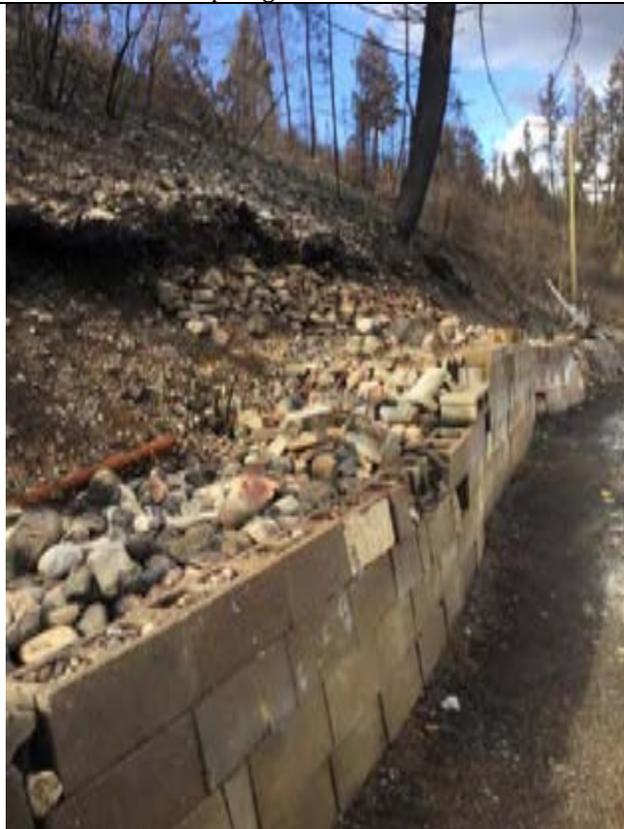
Photo 4: View of retaining wall and slope above lower property at 2 Nerie Rd.

Recommended Recovery Response and Considerations for Future Development:	Short term: Be prepared for higher than usual runoff and associated soil erosion from slopes above.	
	Long term: Consider soils/geotechnical assessment for burned slopes. (planting completed in late fall 2021)

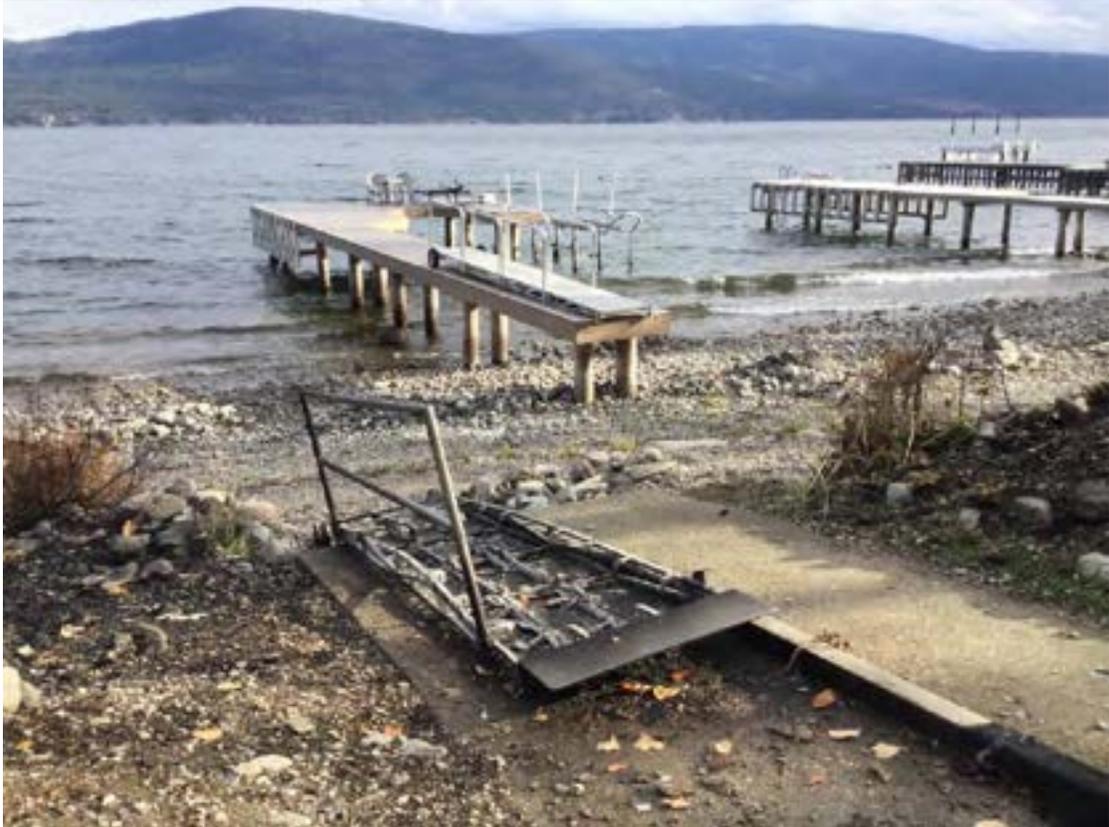
Photo 1: View of foreshore area at 7 Nerie Rd.

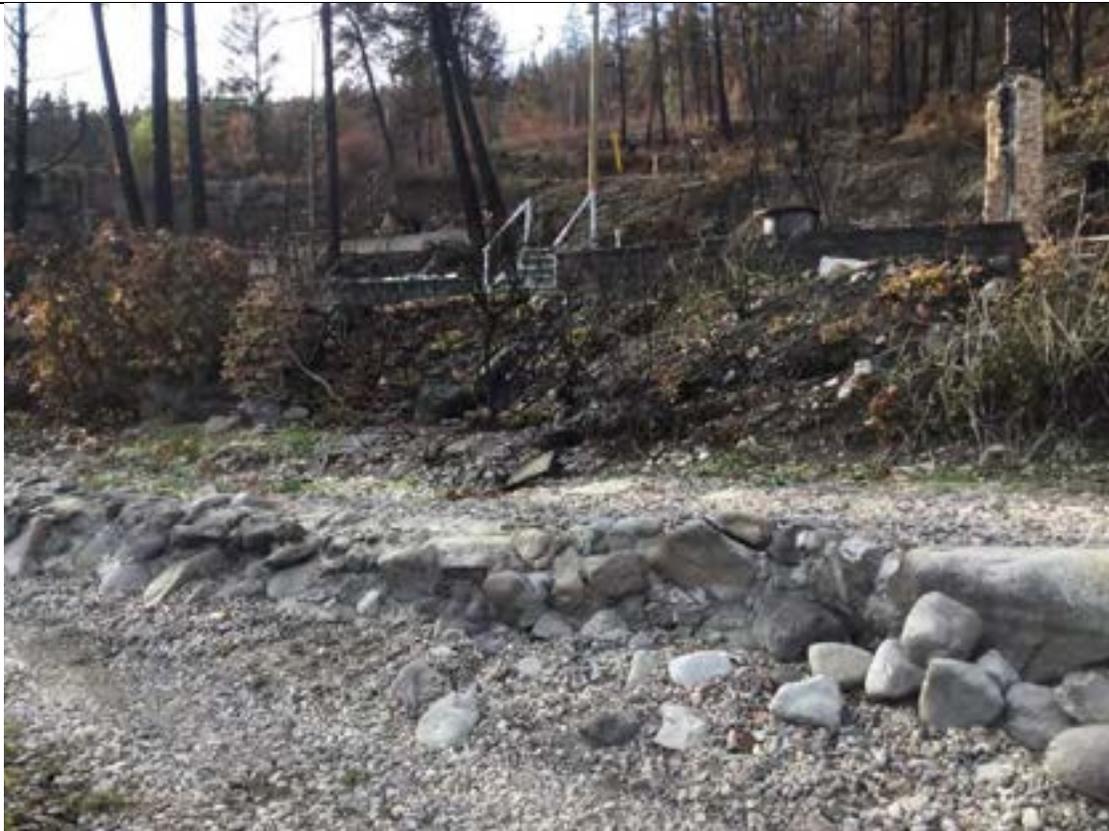
Photo 2: View from foreshore area at 7 Nerie Rd. with low mortared rock wall.

Recommended Recovery Response and Considerations for Future Development:	Short term: Be prepared for higher than usual runoff and associated soil erosion from slopes above.

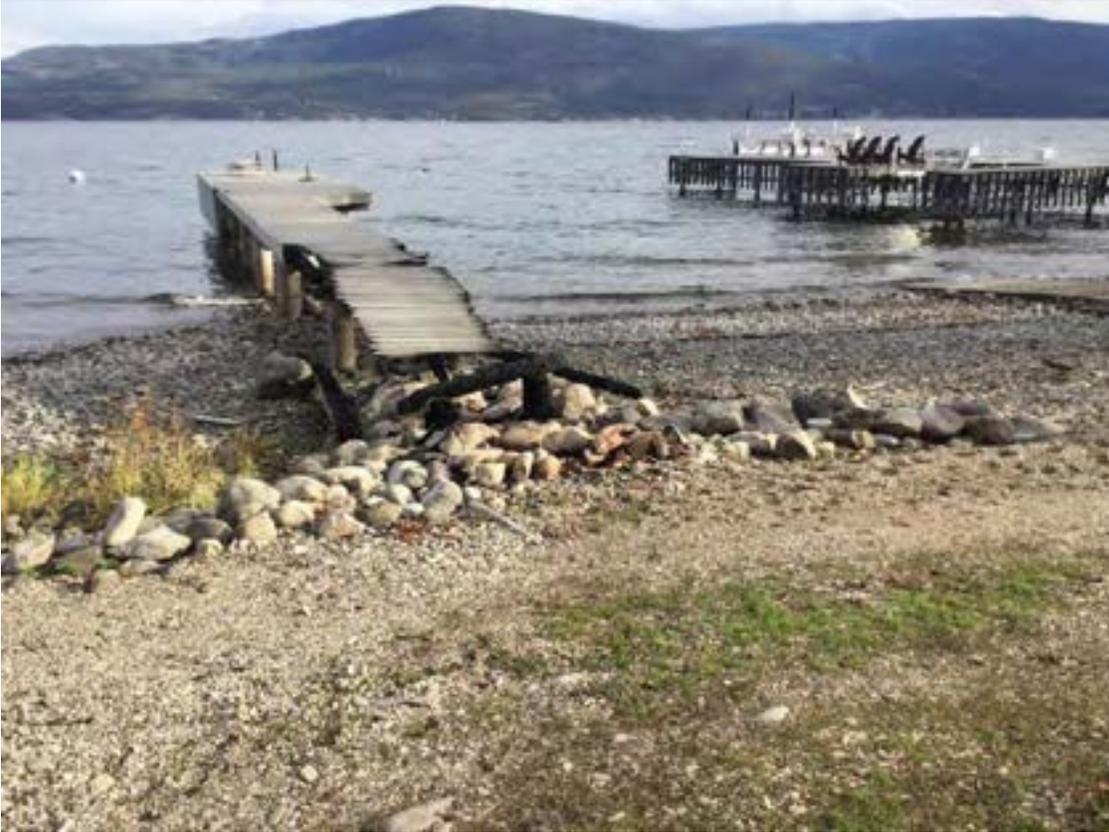
Photo 1: View of foreshore area at 11 Nerie Rd.

Recommended Recovery Response and Considerations for Future Development:	Short term: Be prepared for higher than usual runoff and associated soil erosion from slopes above.

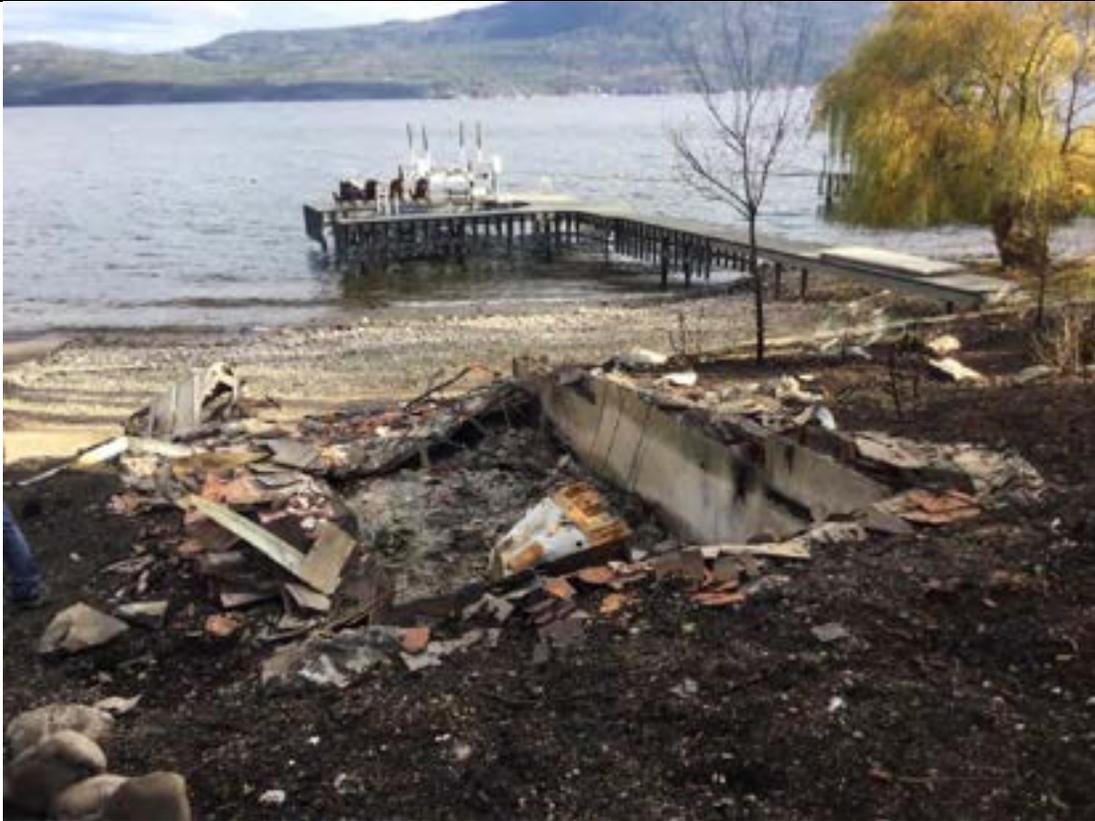
Civic Address:	13 Nerie Rd.	Date of Inspection:	11/5/2021
PID:	004-200-161	Author:	J. Clarke, P.Geo.
RDCO Area:	Estamont		
Domestic water supply source:	Estamont Community Water System		
Nearest Waterbody (lake or stream)	Okanagan Lake		
Element at Risk:	Okanagan Lake		
Structures Lost:	All, including boat house		
Observed Site Conditions:	Terraced lot, with rock retaining walls at house and retaining wall along foreshore. Boat house along foreshore lost.		
Soils:	Sandy gravels		
Slopes:	15% to base of wall		
Groundwater Observations:	No seepage noted.		
Foreshore Conditions:	Retaining wall along foreshore (0.8 m high), boat house burned, no ramp, dock ok		
Setback Distance & Elevation from HWM* or Top of Bank (SHIM):	Est. ~15 m setback from lake to residence; est. >1.5m elevation. To be confirmed.		
Wildfire Effects Upslope/Upstream:	Slopes above the lot have been severely burned.

Hazards Noted:	Potential for upslope soil erosion.	
Spatial Likelihood:	Low potential for sediment delivery to lower slopes and to Okanagan Lake.	
Hazard Level: MODERATE	Spatial Likelihood: LOW	Risk Level: LOW

Photo 1: View of foreshore area at 13 Nerie Rd.

Recommended Recovery Response and Considerations for Future Development:	Short term: Be prepared for higher than usual runoff and associated soil erosion from slopes above.

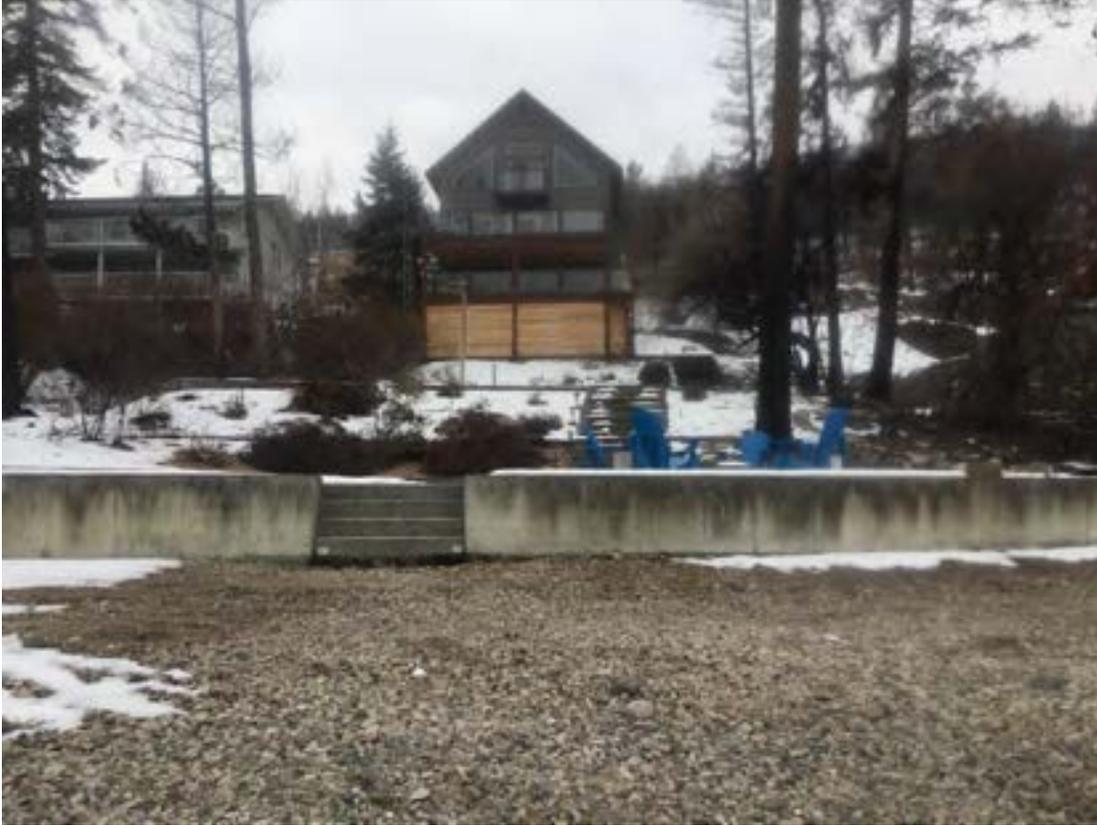
Wildfire Effects Upslope/Upstream:	Residence is unburned. Vegetation damage on property. Burned catchment area upslope.

Hazards Noted:	None	
Spatial Likelihood:	Low potential for sediment delivery to Okanagan Lake	
Hazard Level: LOW	Spatial Likelihood: LOW	Risk Level: VERY LOW

Photo 1: View upslope from foreshore area at 17 Nerie Rd.

Recommended Recovery Response and Considerations for Future Development:	Short term: Be prepared for higher than usual runoff and associated soil erosion from slopes above.
	Long term: Consider riparian vegetation restoration to improve foreshore condition.
