CLARKE GEOSCIENCE LTD.

POST-WILDFIRE ENVIRONMENTAL AND HAZARDOUS CONDITIONS ASSESSMENT OF THE NORTH WESTSIDE ROAD AREA

Dated: February 1, 2022
Presented To: Regional District of Central Okanagan
Attention: Brittany Nichols, Environmental Planner
CGL Project # 21-0115 EOC #A21-674

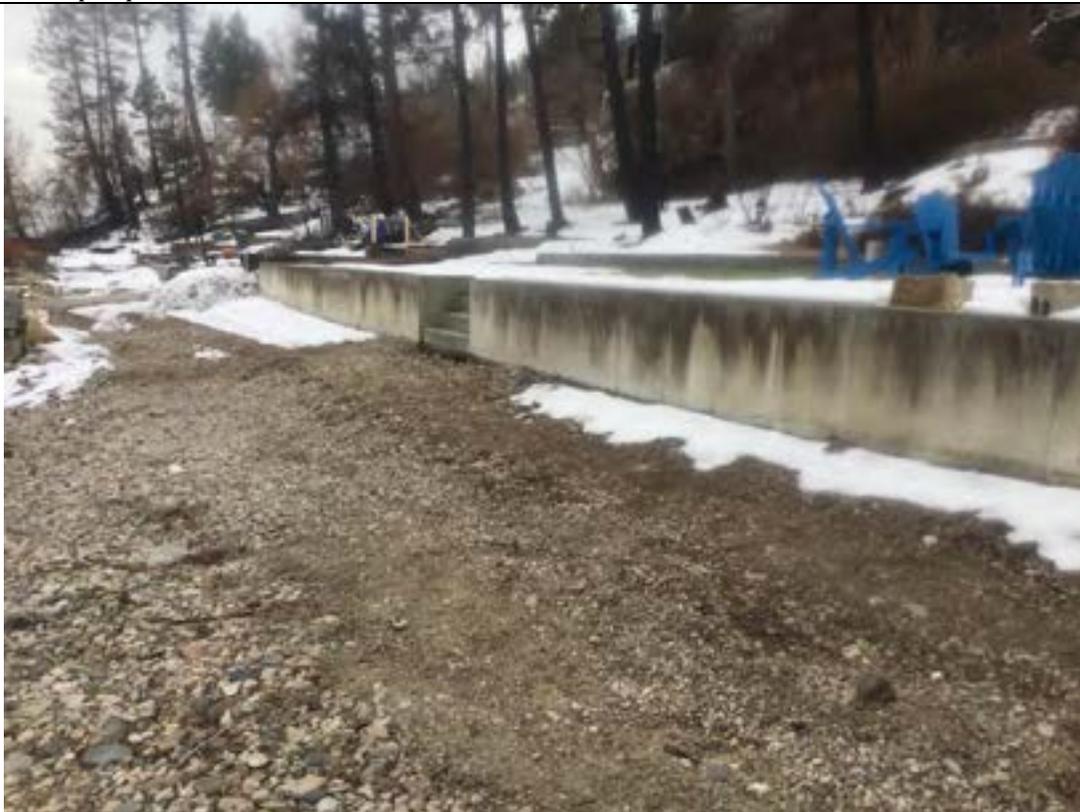
Photo 2: View of retaining wall along foreshore area at 17 Nerie Rd.

Recommended Recovery Response and Considerations for Future Development:	Short term: Be prepared for higher than usual runoff and associated soil erosion from slopes above.
	Long term: Consider riparian vegetation restoration to improve foreshore condition.

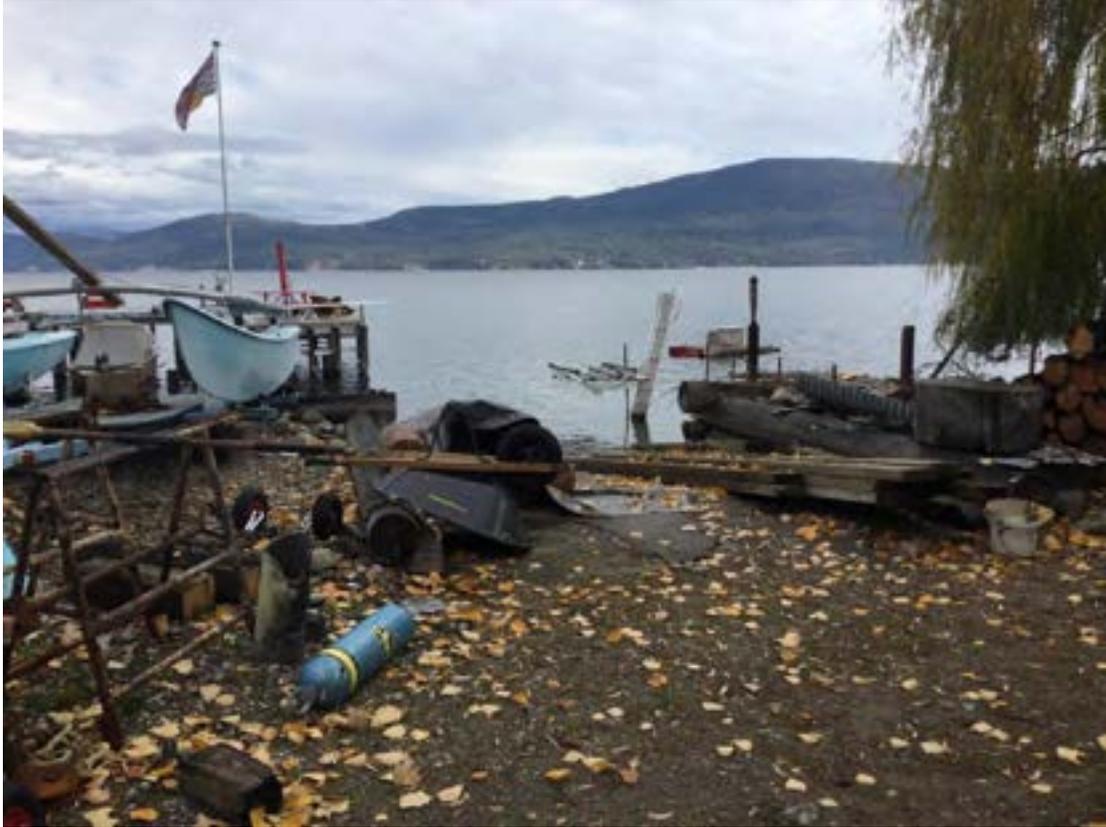
Hazards Noted:	Disturbed soils and seepage create potential for instability and soil erosion. Piped stream flow and drainage across mid-slope area.	
Spatial Likelihood:	Potential sediment delivery to lower property, moderate potential for sediment delivery to Okanagan Lake.	
Hazard Level: HIGH	Spatial Likelihood: MODERATE	Risk Level: HIGH

Photo 1: View of foreshore area at 23 Nerie Rd.

Recommended Recovery Response and Considerations for Future Development:	Short term: Be prepared for higher than usual runoff and groundwater seepage.	
	Long term: Sediment and erosion control measures are recommended. Measures to manage onsite drainage may be needed. Consider geotechnical assessment for future development.

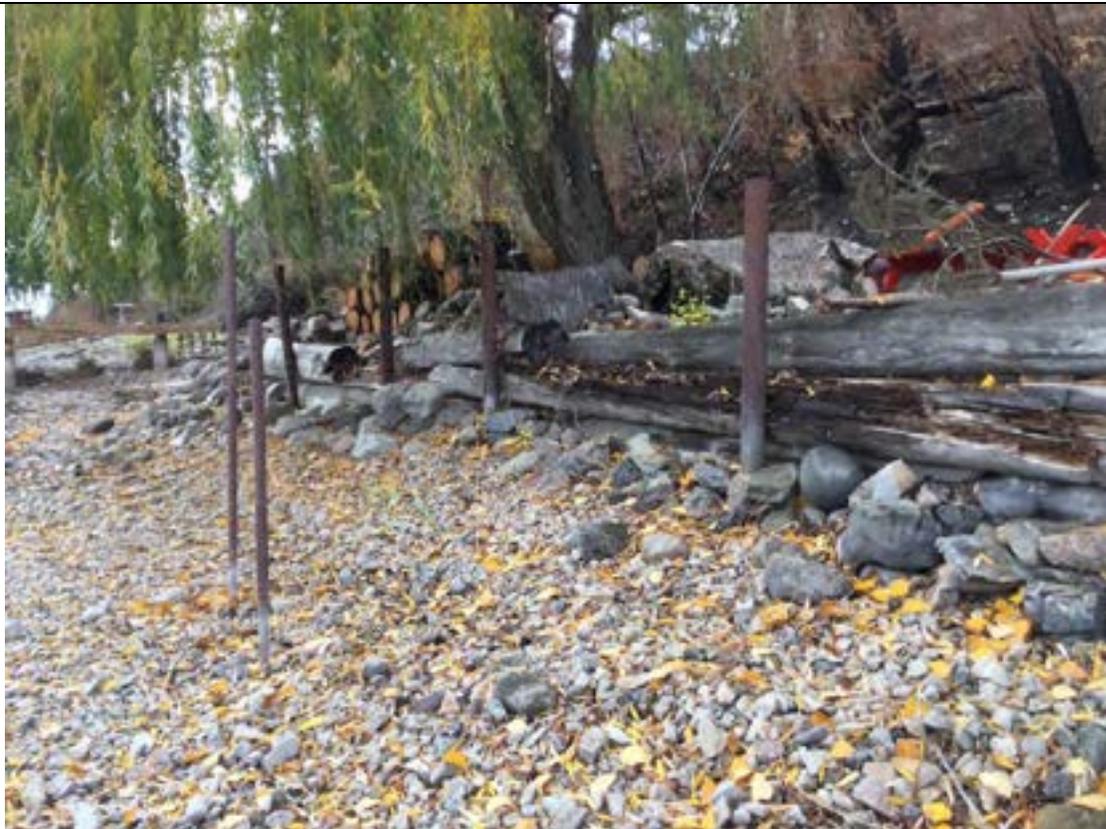
Photo 2: View of log retaining wall along foreshore at 23 Nerie Rd.

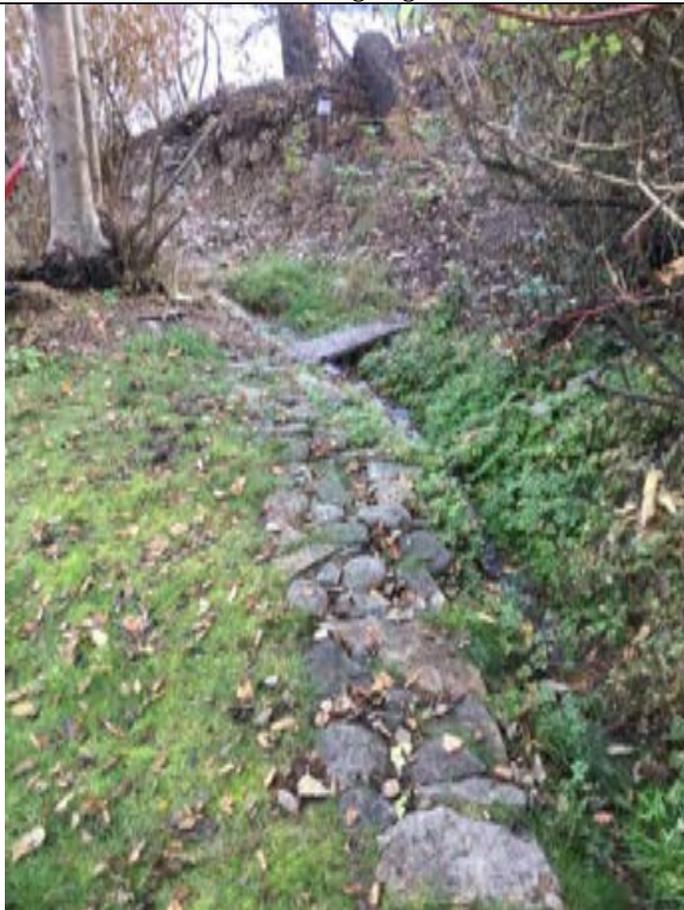
Photo 4: Small spring-fed stream flowing along south property line at 23 Nerie Rd.

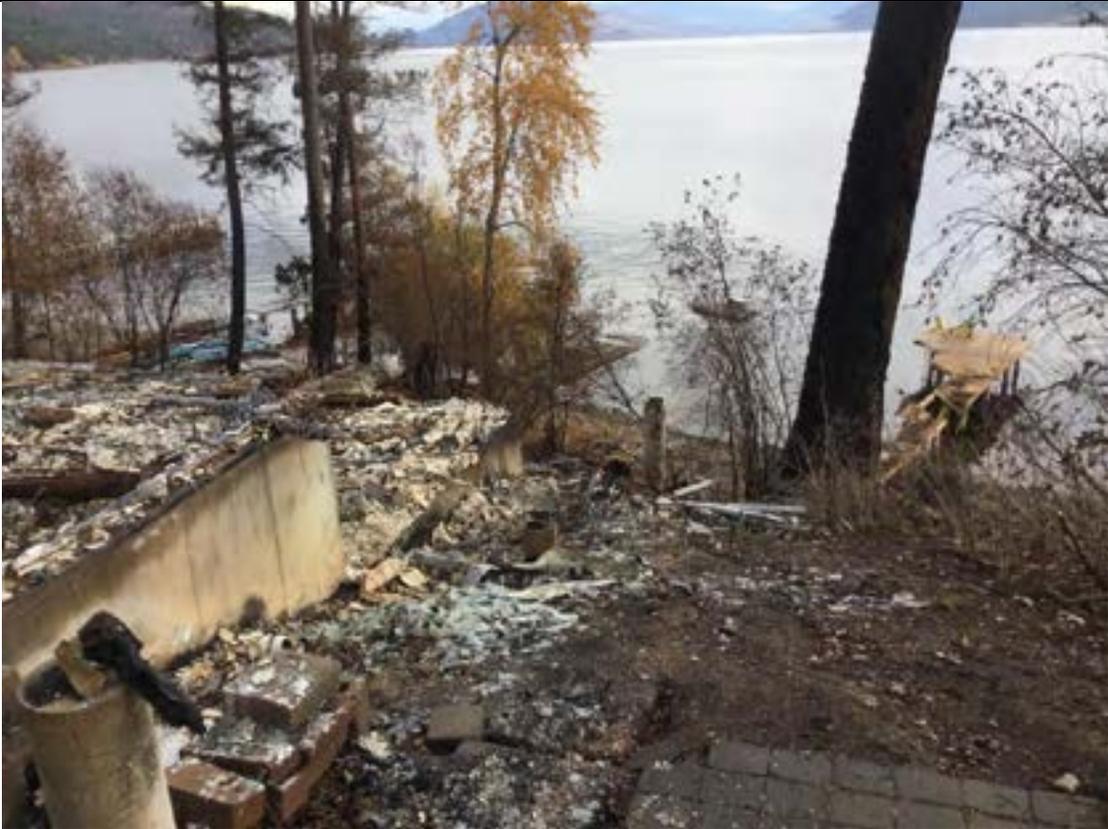
Hazards Noted:	Mineral soils are exposed and subject to erosion and shallow destabilization.	
Spatial Likelihood:	Potential sediment delivery to lower property, moderate potential for sediment delivery to Okanagan Lake.	
Hazard Level: HIGH	Spatial Likelihood: MODERATE	Risk Level: HIGH

Photo 1: View downslope towards lake at 25 Nerie Rd

Recommended Recovery Response and Considerations for Future Development:	Short term: Be prepared for higher than usual runoff and groundwater seepage.	
	Long term: Sediment and erosion control measures are recommended. Measures to manage onsite drainage may be needed. Consider geotechnical assessment for future development.

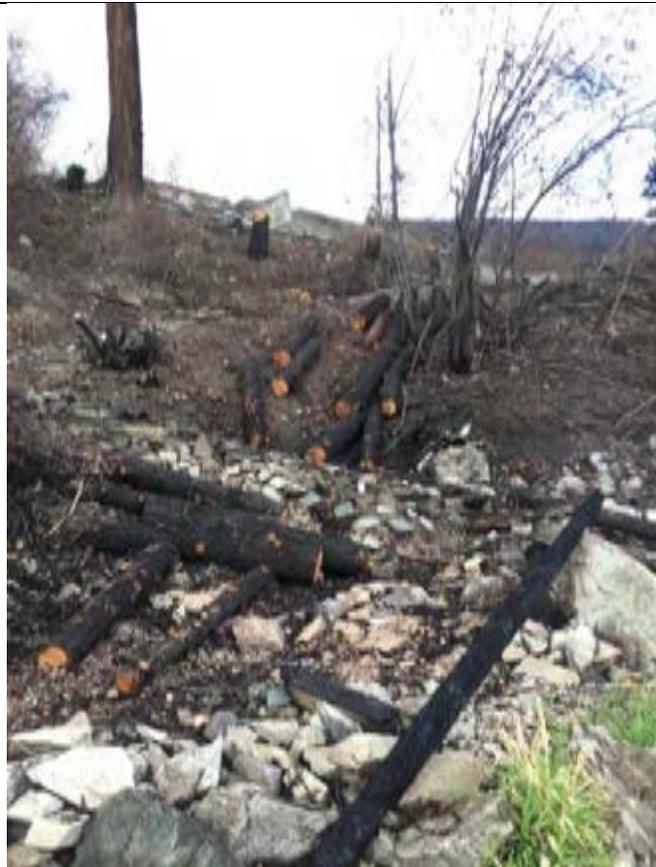
Photo 2: View upslope from toe of slope at foreshore at 25 Nerie Rd.

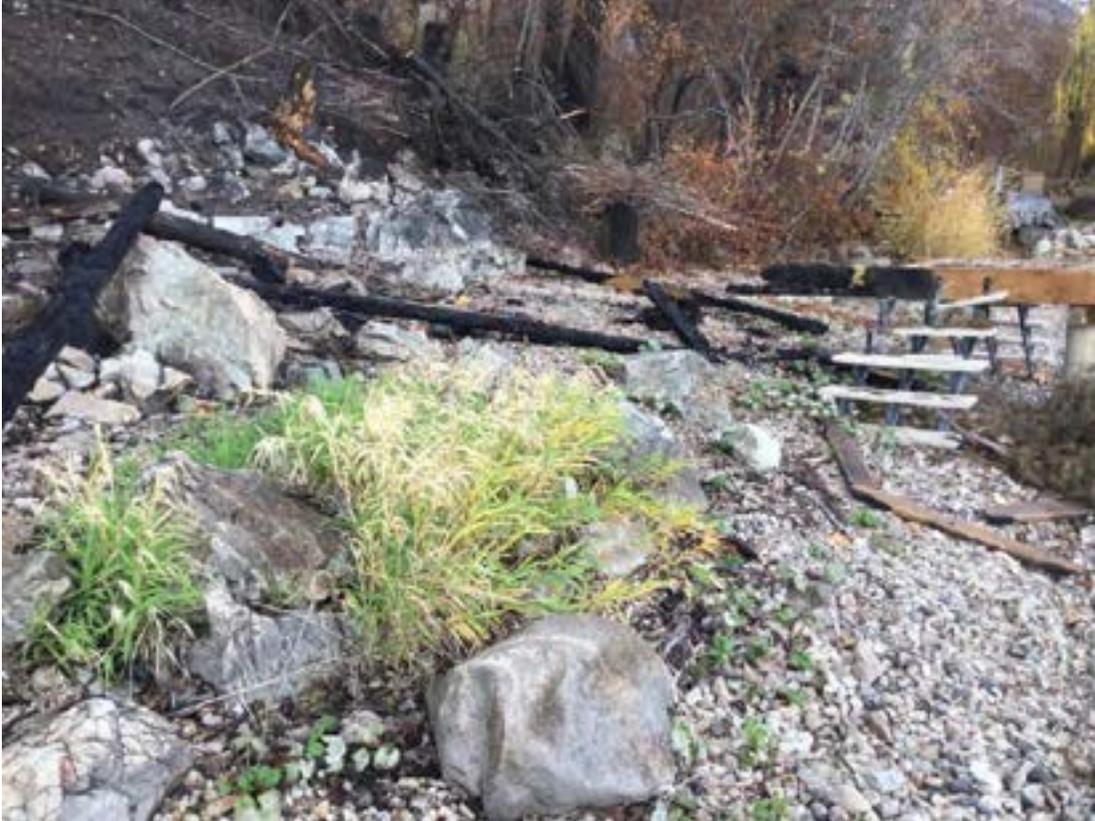
Foreshore Conditions:	Relatively natural shoreline, cobble gravel and rock, wood dock on wood piles is badly damaged		
Setback Distance & Elevation from HWM* or Top of Bank (SHIM):	Est. >15 m setback from lake to residence; est. >1.5m elevation. Setback from piped stream to be confirmed.		
Wildfire Effects Upslope/Upstream:	Terraced developed residential area, short slopes and terraced lots, scattered partial burn areas immediately upslope.

Photo 3: View of foreshore area at 25 Nerie Rd.

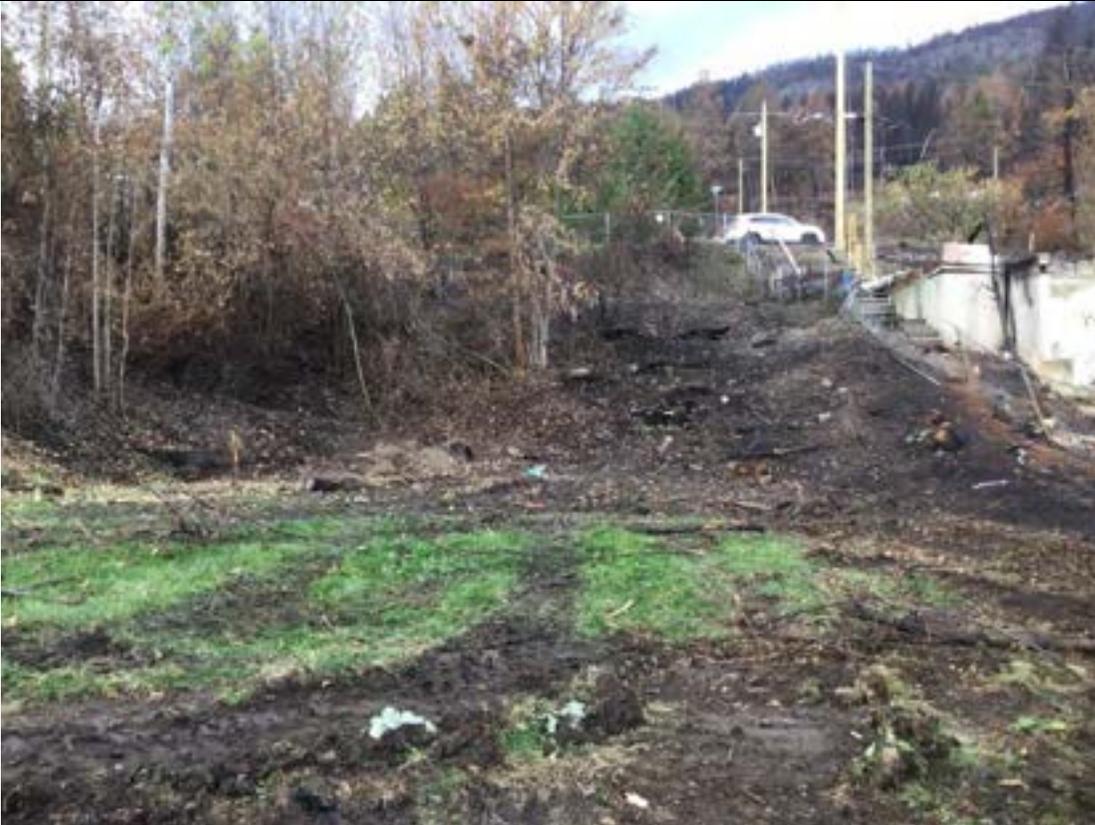
Photo 4: View upslope from upper part of lot towards Nerie Rd at 25 Nerie Rd.

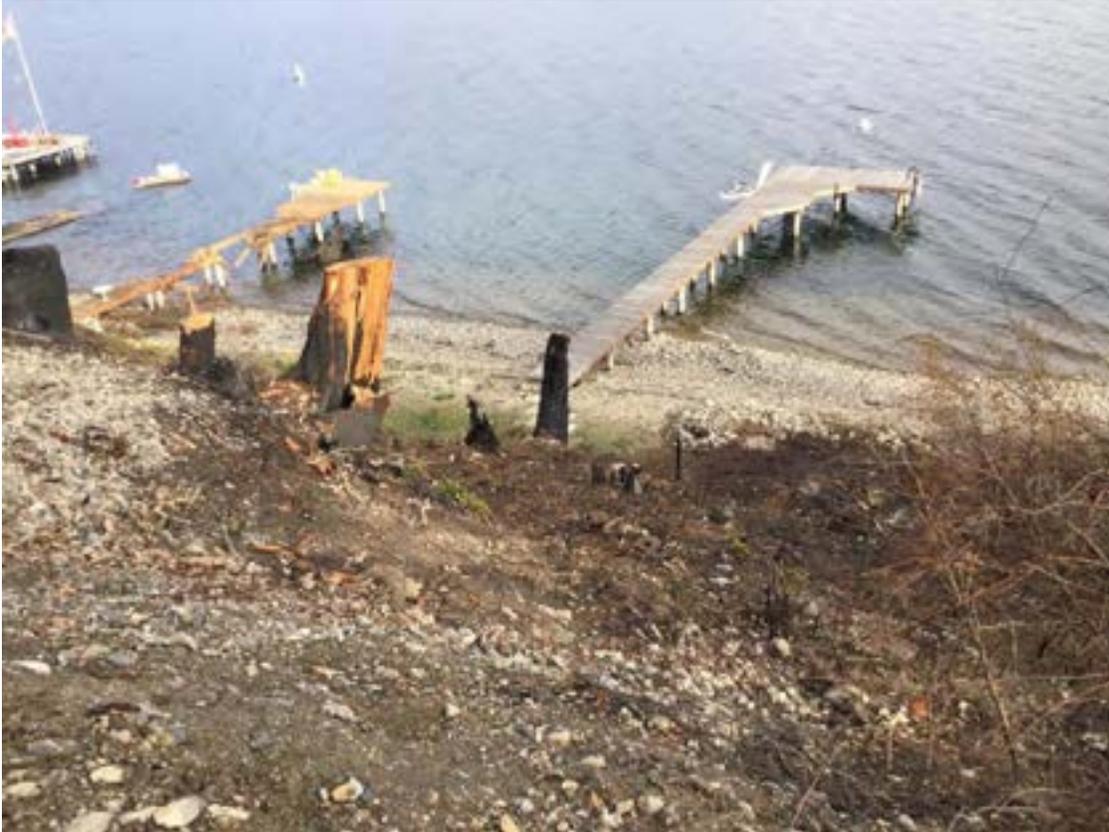
Hazards Noted:	Disturbed soils and seepage create potential for instability and soil erosion. Piped stream flow and drainage across mid-slope area.	
Spatial Likelihood:	Potential sediment delivery to lower property, moderate potential for sediment delivery to Okanagan Lake.	
Hazard Level: MODERATE	Spatial Likelihood: MODERATE	Risk Level: MODERATE

Photo 1: View downslope towards lake at 31 Nerie Rd (new build under construction)

Recommended Recovery Response and Considerations for Future Development:	Short term: Be prepared for higher than usual runoff and groundwater seepage.
	Long term: Sediment and erosion control measures are recommended. Measures to manage onsite drainage may be needed. Consider geotechnical assessment for future development.

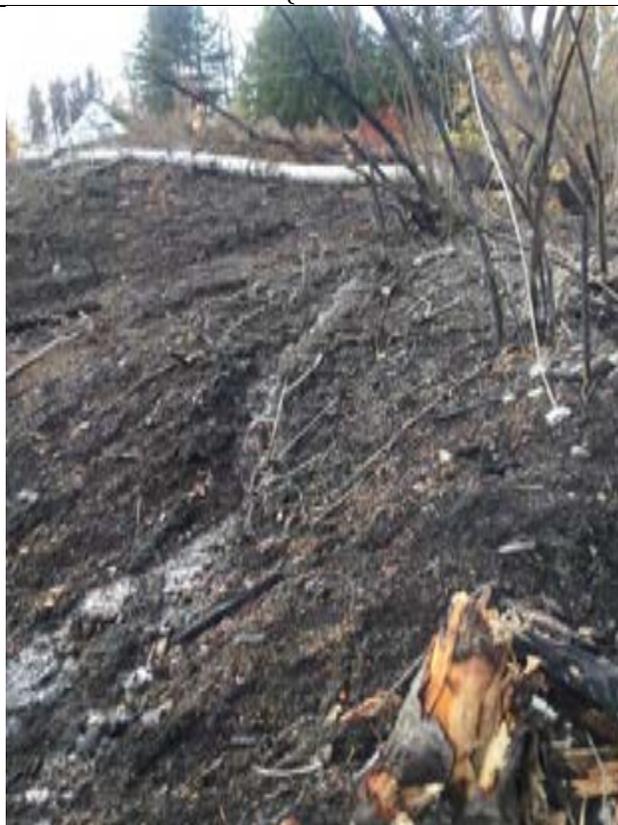
Photo 2: View of overland flow along upper part of 31 Nerie Rd.

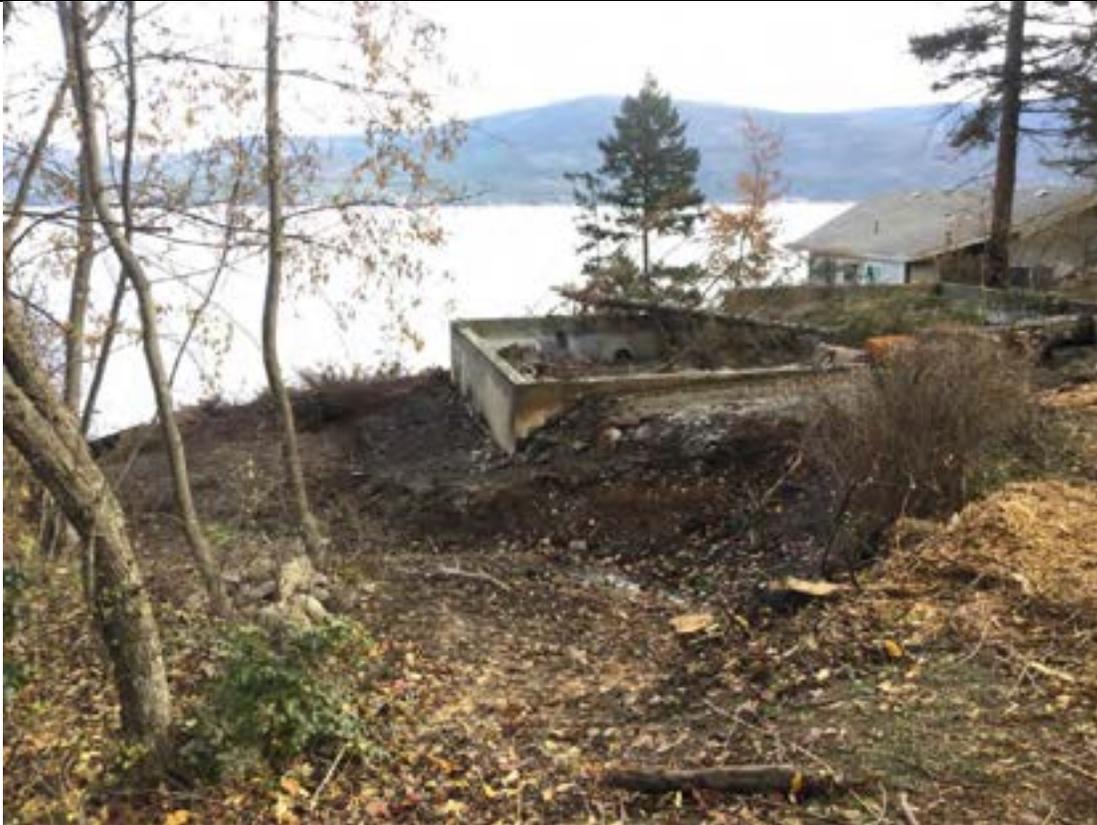
Photo 1: View of upper part of lot at 37 Nerie Rd, culvert outlet and stream flow in foreground

Recommended Recovery Response and Considerations for Future Development:	Short term: Be prepared for higher than usual runoff and groundwater seepage.
	Long term: Sediment and erosion control measures are recommended. Measures to manage onsite drainage may be needed. Consider geotechnical assessment for future development.

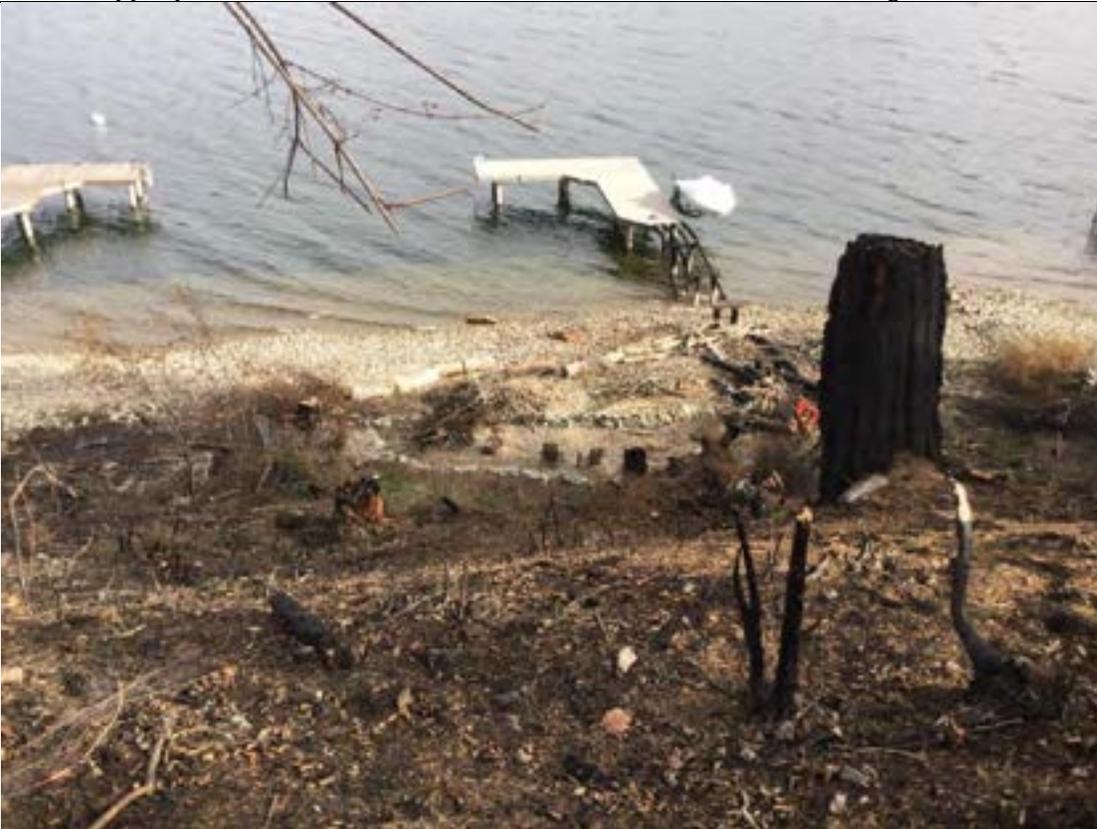
Photo 2: View of foreshore area at 37 Nerie Rd.

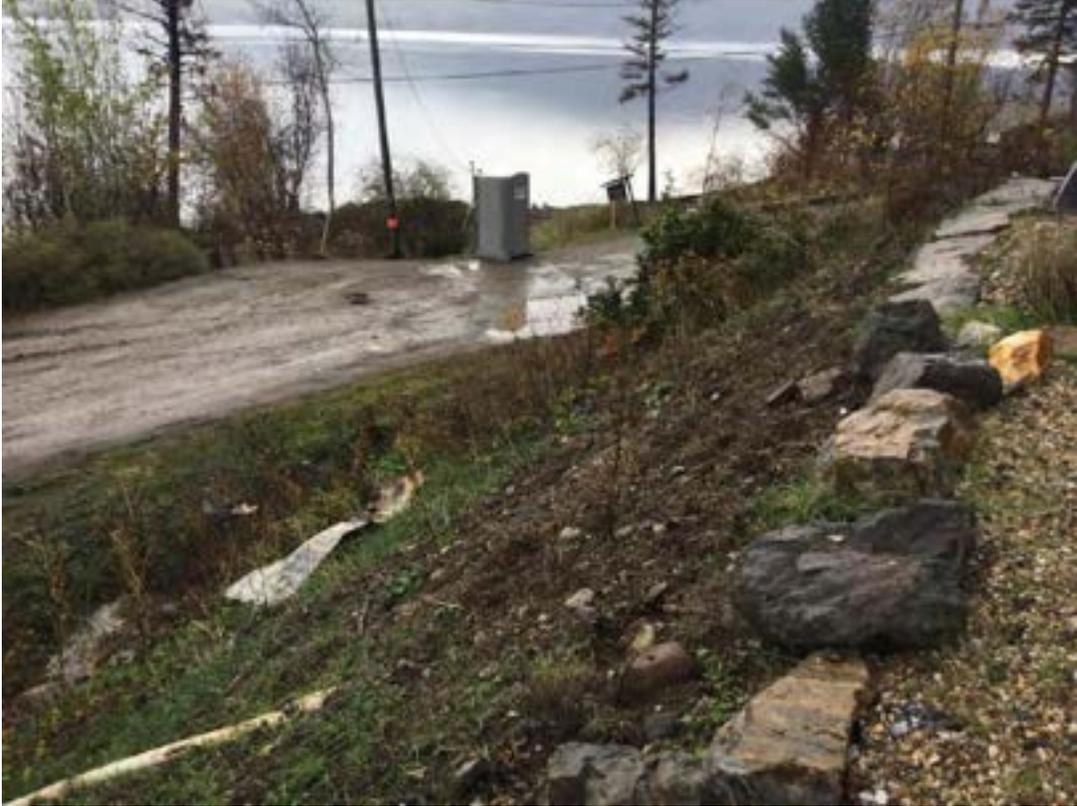
Photo 1: View of corner property at 104 Elliot Rd towards ditchline and culvert across Nerie Rd. Noted, two white PVC drain pipes along cutslope.

Recommended Recovery Response and Considerations for Future Development:	Short term: Be prepared for higher than usual runoff and groundwater seepage. Maintain clear passage for flow through driveway culvert, roadside ditches, and culvert under Nerie Road.
	Long term: Consider groundwater assessment for future development.

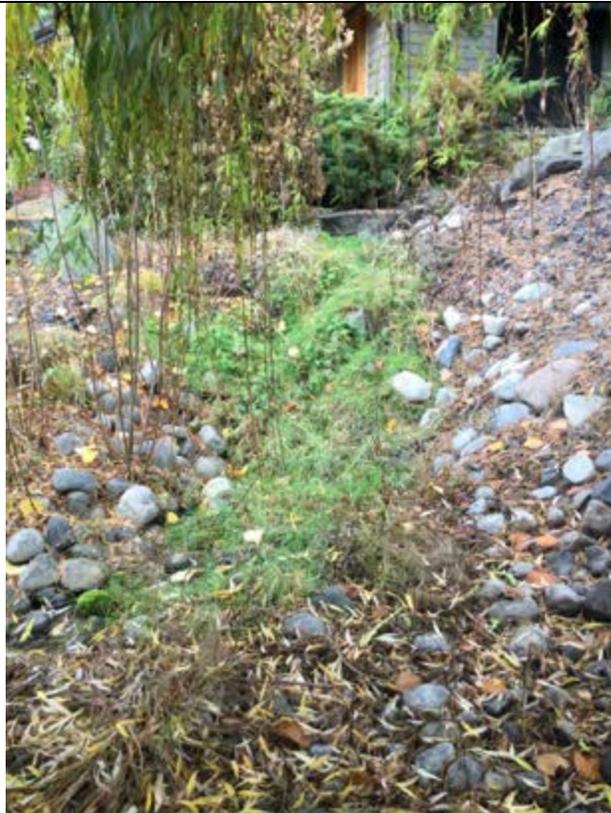
Photo 2: View of spring-fed stream along south property line at 104 Elliot Rd.

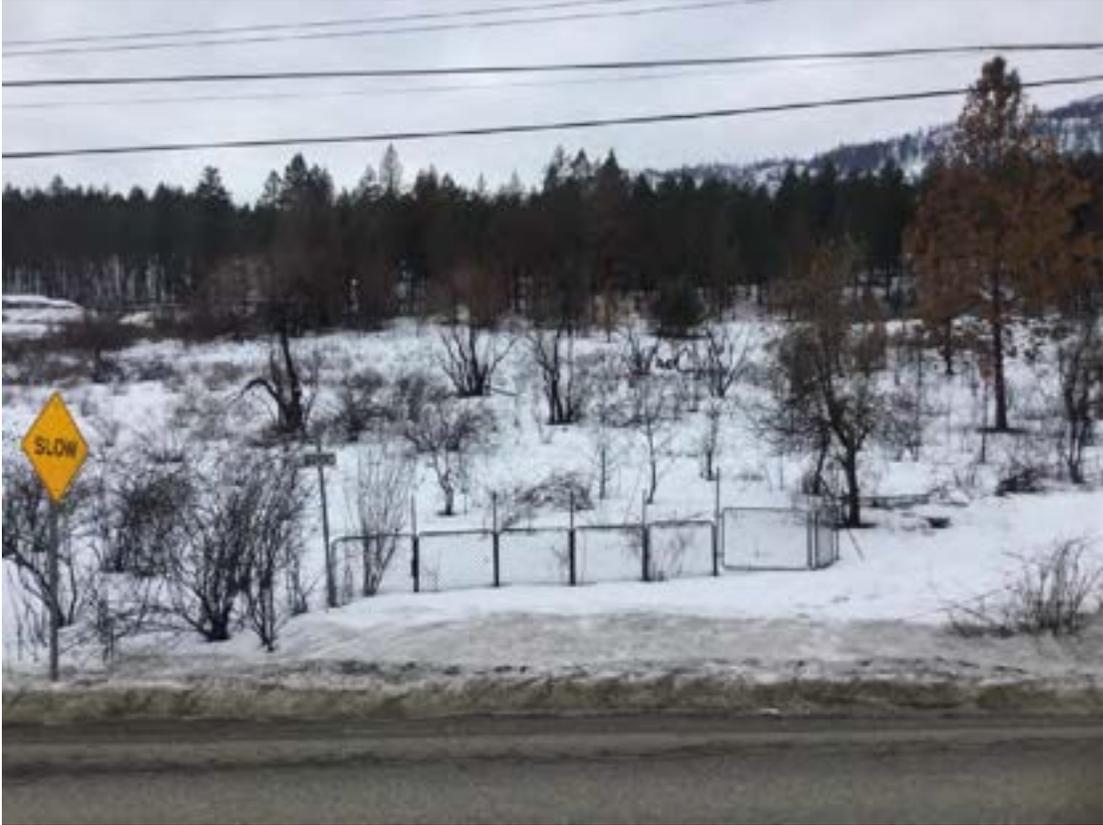
Photo 1: View upslope to 8700 N Westside Rd

Recommended Recovery Response and Considerations for Future Development:	Short term: Be prepared for higher than usual runoff from slopes above. Ensure clear passage through Westside Road culvert.

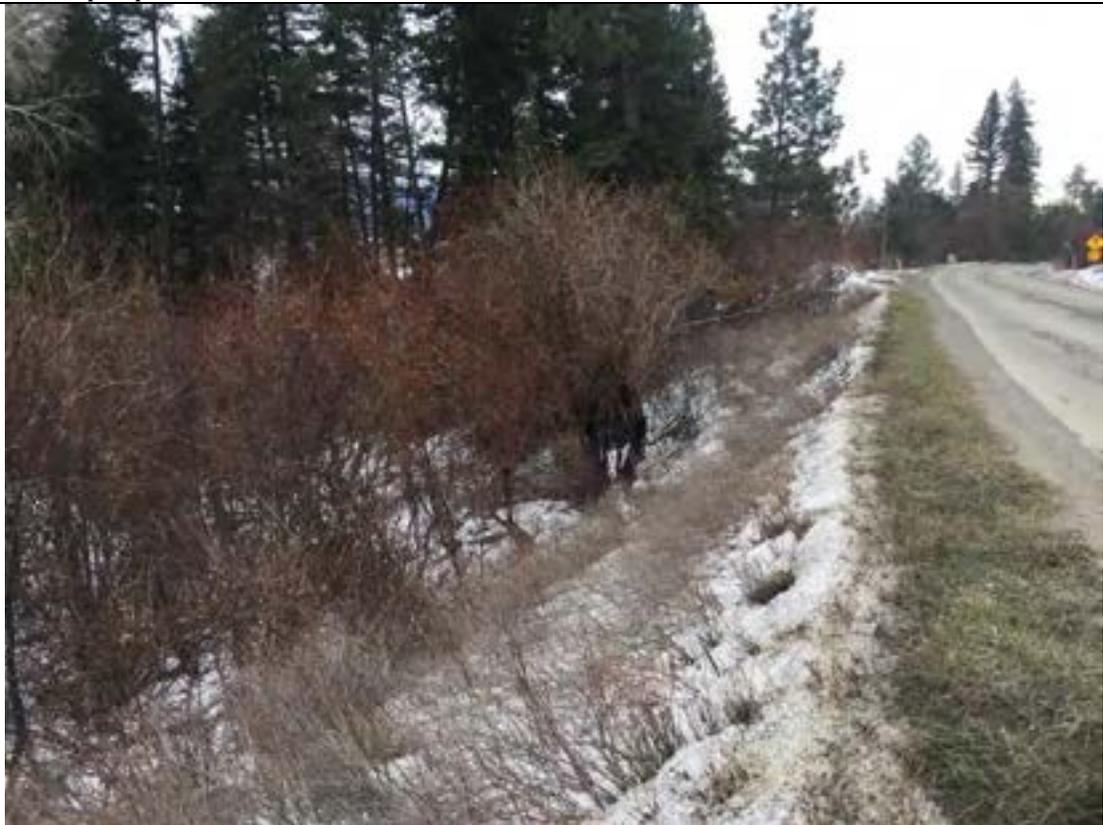
Photo 2: View of downslope side of road across from 8700 N Westside Rd at culvert crossing

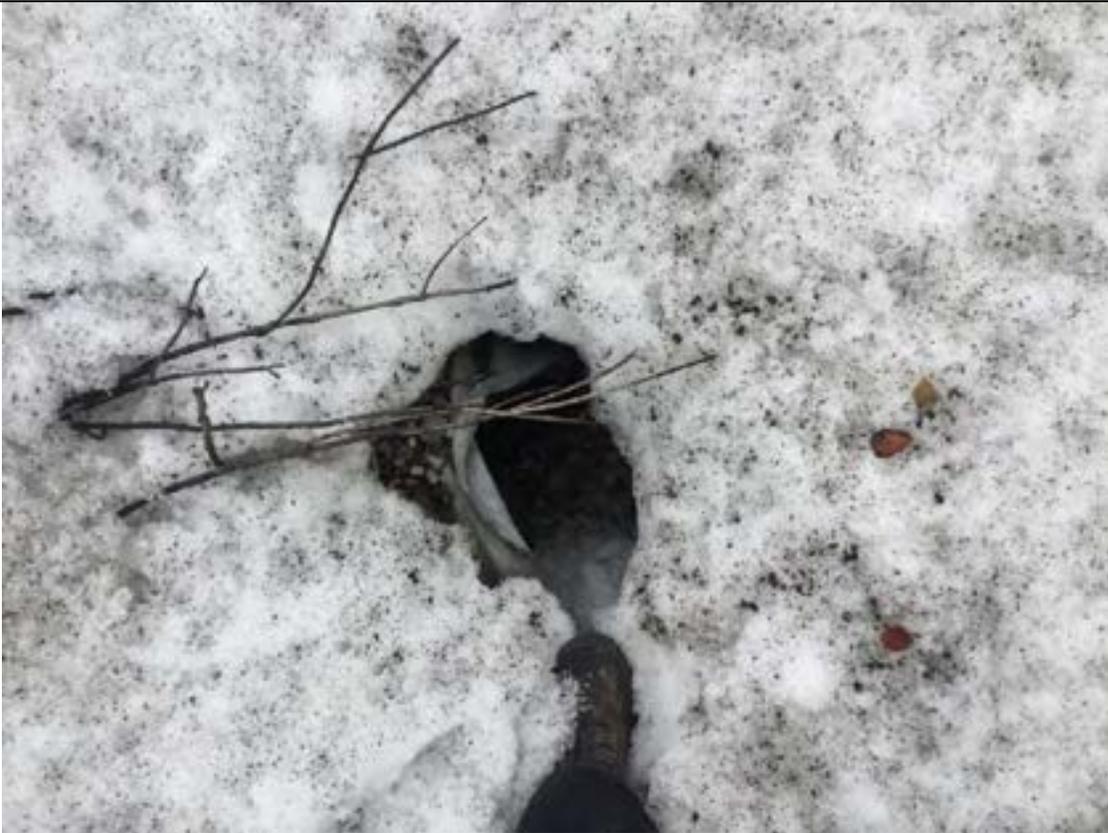
Photo 3: Partly obscured inlet of ~400 mm culvert at 8700 N Westside Rd.

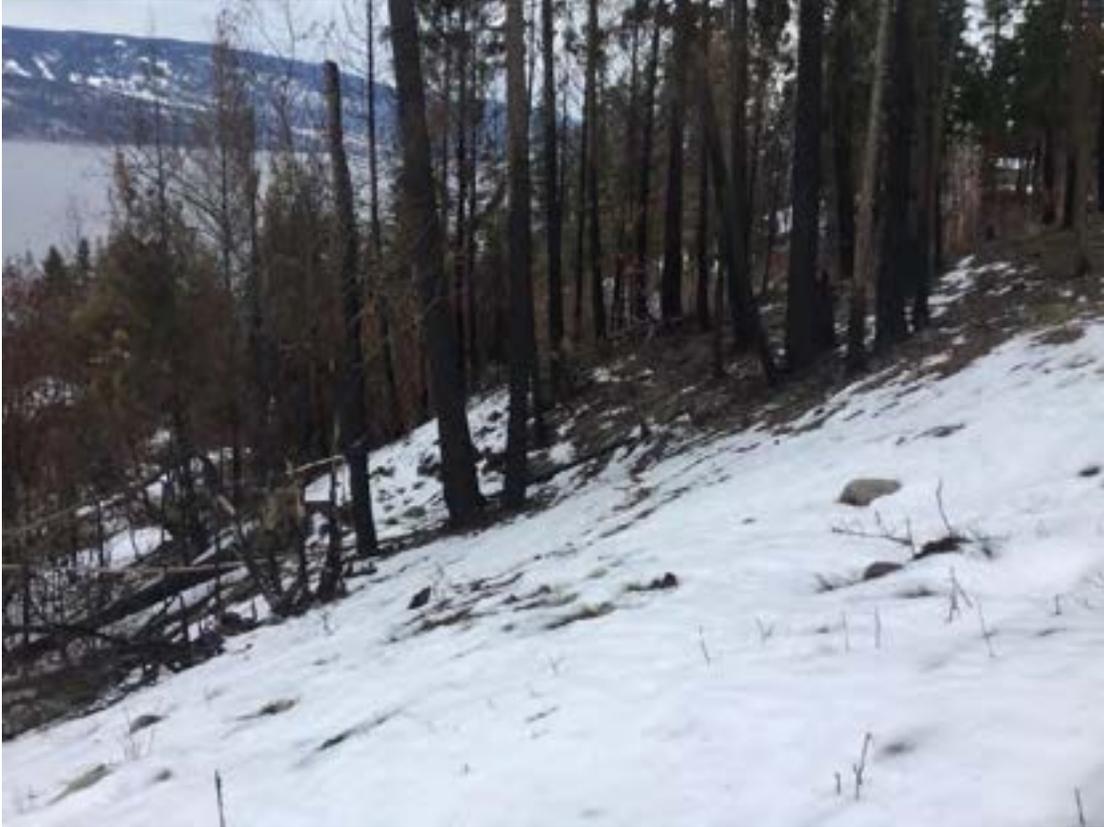
Photo 1: View of slopes along south side of 8715 N Westside Rd.

Recommended Recovery Response and Considerations for Future Development:	
	Long term: Consider groundwater assessment and soils/geotechnical assessment for future development.

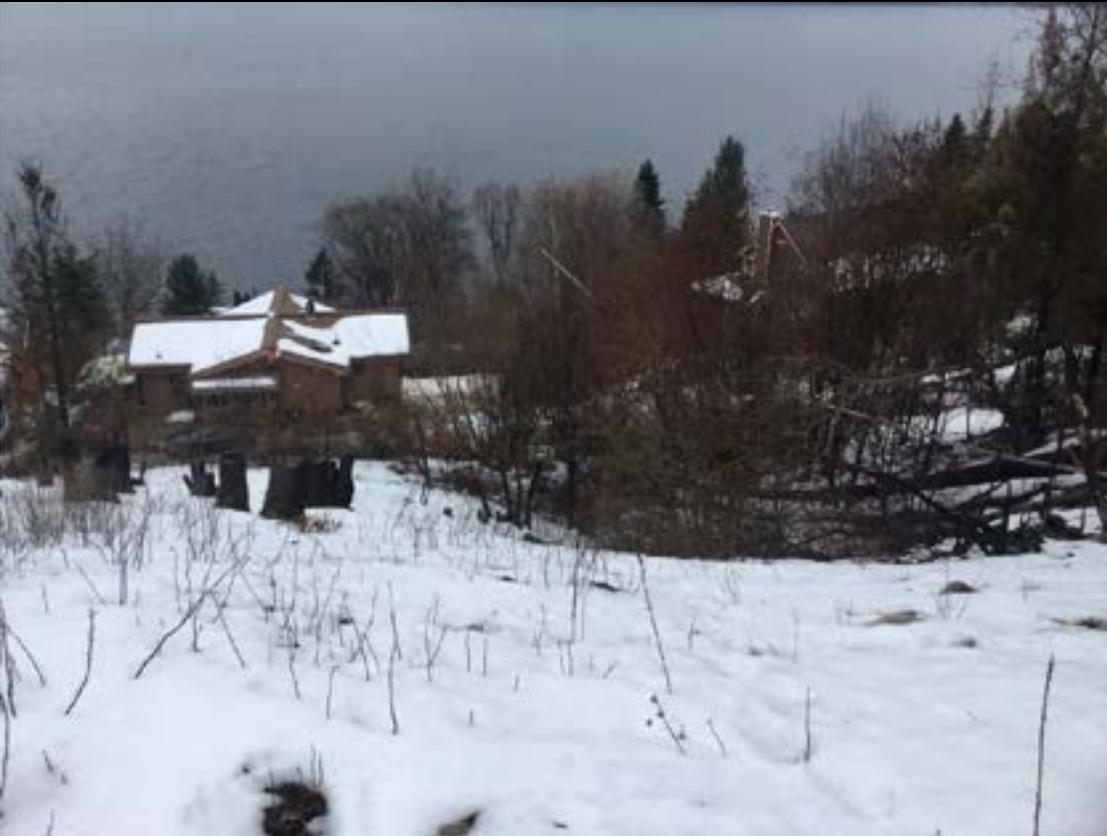
Photo 2: View downslope towards Okanagan Lake from 8715 N Westside Rd.

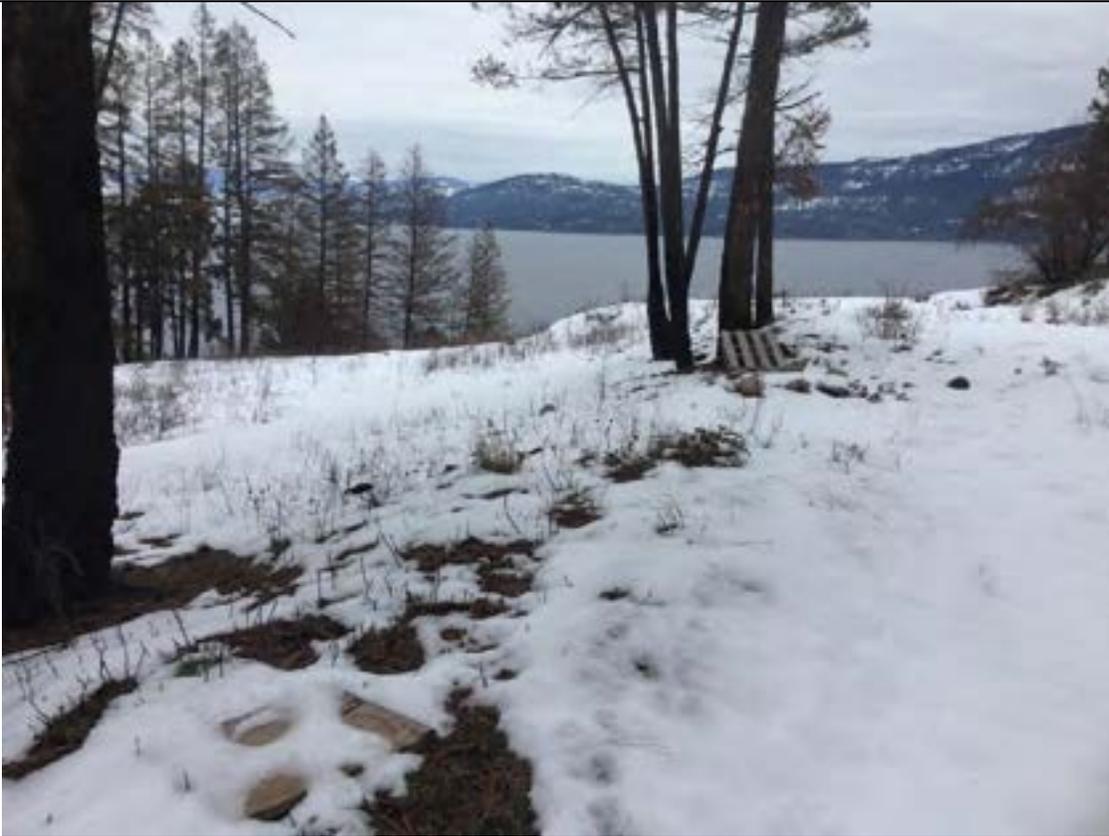
Photo 3: View of level area at top of 8715 N Westside Rd.

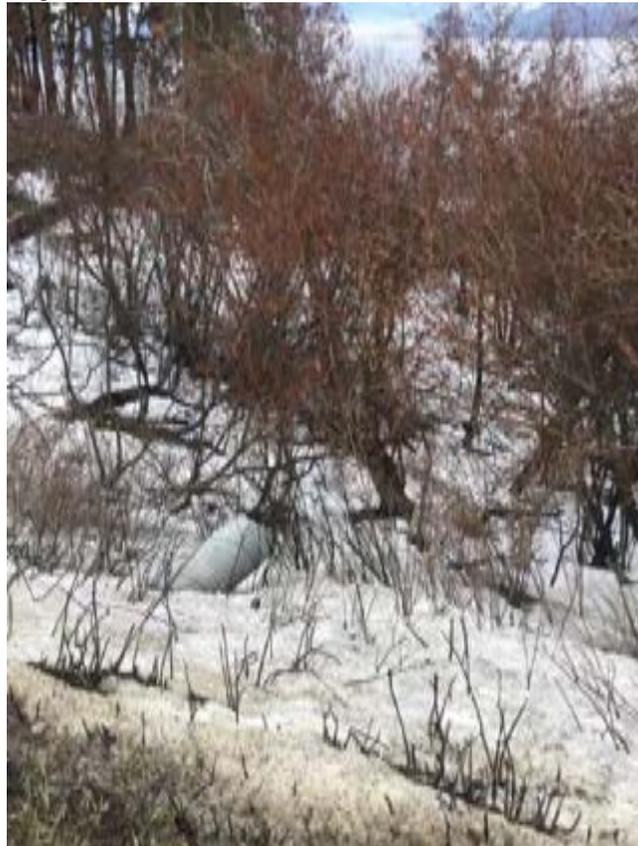
Photo 4: View of culvert outlet on Westside Road, draining into gully south of 8715 N Westside Rd.
